**Regency Palms
Port Richey, Florida**

**Multi-Family Mortgage
Revenue Bond Program
Application**

Property Name: Regency Palms Apts		Property Type: Multifamily Apartments									
Address: 8332 Alnwick Circle		Property Age: 16									
City and State: Port Richey, FL		No. of units: 200									
Site Survey Date: 11/4-5/2015		Square feet: 248,815									
Report Date: November 12, 2015		Analysis Term: 20									
EBI Project #: 1715000325											
Section #	Section Name	Condition					Action Required	Critical Repairs	Non-Critical Repairs	Replacement Reserves	
		Excellent	Good	Fair	Poor	NA					
SITE CONDITIONS

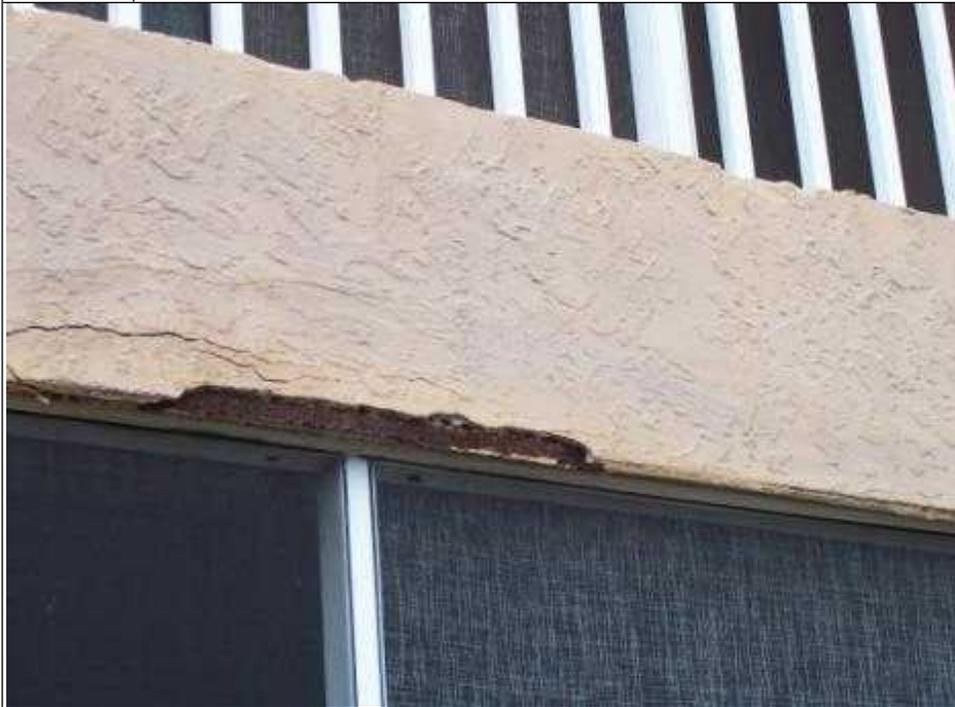
12. Damaged stucco and deteriorated paint (Non-Critical Repairs)

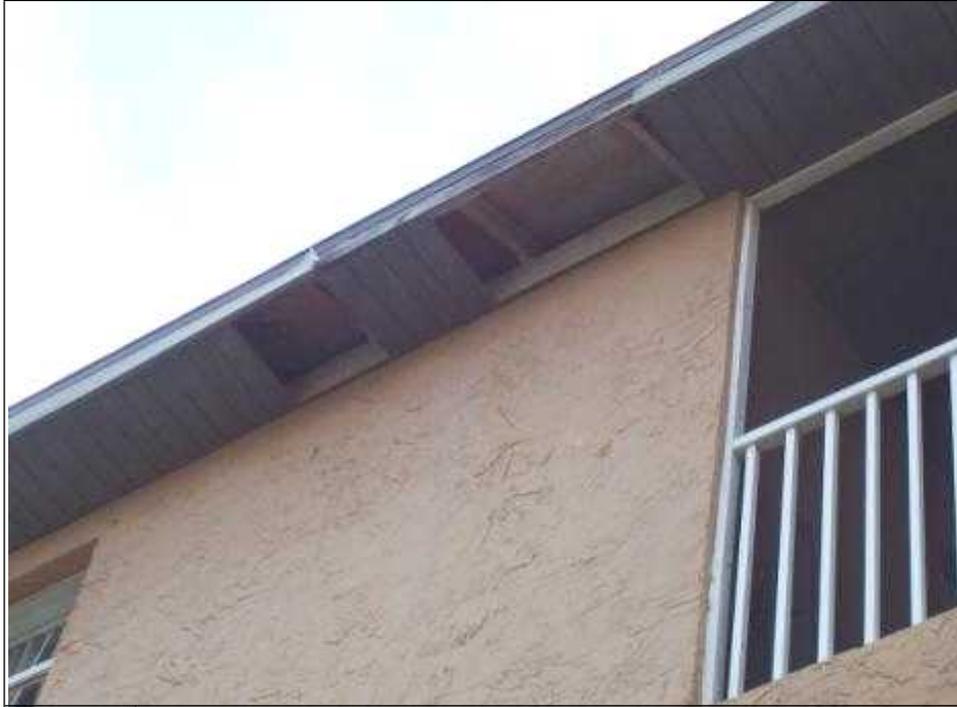
13. Damaged soffit and fascia at east side of building 10 (Non-Critical Repairs)

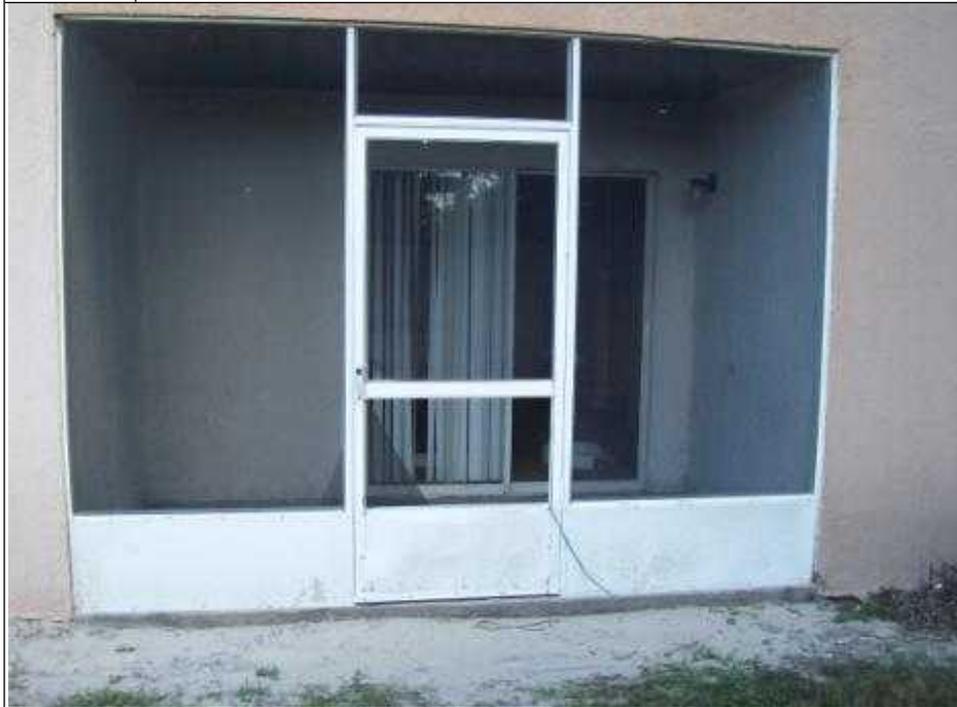
14. Patio enclosure with a damaged area of screen (Non-Critical Repairs)

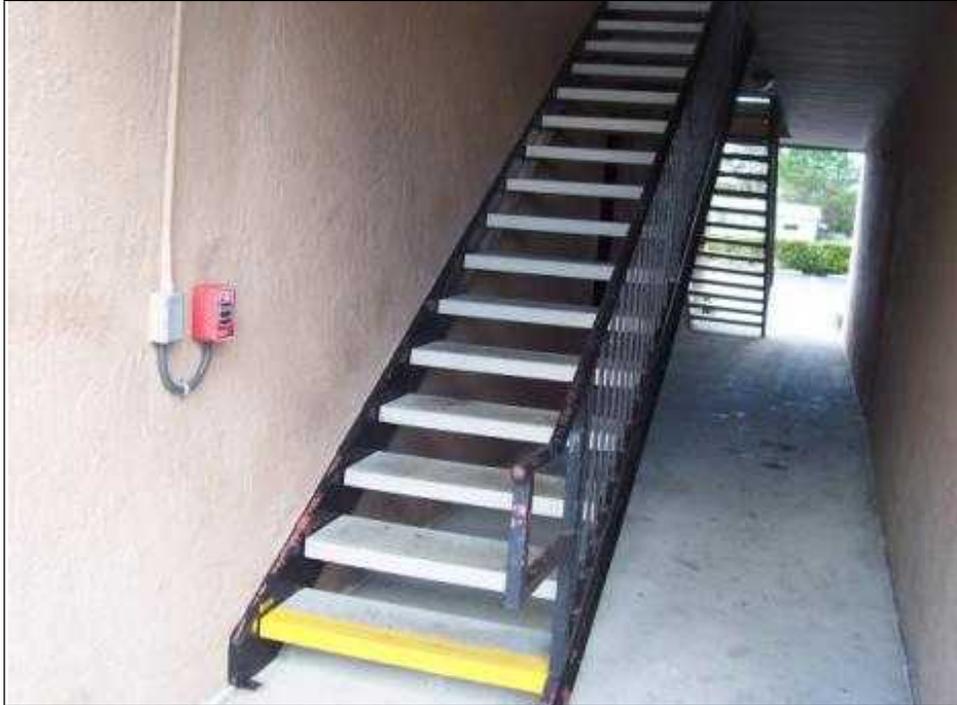
17. Exterior stairways and a pull station located in a breezeway with no cane barrier protection provided (Critical Repairs)

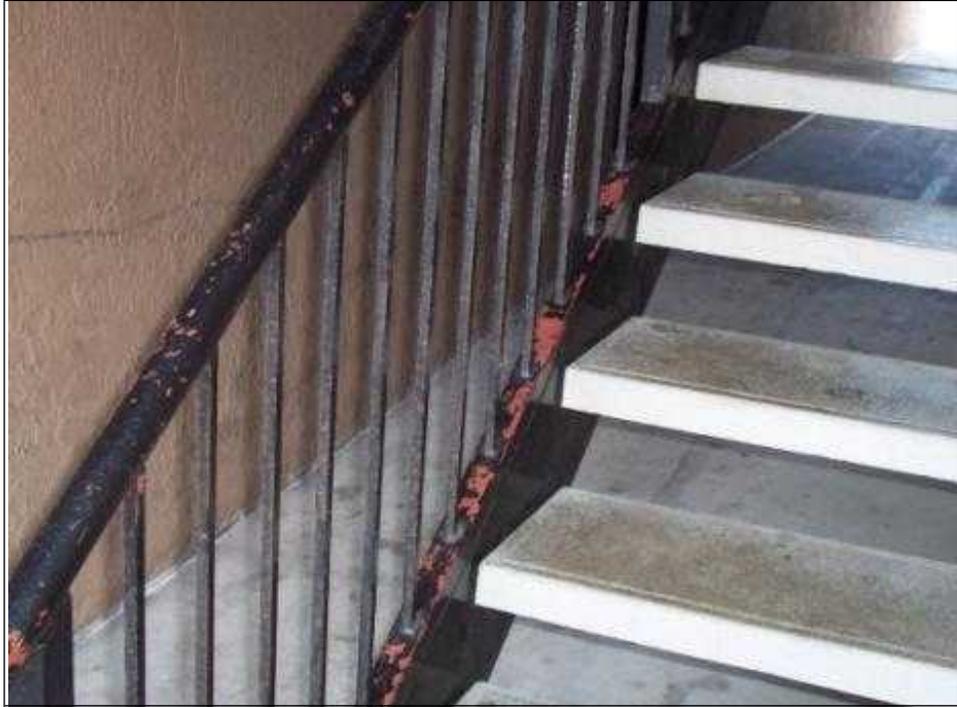
19. Deteriorated paint on exterior stairway (Non-Critical Repairs)

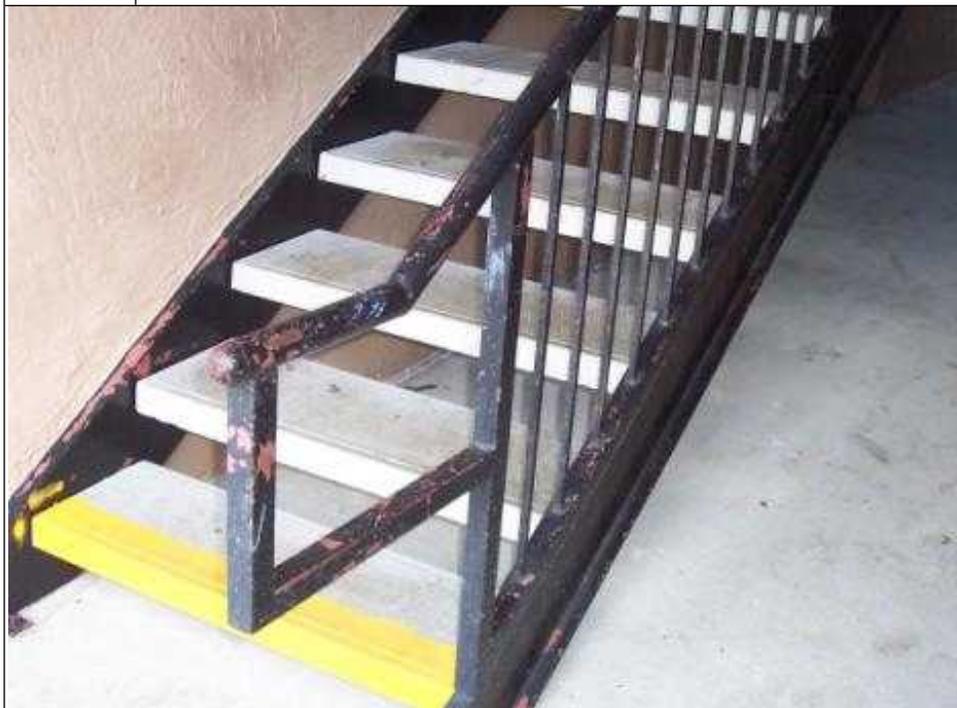
20. Another view of deteriorated paint located on an exterior stairway (Non-Critical Repairs)

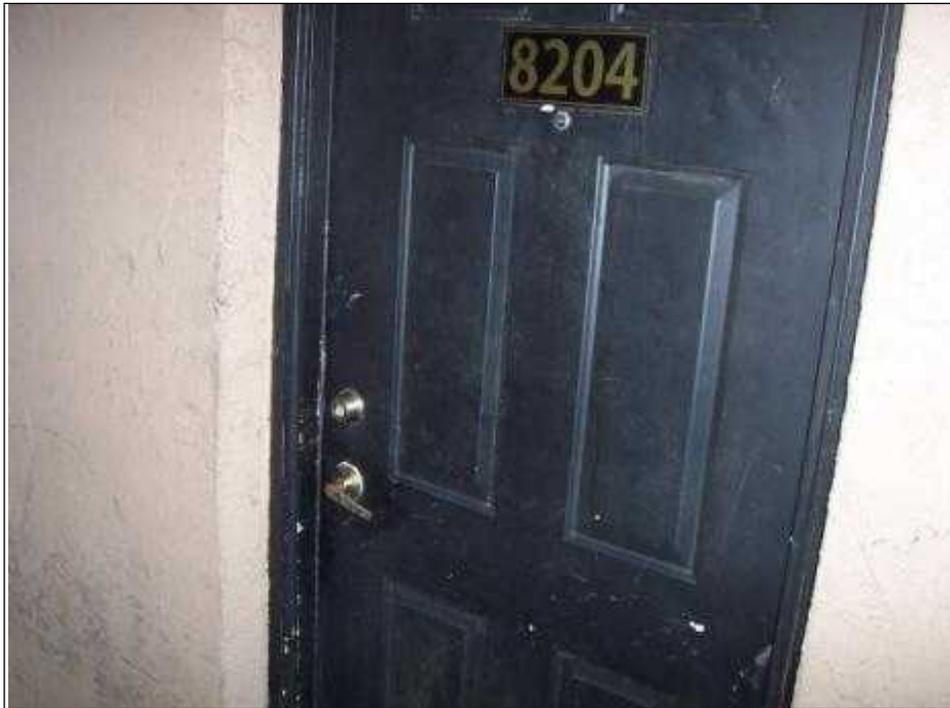
21. Deteriorated paint on door and trim at dwelling unit entrance door (Non-Critical Repairs)

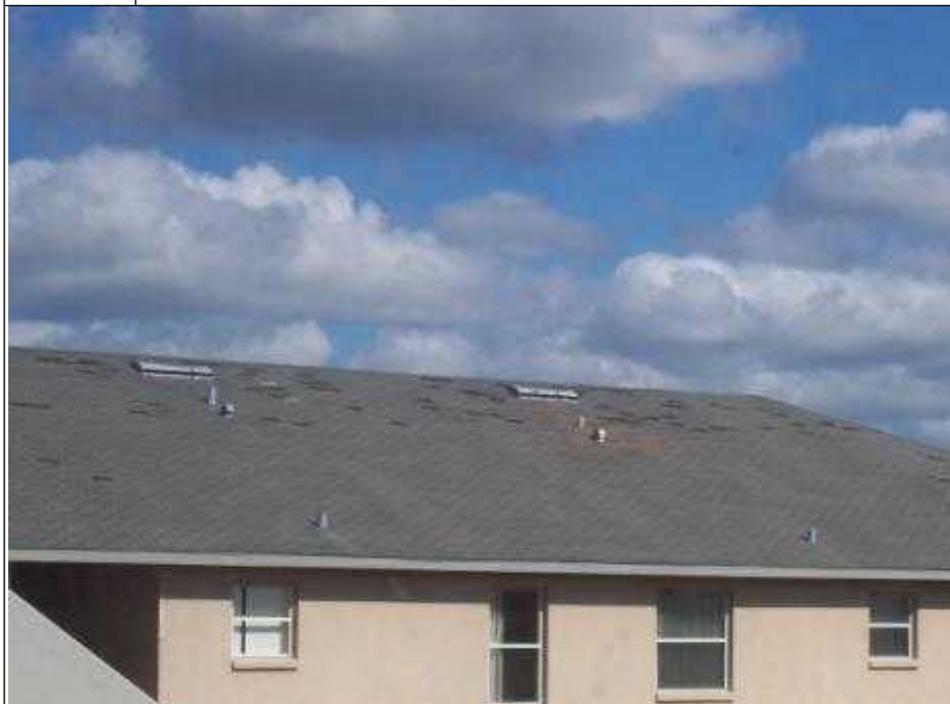
22. Areas of asphalt shingles missing from an apartment roof (Non-Critical Repairs)

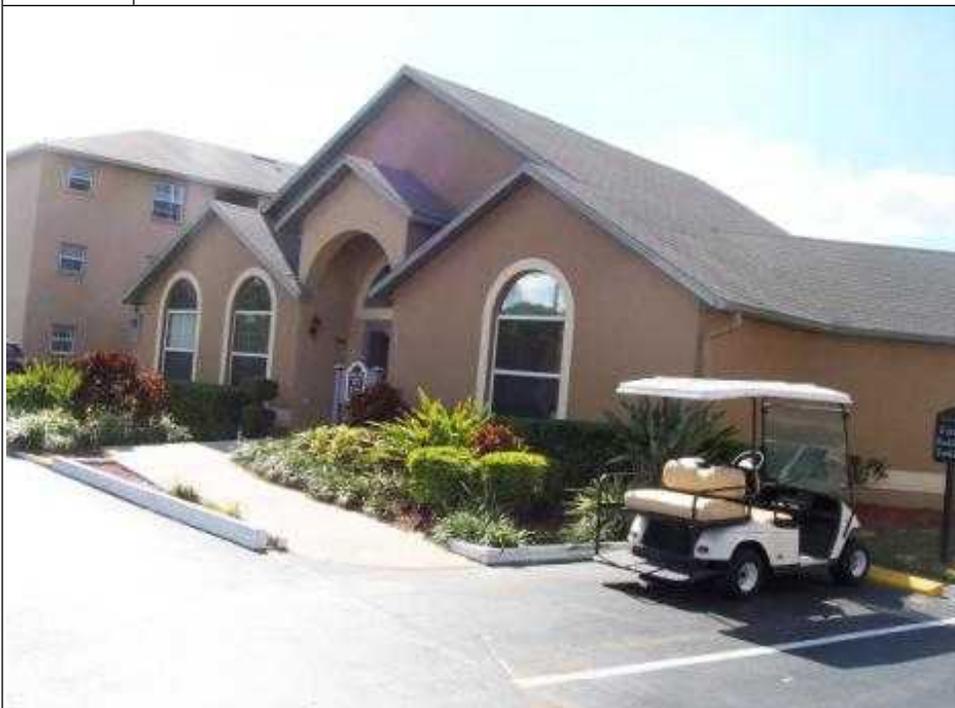
26. Front façade of leasing office and a sidewalk providing accessing between the parking area and primary entrance to the building with no van-accessible parking space provided (Critical Repairs)

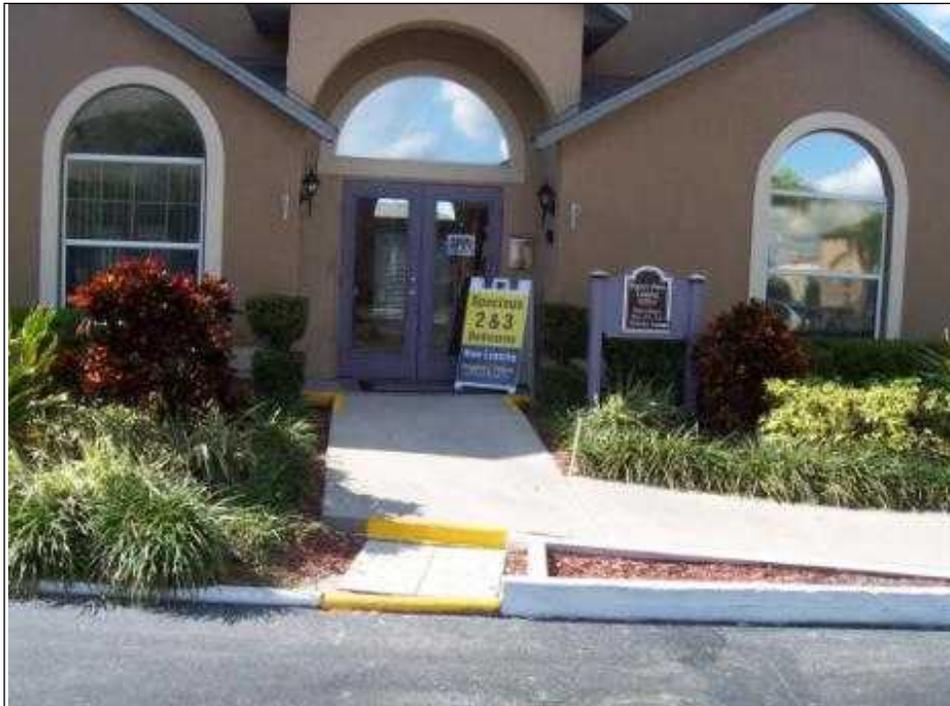
27. Primary entrance at leasing office is not provided with accessible signage indicating it as an accessible building entrance (Critical Repairs)

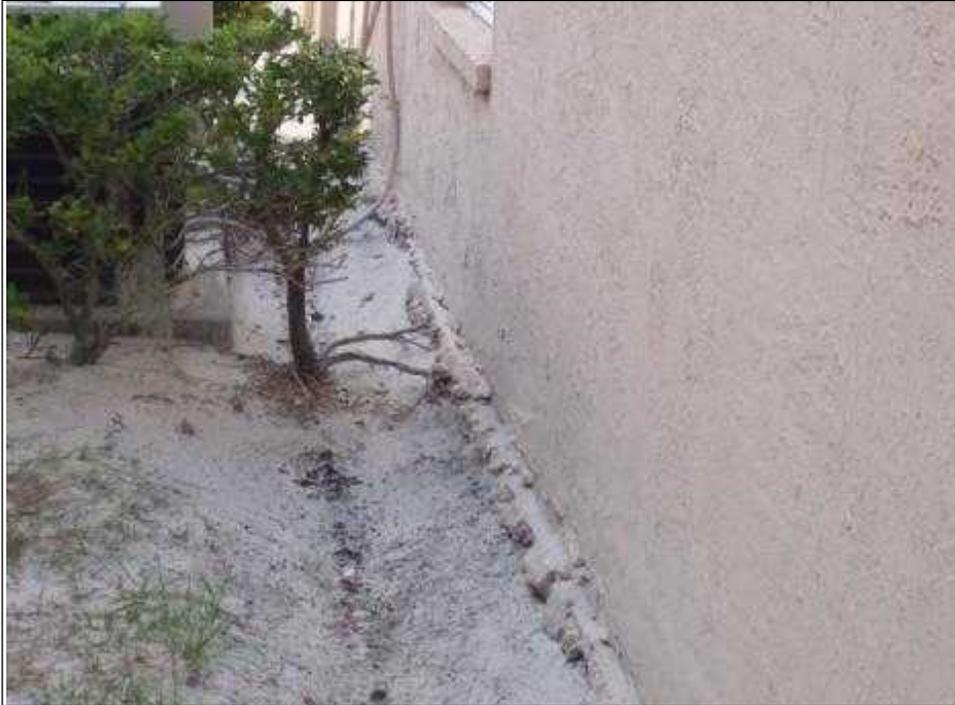
31. Soil erosion located in landscaping at building perimeters throughout Subject Property (Non-Critical Repairs)

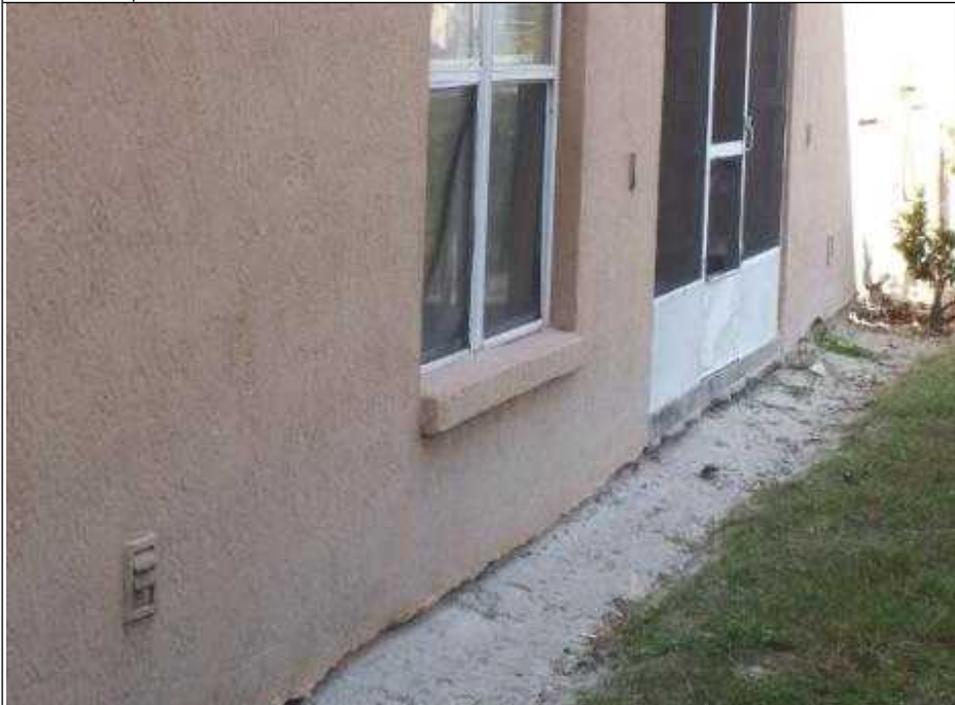
32. Another view of the soil erosion observed adjacent the building facades(Non-Critical Repairs)

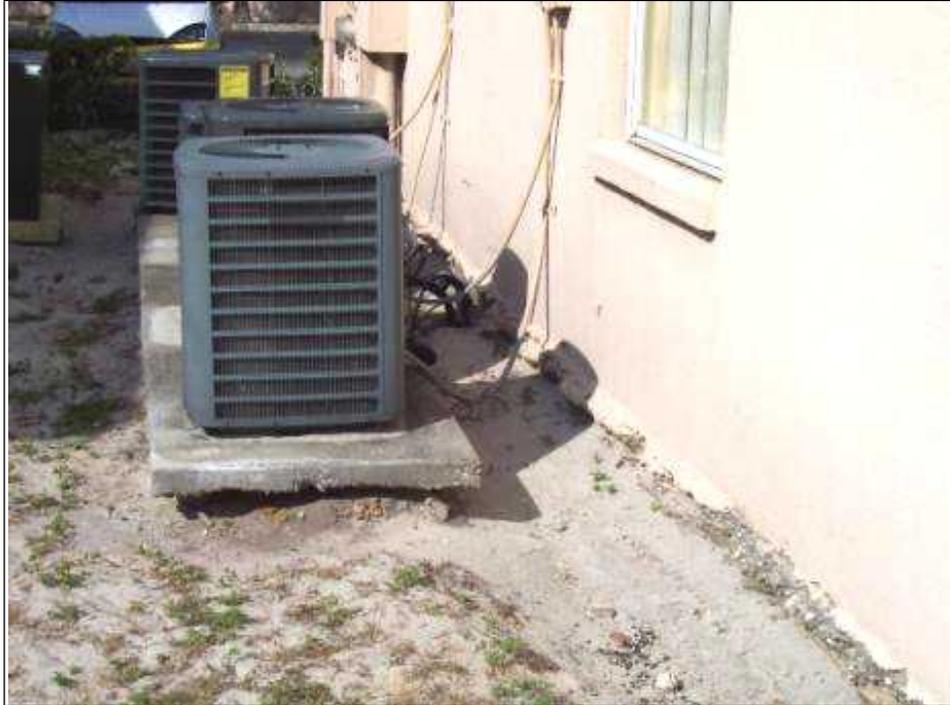
33. A third view of the soil erosion observed below the condenser unit pads (Non-Critical Repairs)

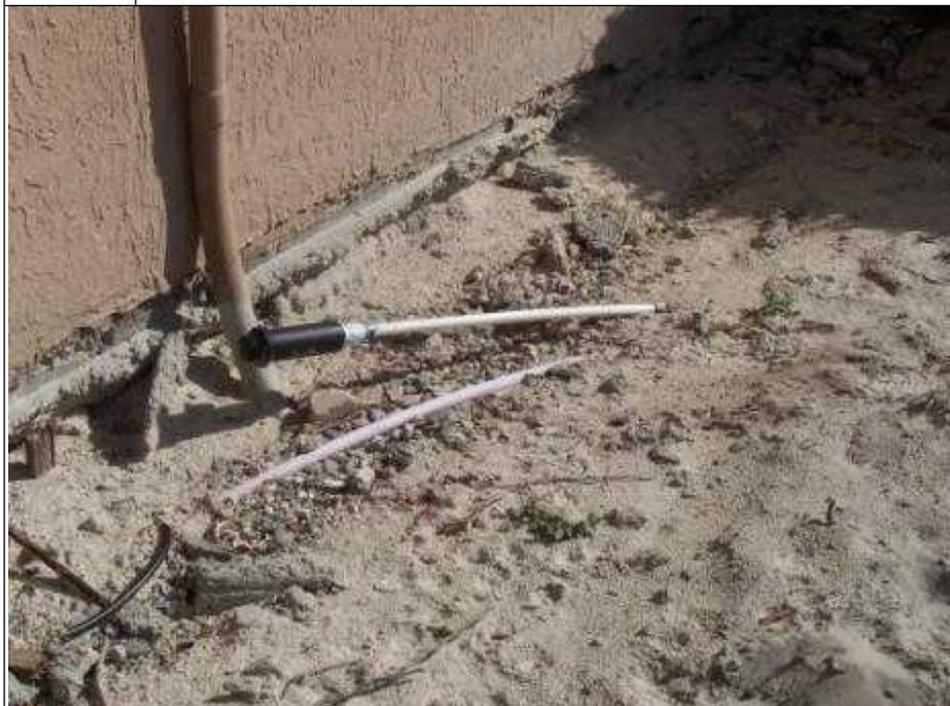
34. Soil erosion and damaged irrigation system sprinkler head (Non-Critical Repairs)

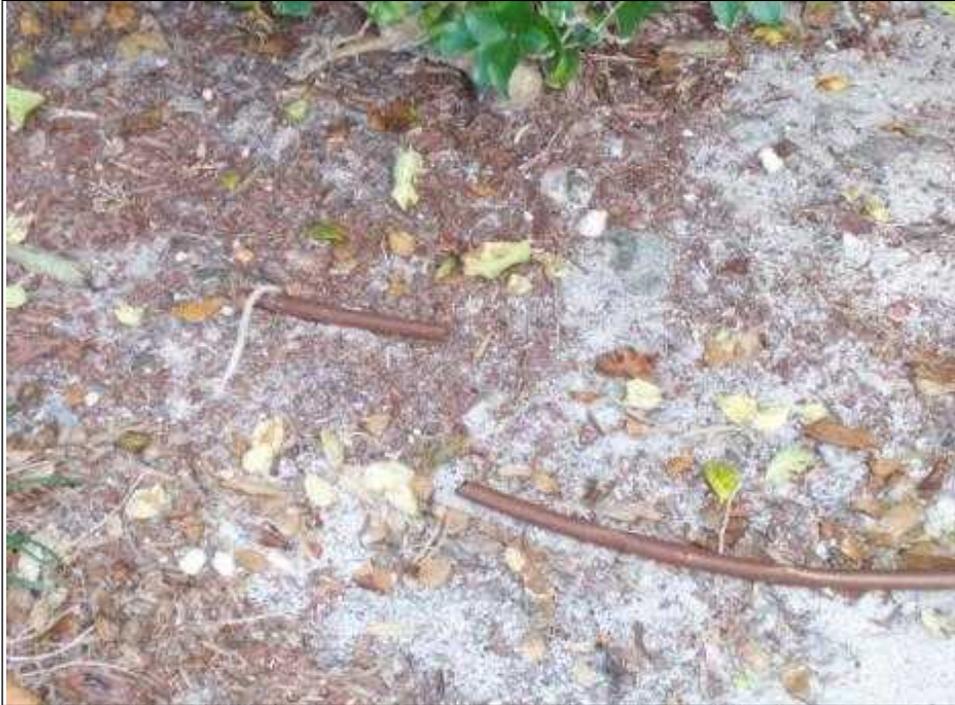
35. Damaged tubing associated with the irrigation system (Non-Critical Repairs)

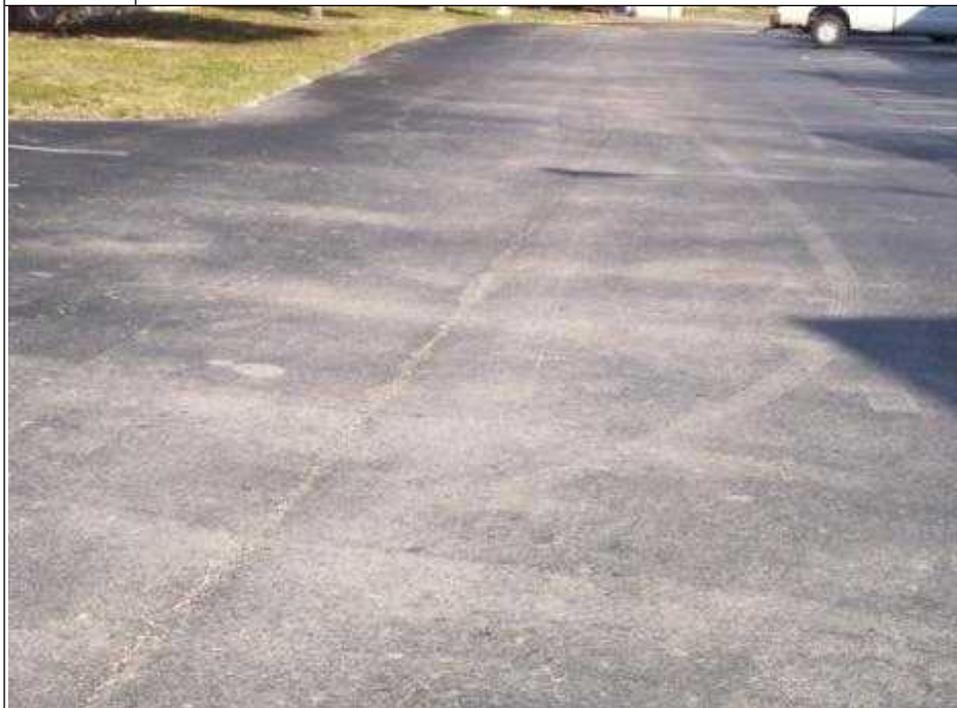
38. Deteriorated sealant on parking area asphalt pavement (Non-Critical Repairs)

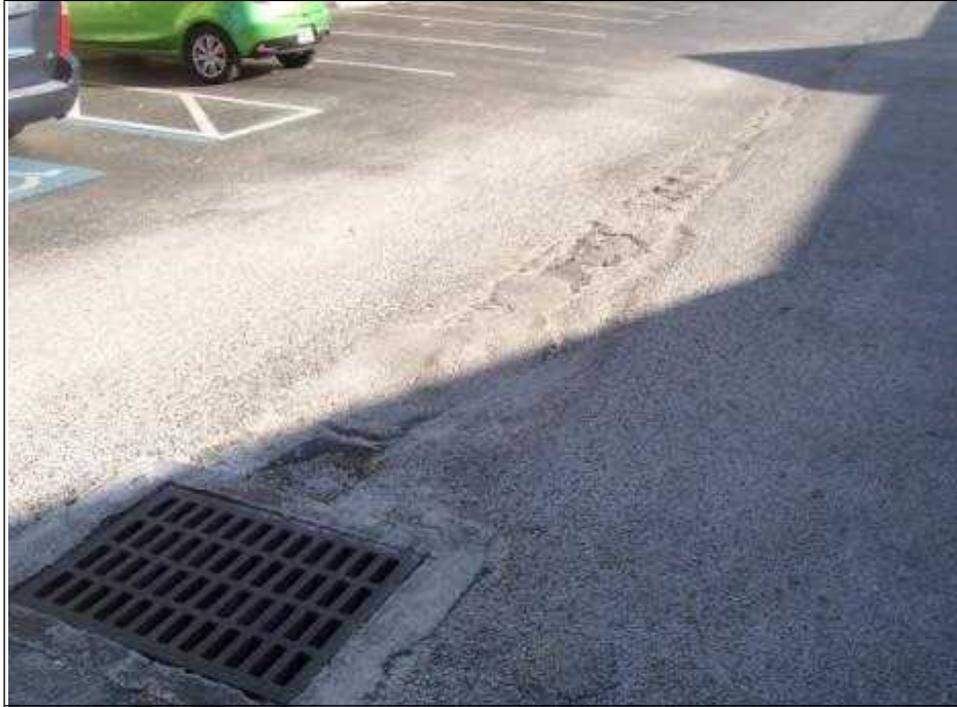
39.

Damaged area of pavement along the centerline of the drive lane (Non-Critical Repairs)

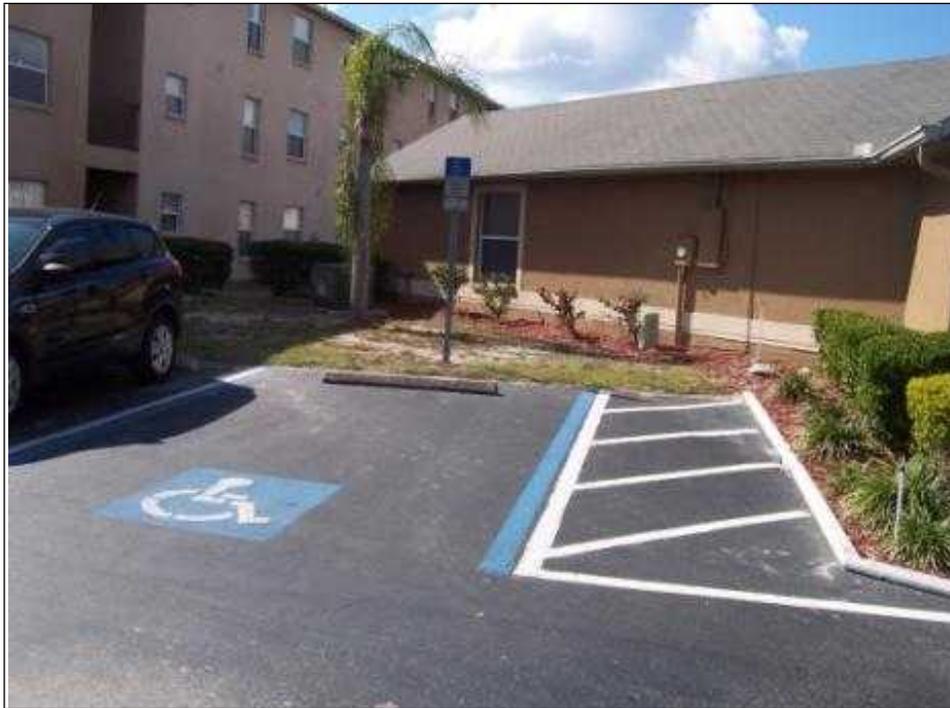
41.

A standard accessible parking space is provided adjacent to the leasing office but a van-accessible space is not provided (Critical Repairs)

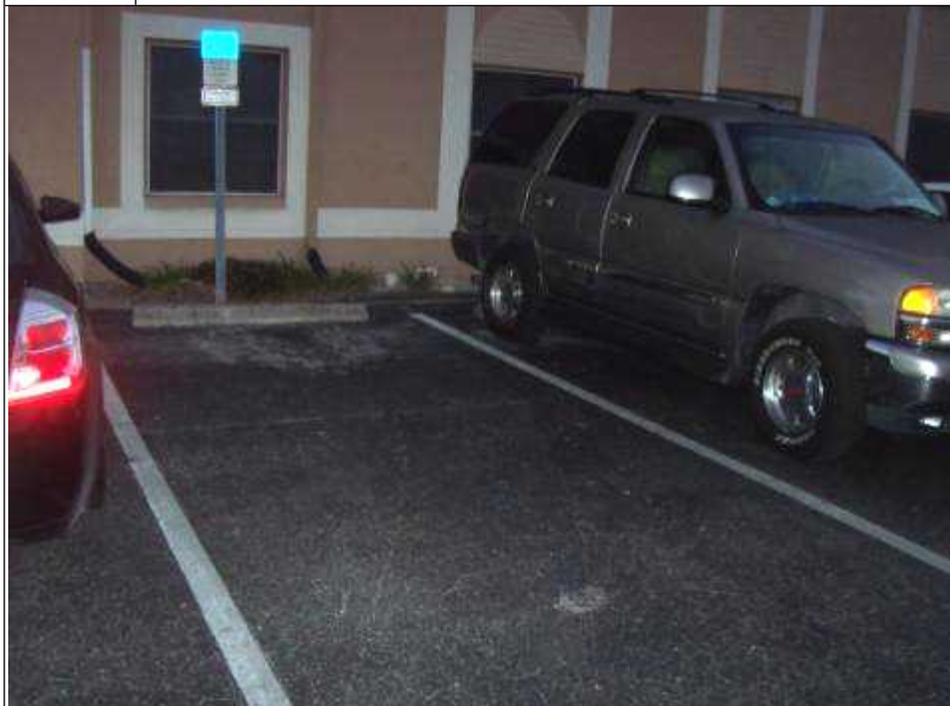
42.

An access aisle is not provided for the accessible parking space located on the west side of building 3 (Critical Repairs)

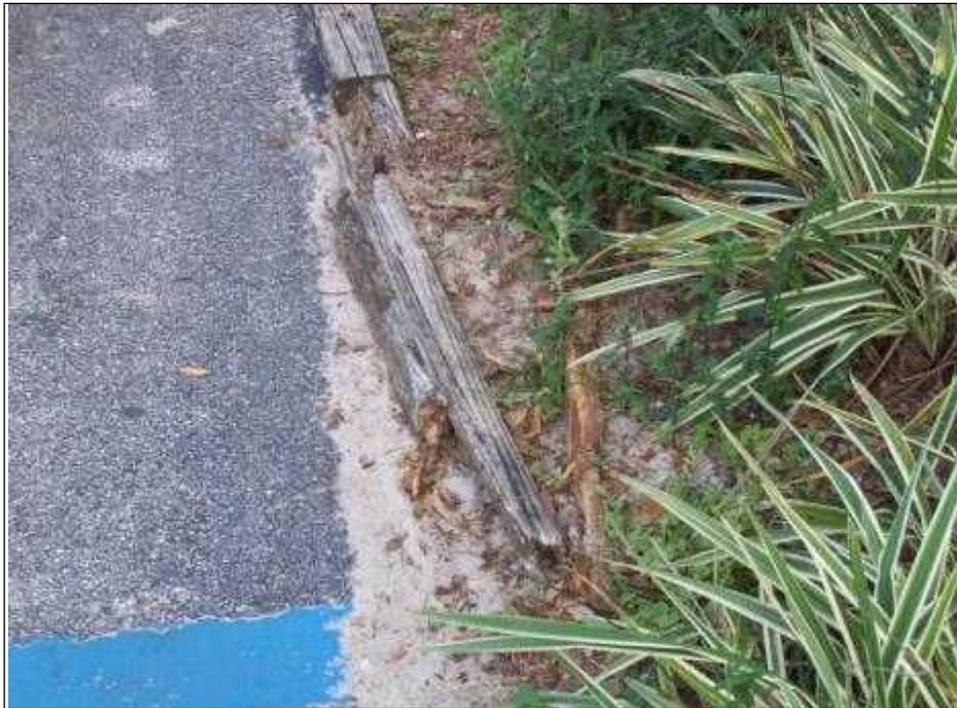
43. Deteriorated landscaped timber curbing located along perimeter of parking area (Non-Critical Repairs)

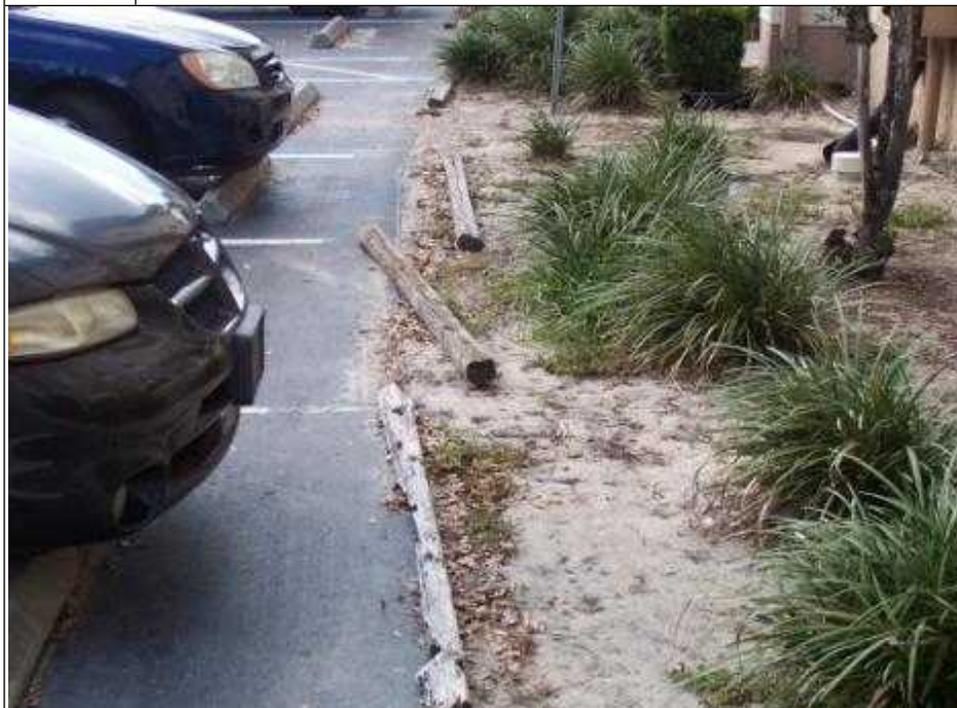
44. Another view of deteriorated landscape timber curbing located along the perimeter of the parking area (Non-Critical Repairs)

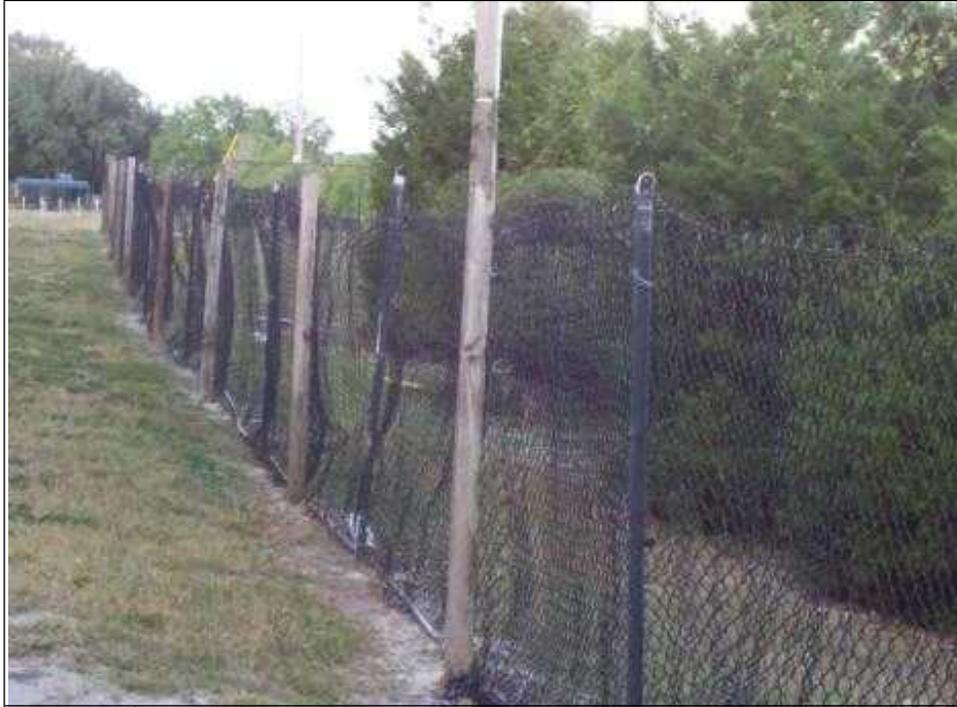
45. Damaged chain link fencing along the eastern boundary of Subject Property (Non-Critical Repairs)

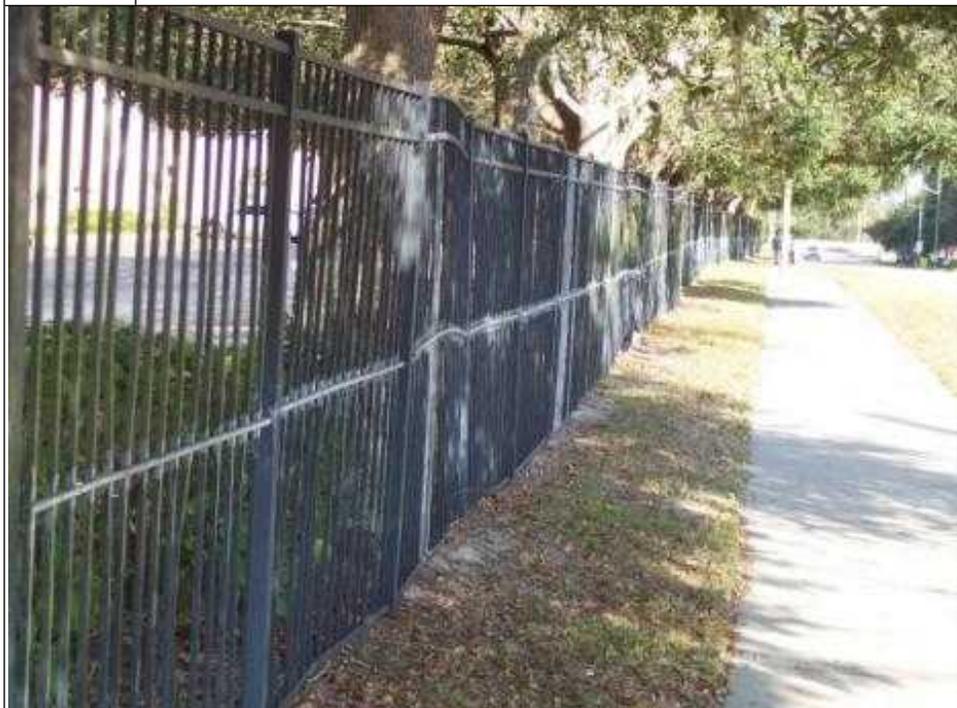
46. Metal fencing south perimeter of Subject Property with paint deterioration noted (Non-Critical Repairs)

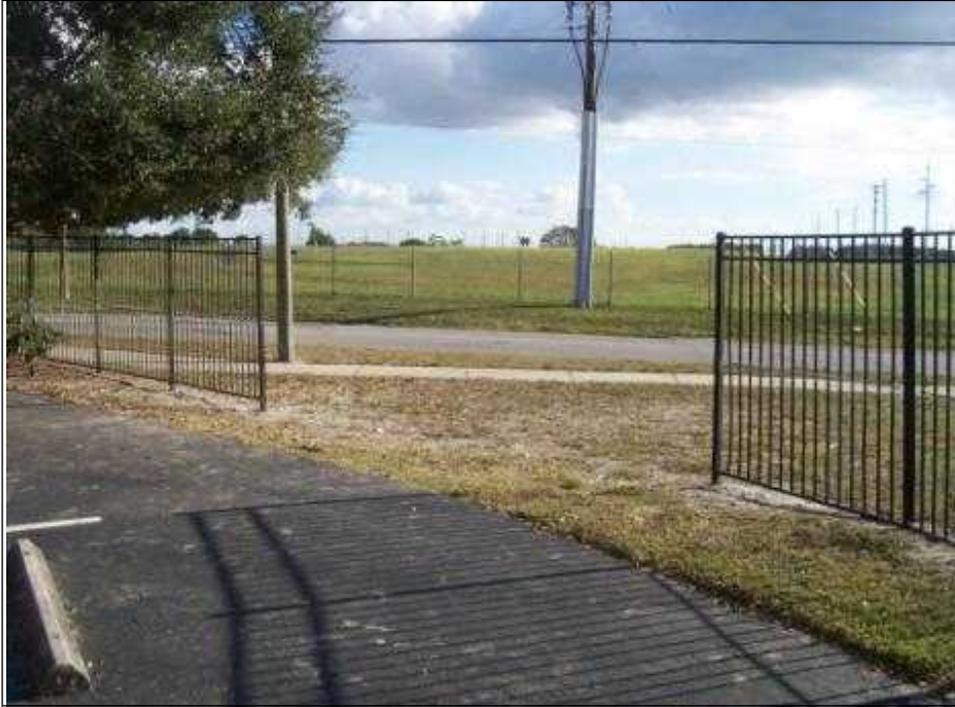
47. Missing fence observed along the southwest perimeter of the site (Non-Critical Repairs)

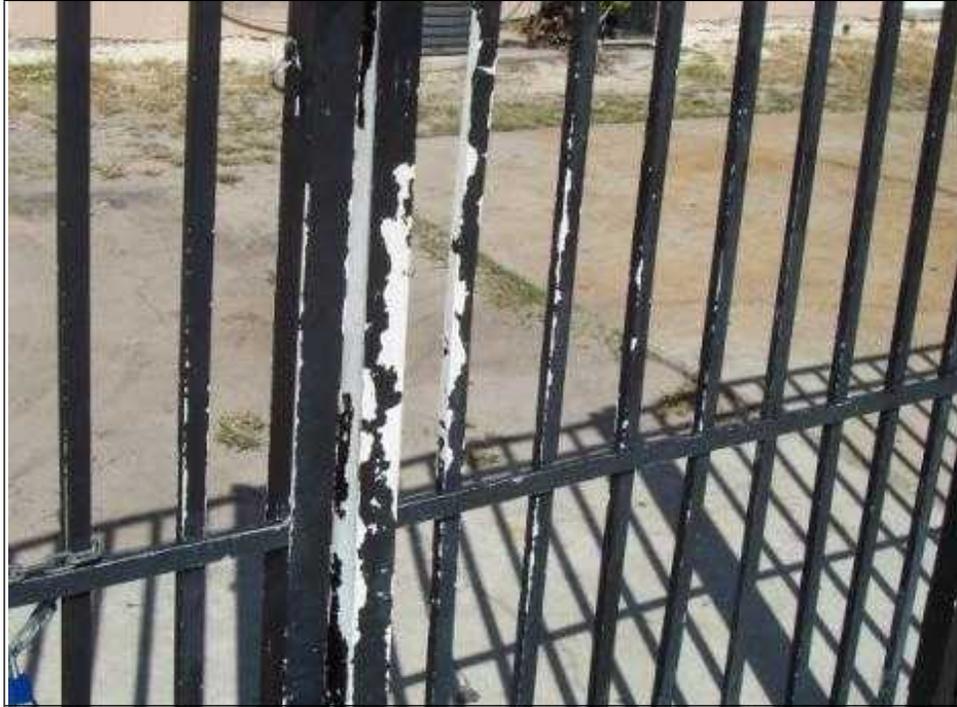
49. Deteriorated paint on fencing (Non-Critical Repairs)

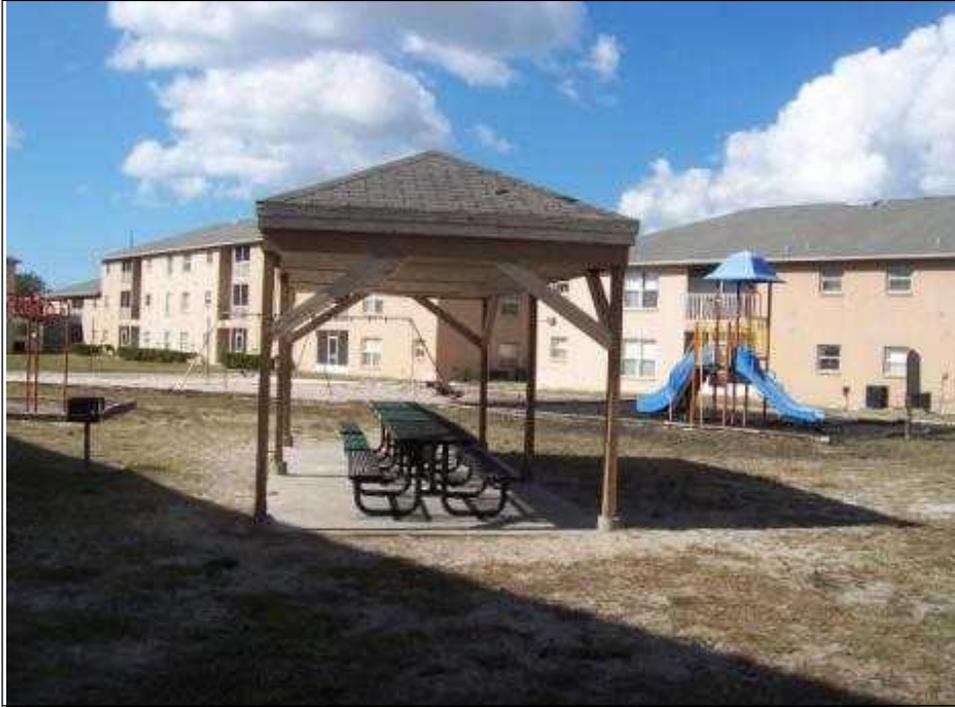
53.

Picnic shelter is not provided with an accessible pathway leading from the parking area (Critical Repair)

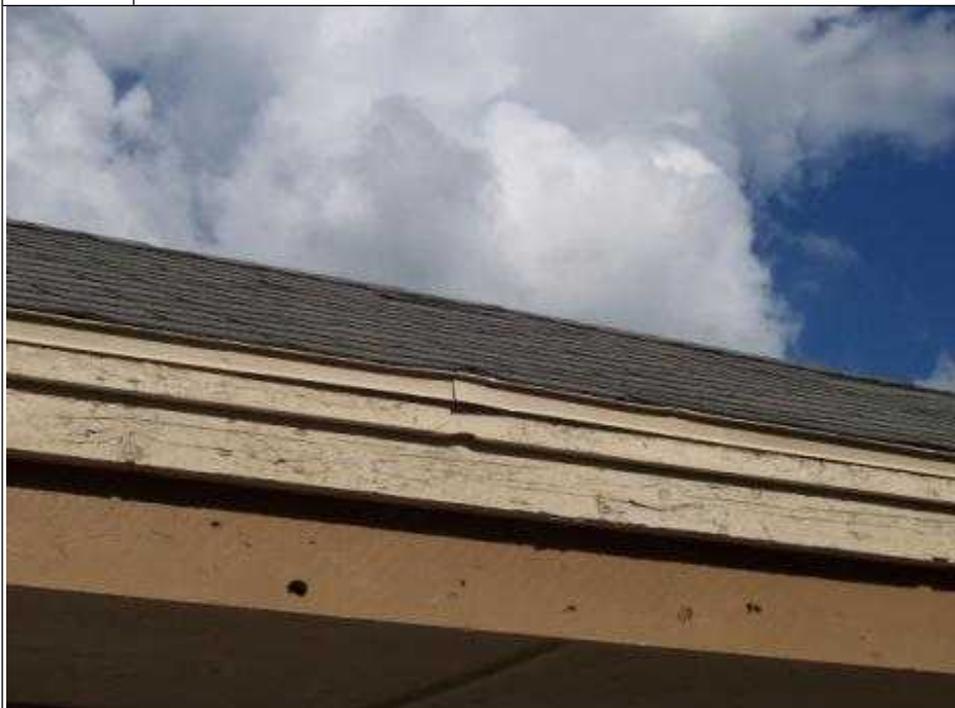
54.

Deteriorated paint on picnic shelter (Non-Critical Repairs)

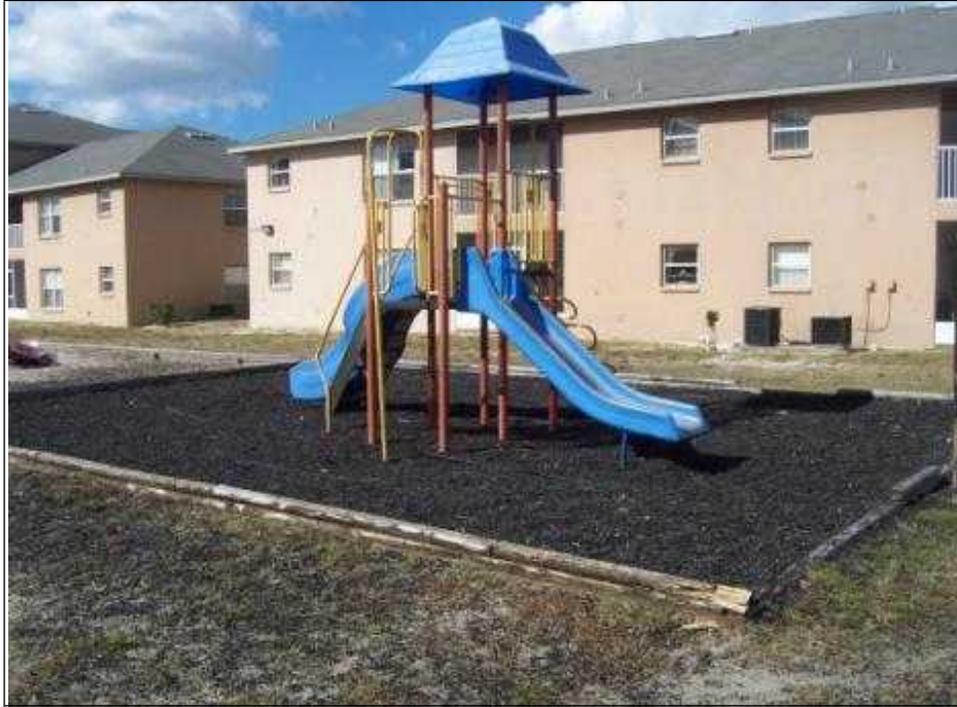
55. Playground is not provided with an accessible pathway leading from the parking area (Critical Repair)

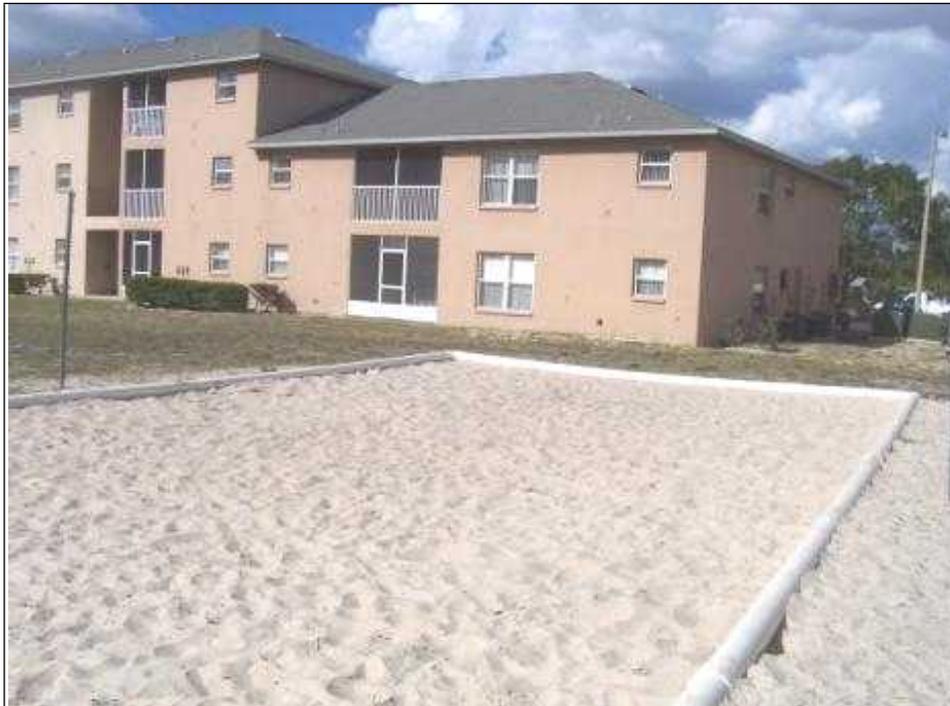
57. Volleyball court is not provided with an accessible pathway leading from the parking area (Critical Repair)

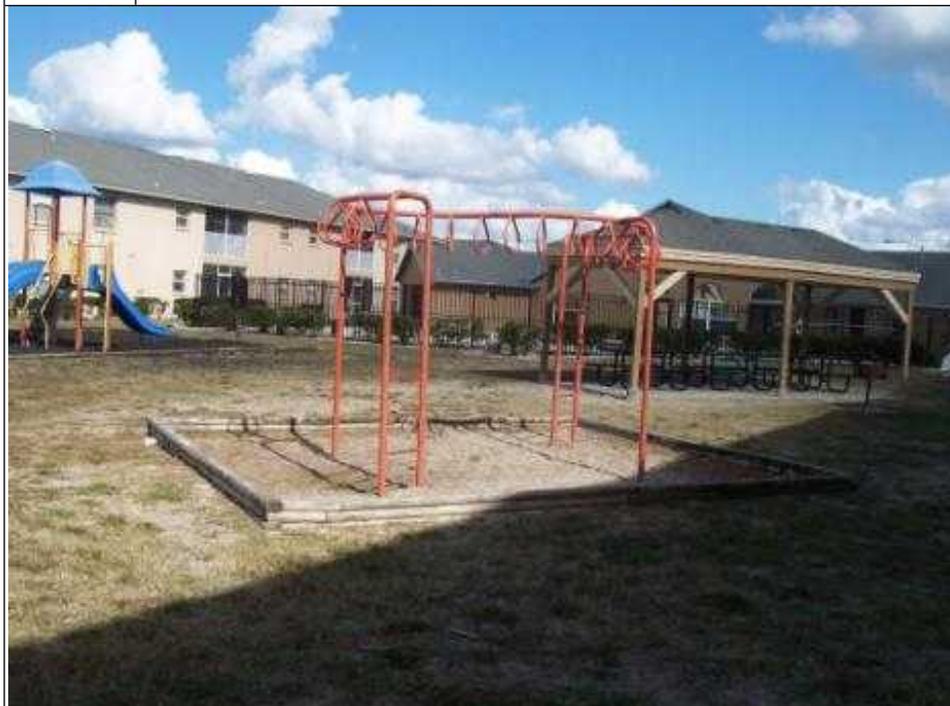
58. Jungle gym is not provided with an accessible pathway leading from the parking area (Critical Repair)

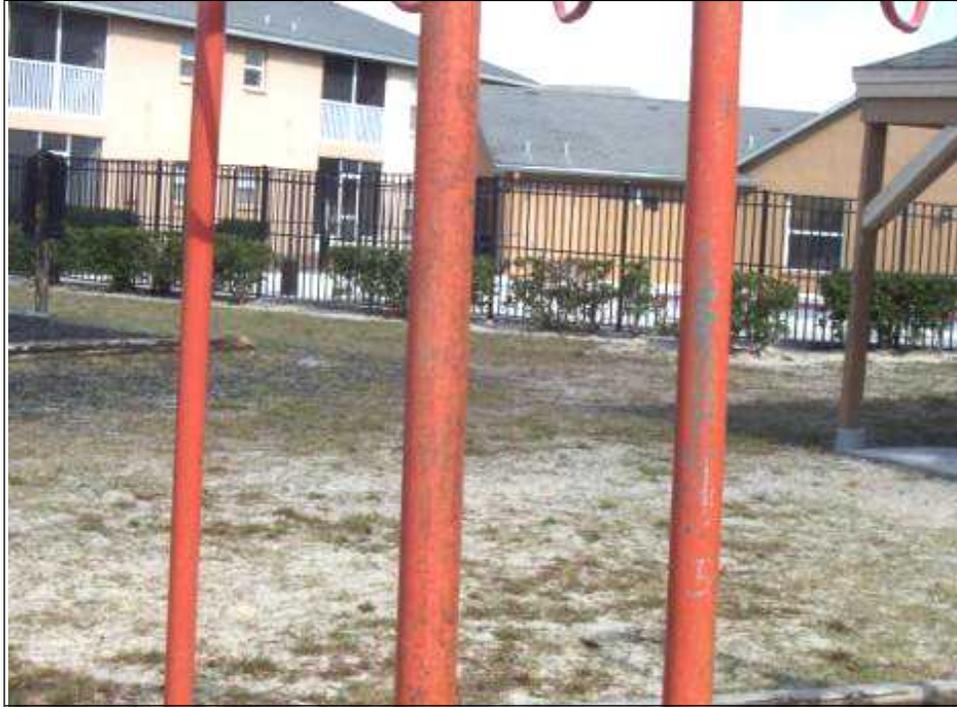
59.

Deteriorated paint noted on the playground equipment (Non-Critical Repairs).

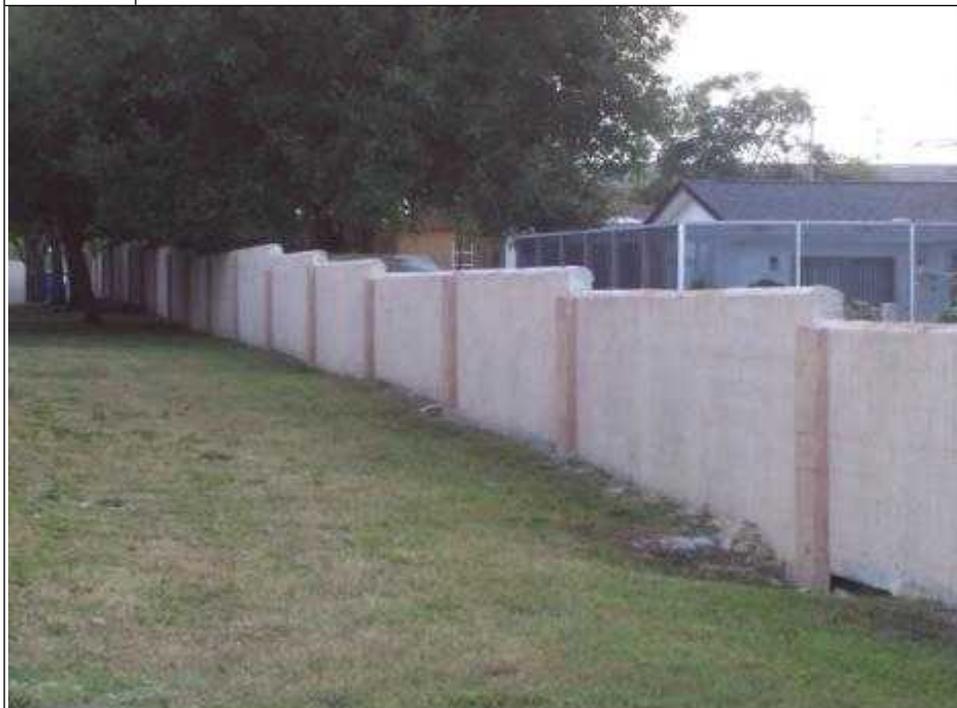
60.

CMU wall with deteriorated paint, located along the northern and western boundaries of Subject Property (Non-Critical Repairs)
