**Regency Palms
Port Richey, Florida**

**Multi-Family Mortgage
Revenue Bond Program
Application**

Property Name: Regency Palms Apts		Property Type: Multifamily Apartments									
Address: 8332 Alnwick Circle		Property Age: 16									
City and State: Port Richey, FL		No. of units: 200									
Site Survey Date: 11/4-5/2015		Square feet: 248,815									
Report Date: November 12, 2015		Analysis Term: 20									
EBI Project #: 1715000325											
Section #	Section Name	Condition					Action Required	Critical Repairs	Non-Critical Repairs	Replacement Reserves	
		Excellent	Good	Fair	Poor	NA					
SITE CONDITIONS

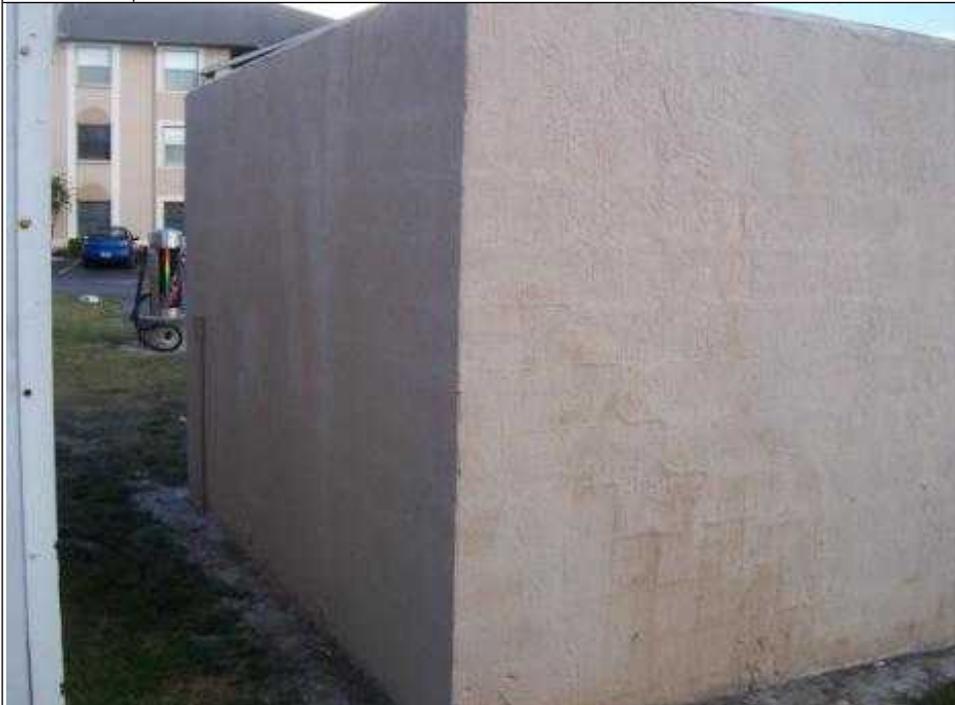
62. Close-up of paint deterioration on the dumpster enclosure (Non-Critical Repairs)

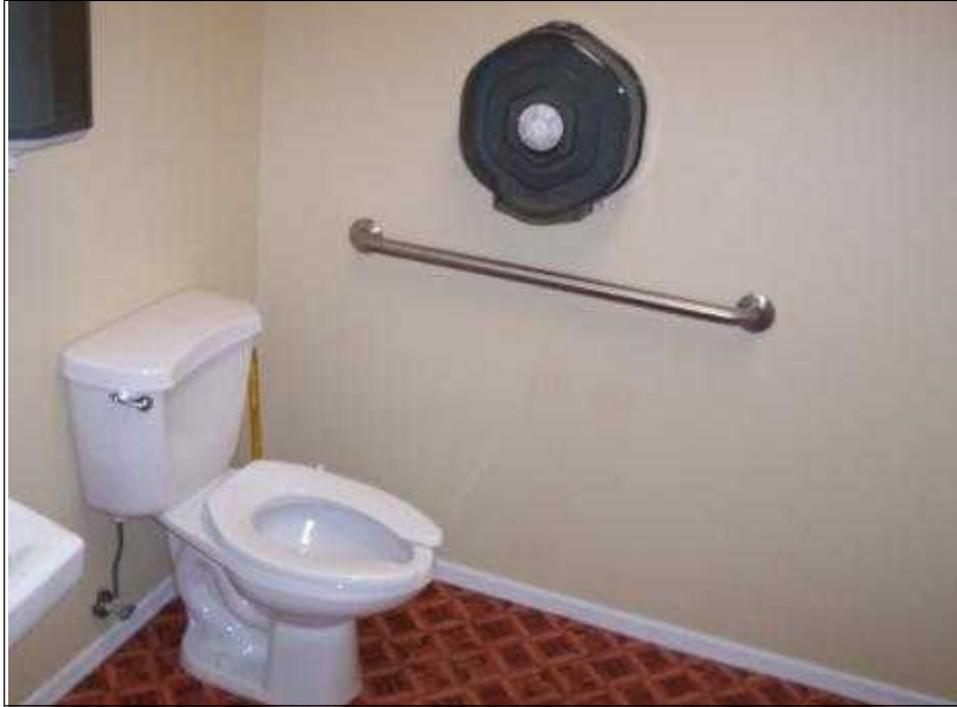
69. Public restroom located in leasing office is not provided with a rear grab bar (Critical Repairs)

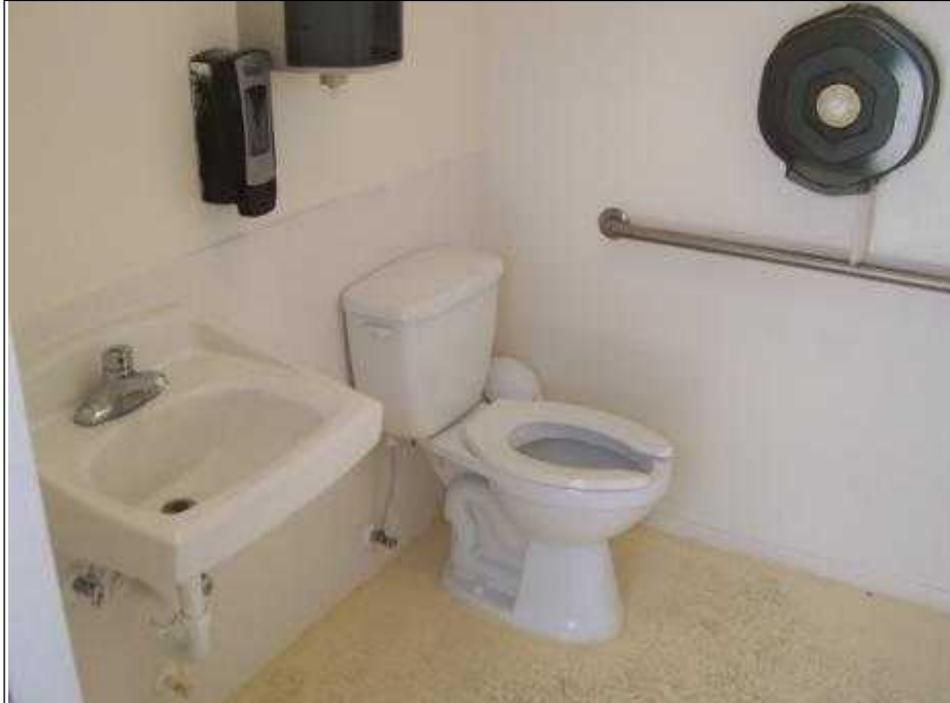
71.

Women's restroom located in leasing office by swimming pool area is not provided with scald/abrasion protection on the exposed sink piping (Critical Repairs)

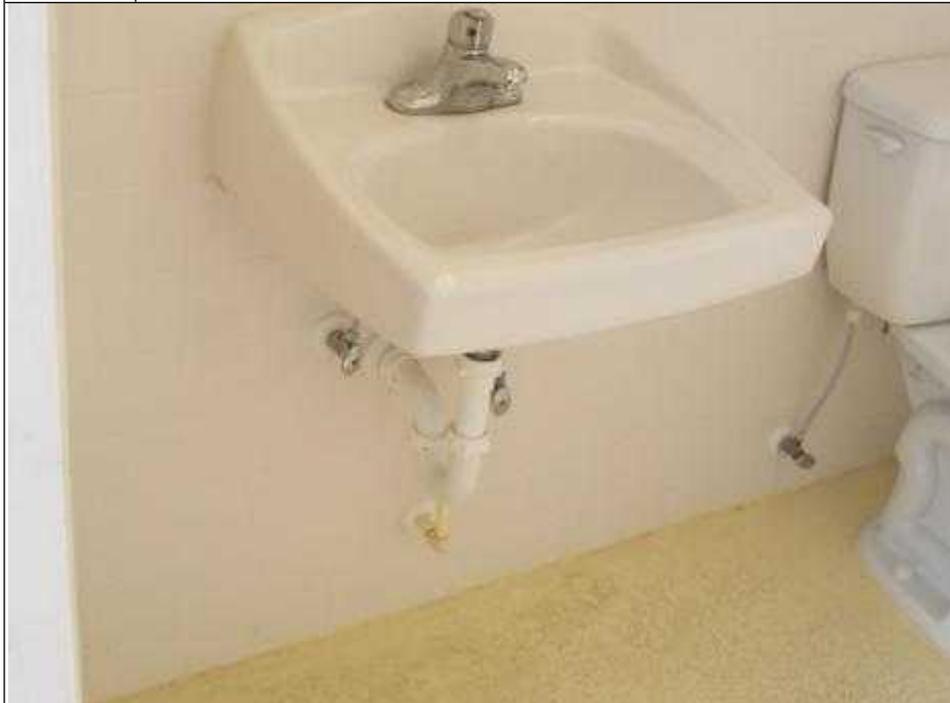
72.

Sink area located in the women's restroom by the swimming pool area is not provided with scald/abrasion protection on the exposed sink piping (Critical Repairs)

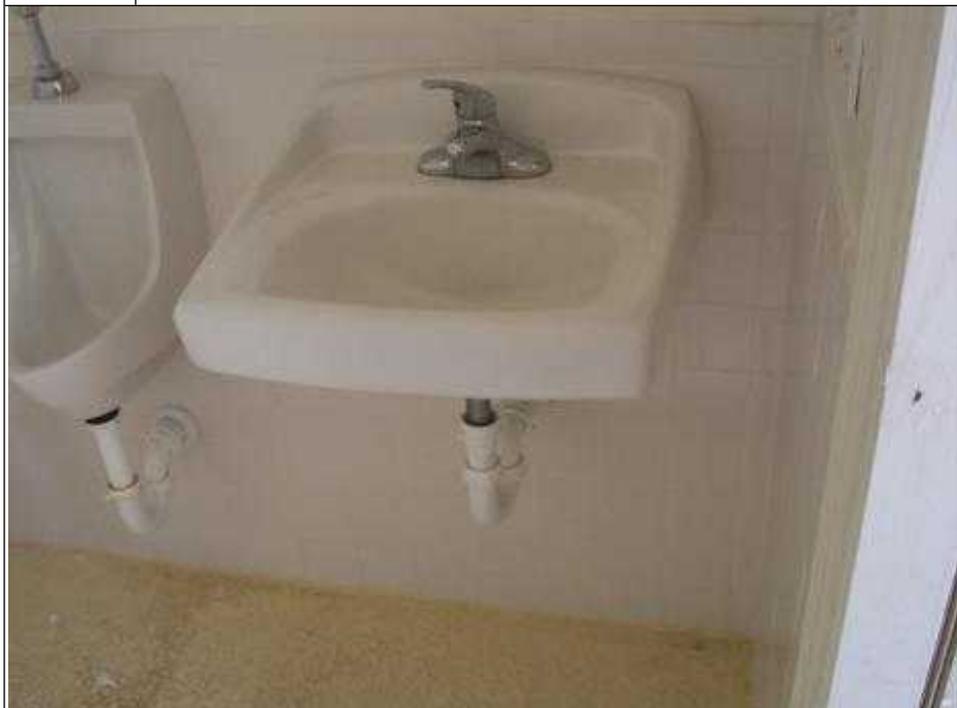
74. Sink area located in men's restroom by swimming pool area is not provided with scald/abrasion protection on the exposed sink piping (Critical Repairs)

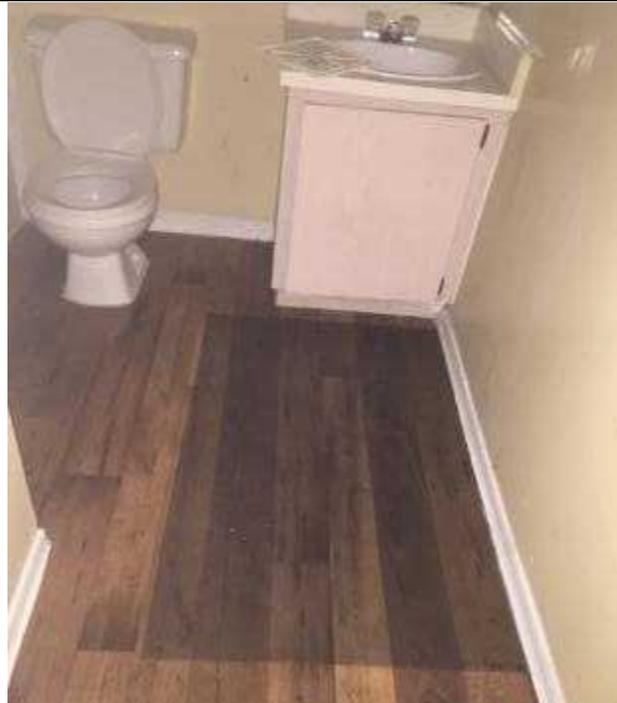
82. Adaptable/ground floor dwelling unit bathroom that requires frontal approach and removable base cabinetry is not provided (Critical Repairs)

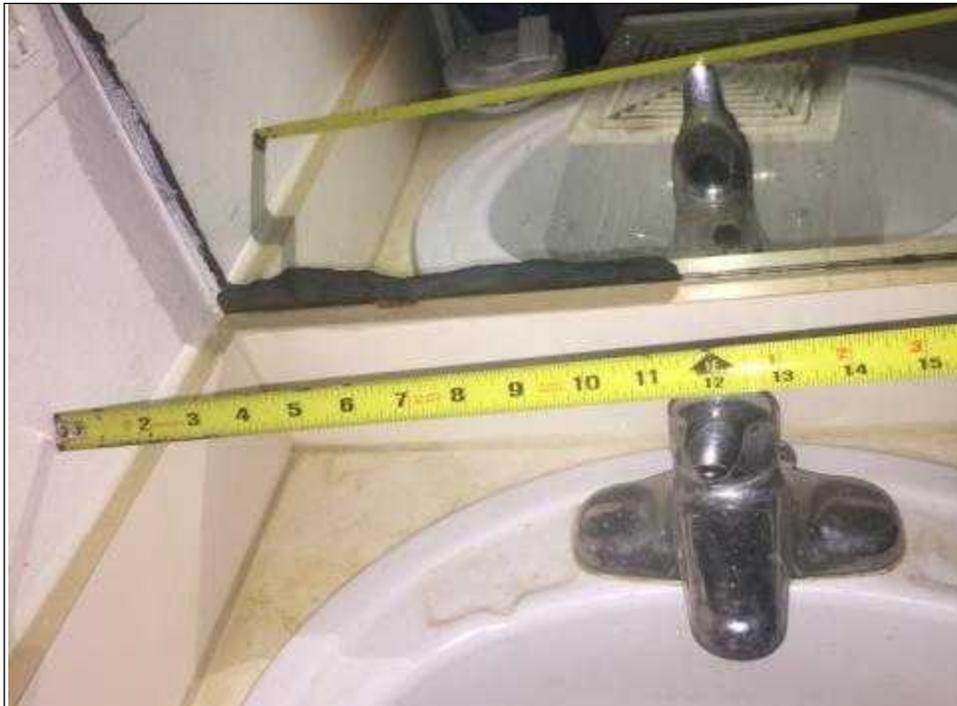
83. Adaptable/ground floor dwelling unit bathroom sink that does not have a compliant 30 x 48-inch, centered, frontal clear floor space because the centerline of the sink is less than 15-inches from the adjacent wall (Critical Repairs)

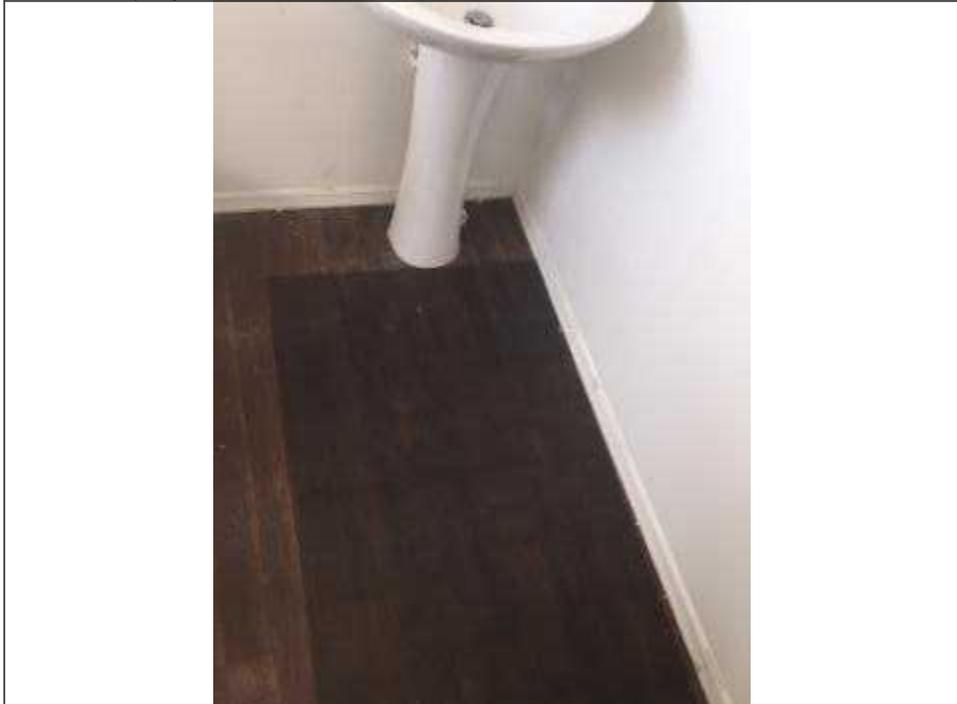
84. Adaptable/ground floor dwelling unit bathroom pedestal sink that does not have a compliant 30 x 48-inch, centered, frontal clear floor space because the centerline of the sink is less than 15-inches from the adjacent wall (Critical Repairs)

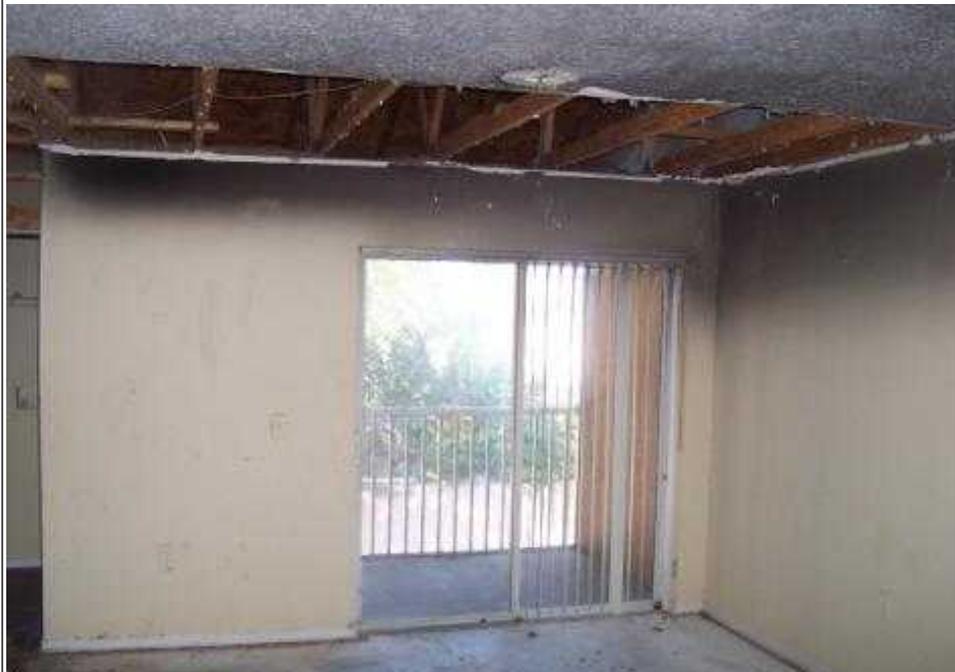
86. Down unit 9105 (Critical Repairs)

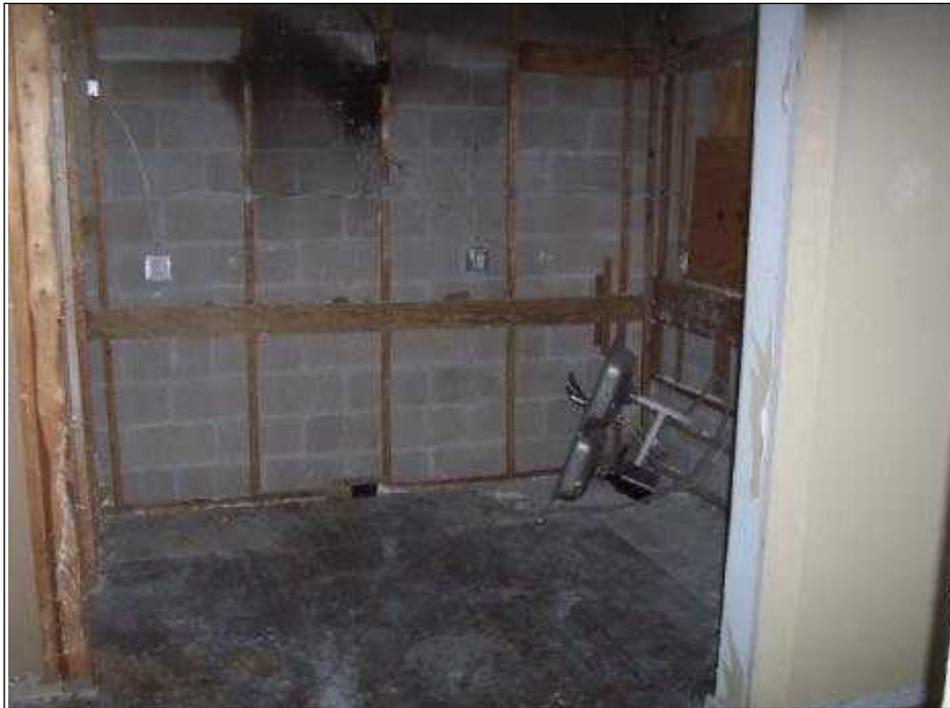
87. Kitchen located in down unit 9105 (Critical Repairs)

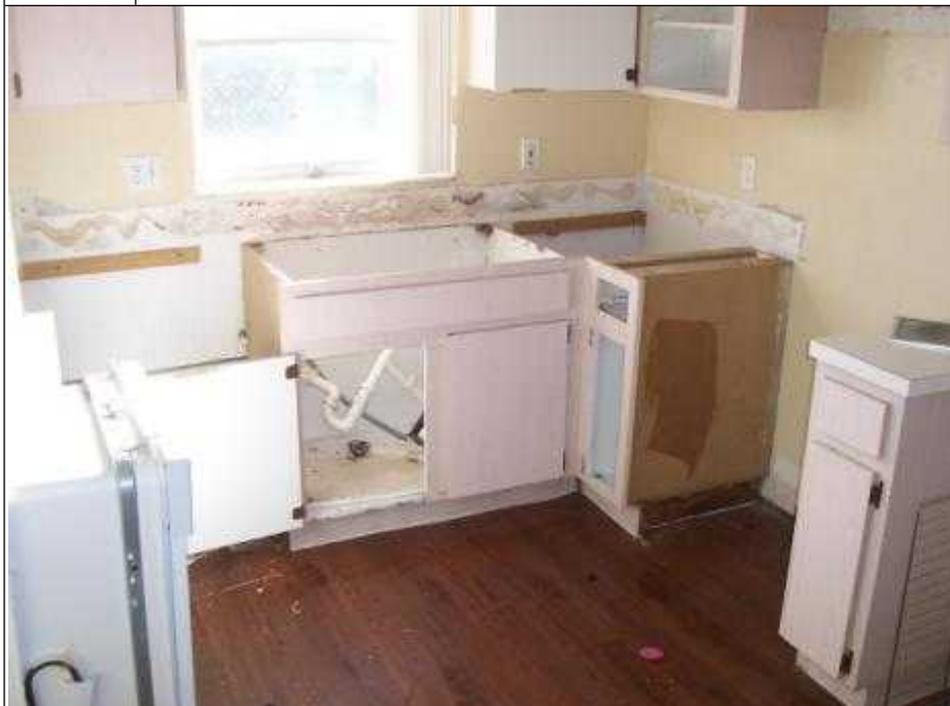
88. Kitchen cabinetry located in down unit 9202 (Critical Repairs)

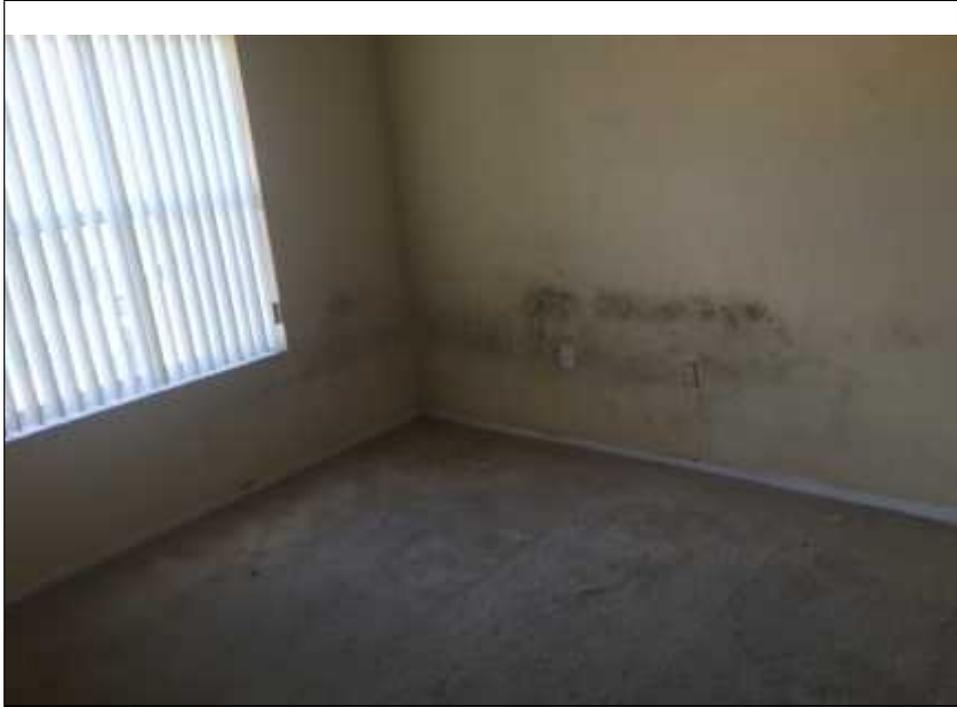
89. Mold on wall in dwelling unit (Non-Critical Repairs)

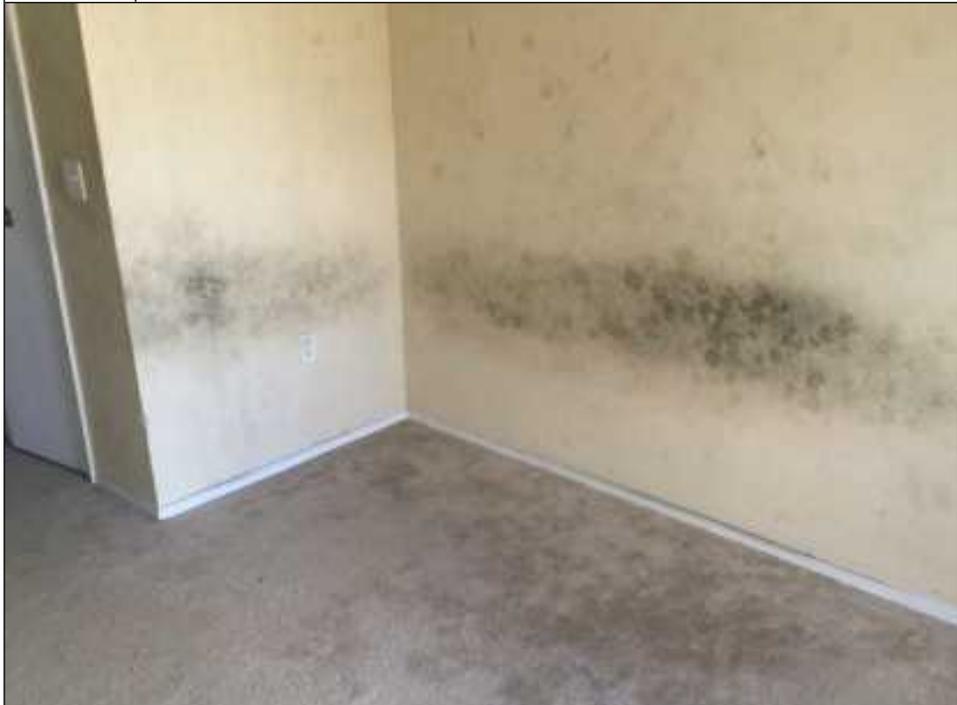
90. Mold on wall in dwelling unit (Non-Critical Repairs)

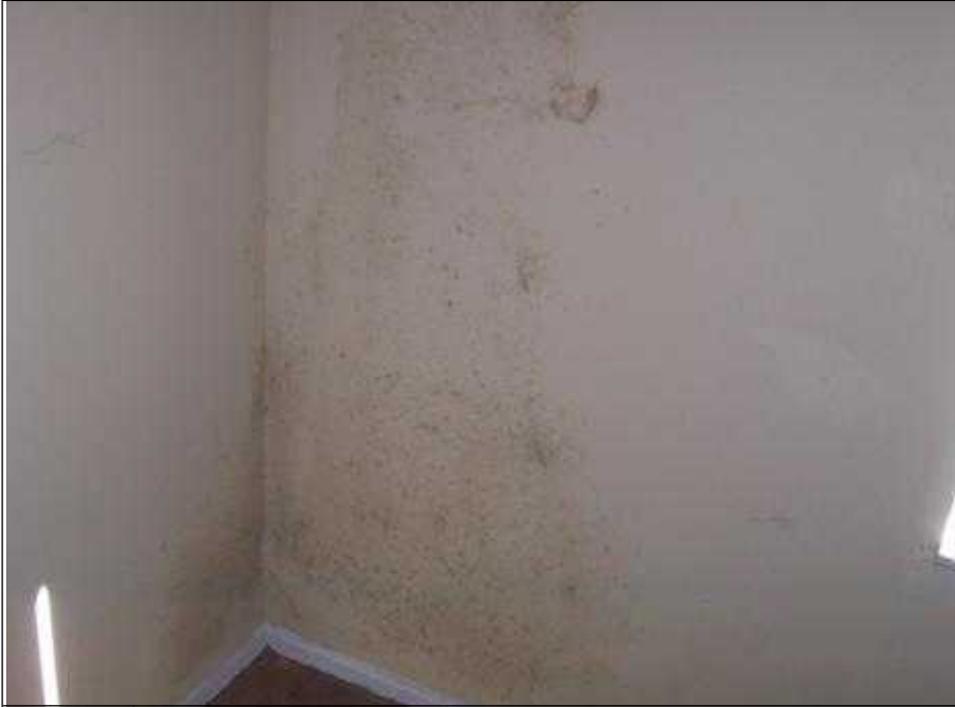
91. Mold observed on wall in dwelling unit (Non-Critical Repairs)
