Thousand Oaks/Trinity Oaks Problem Solving Task Force

October 21, 2013

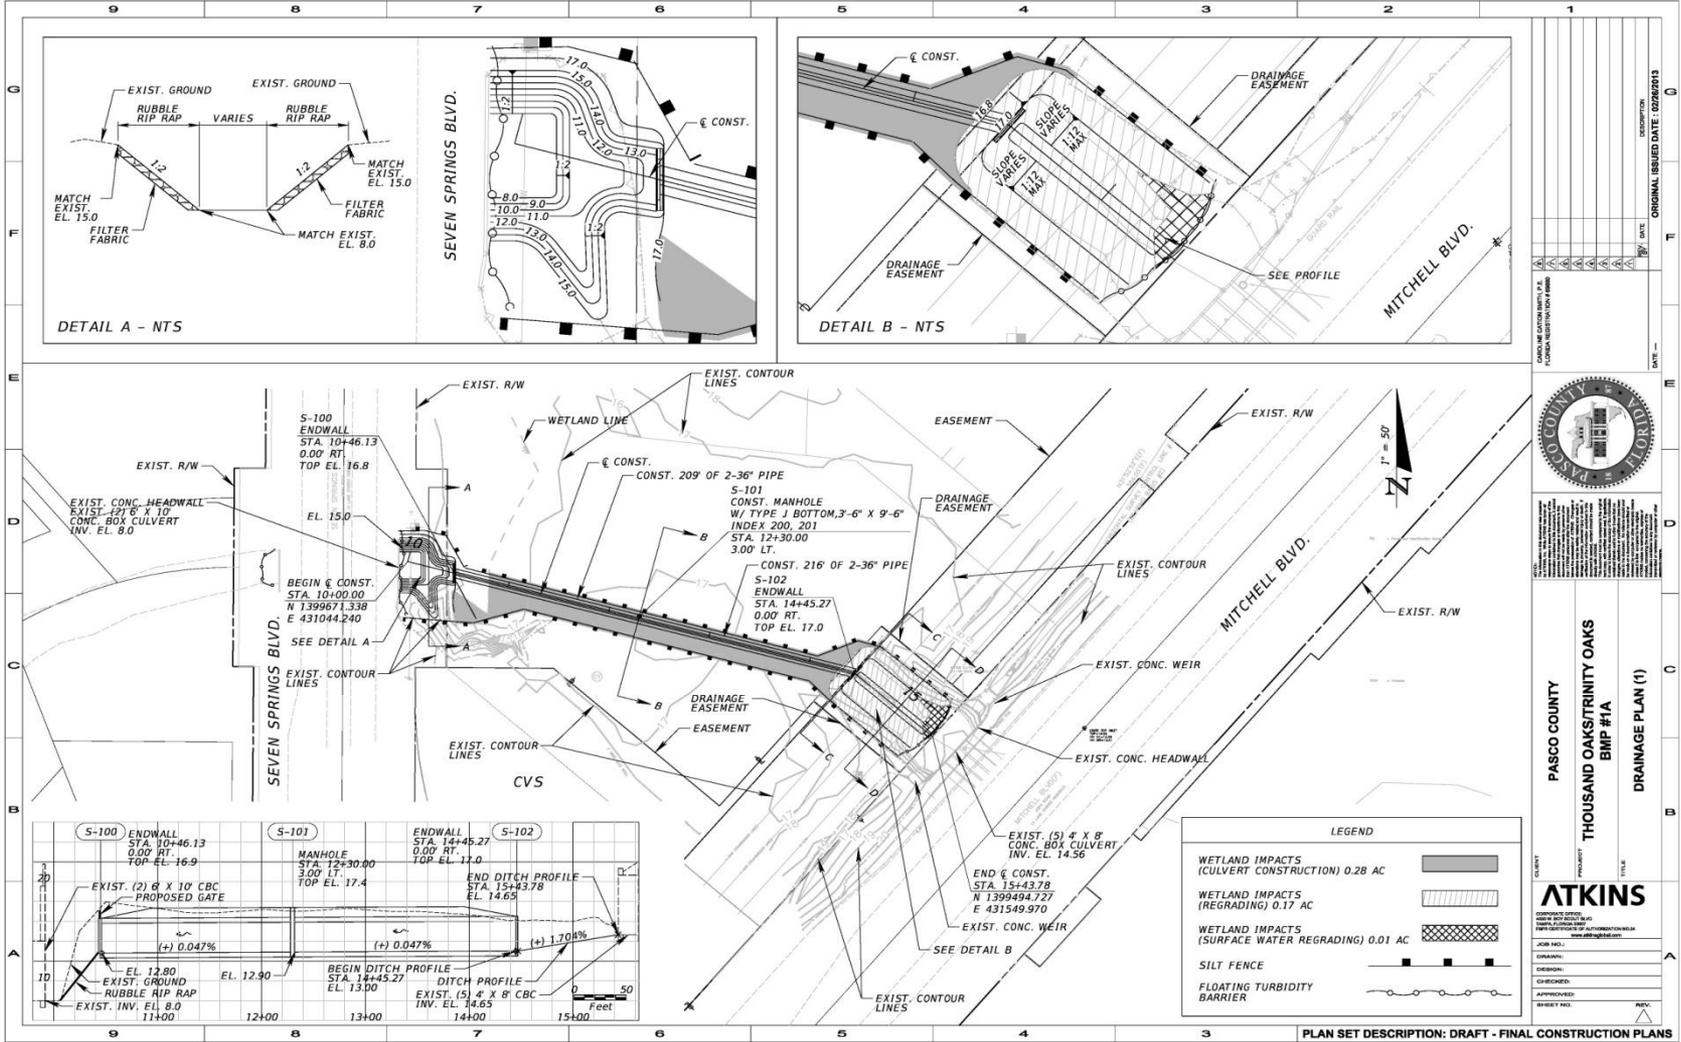
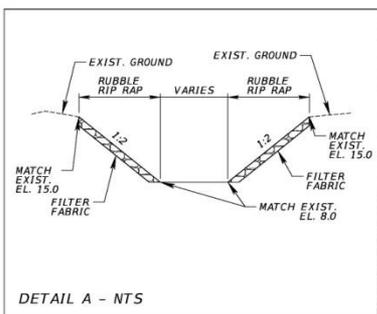
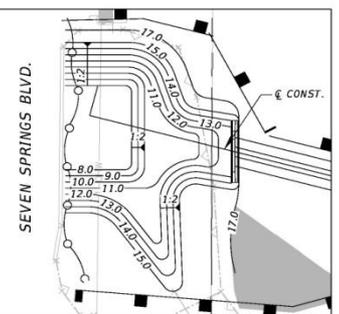
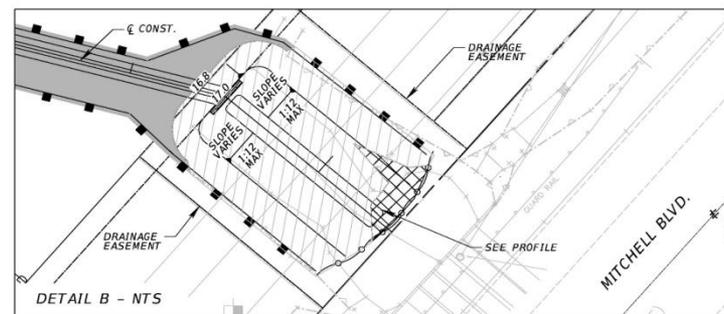
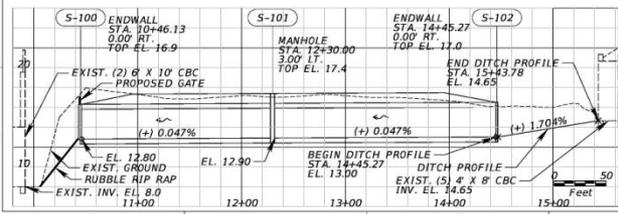
PASCO COUNTY
 THOUSAND OAKS/TRINITY OAKS
 BMP #1A
 DRAINAGE PLAN (1)

- BMP 1A – Predischarge to create storage in the upstream system

BMP 1A PROJECT AREA

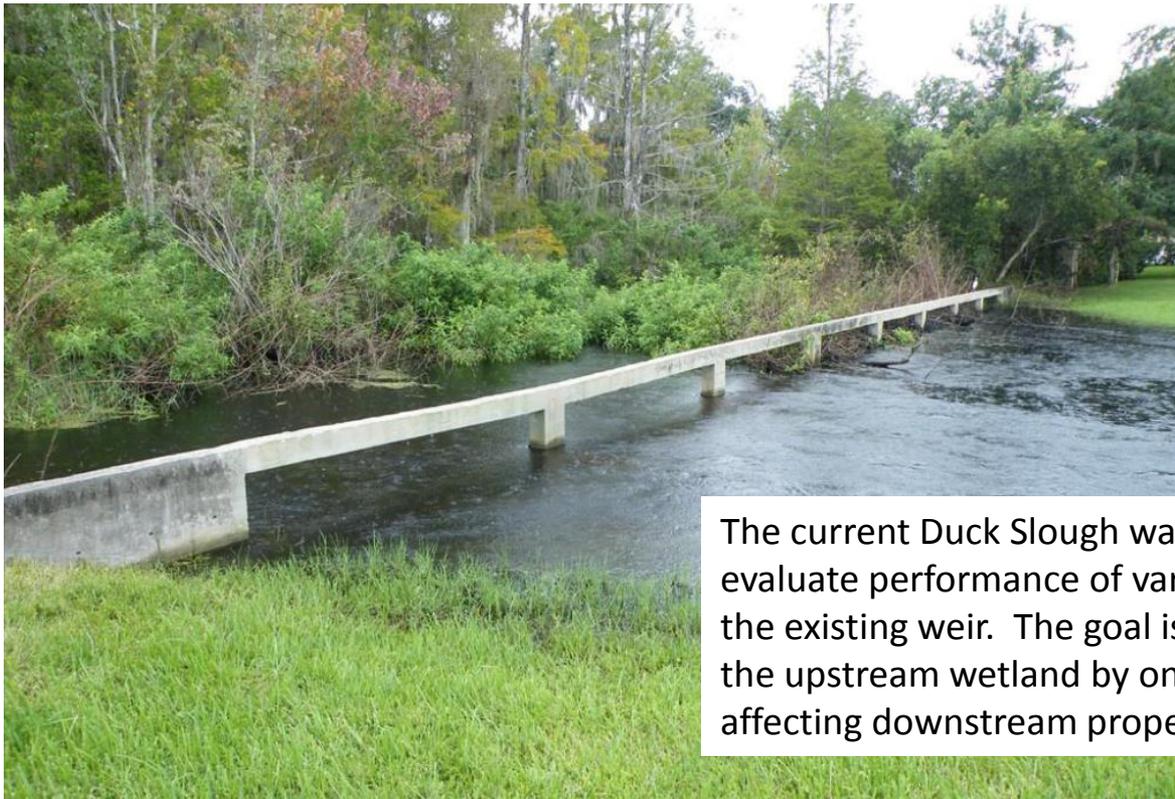
Lowering the Weir Upstream of East Kinsmere

The current Duck Slough watershed model was used to evaluate performance of various alternatives for lowering the existing weir. The goal is to lower normal water level in the upstream wetland by one foot, while not adversely affecting downstream properties.

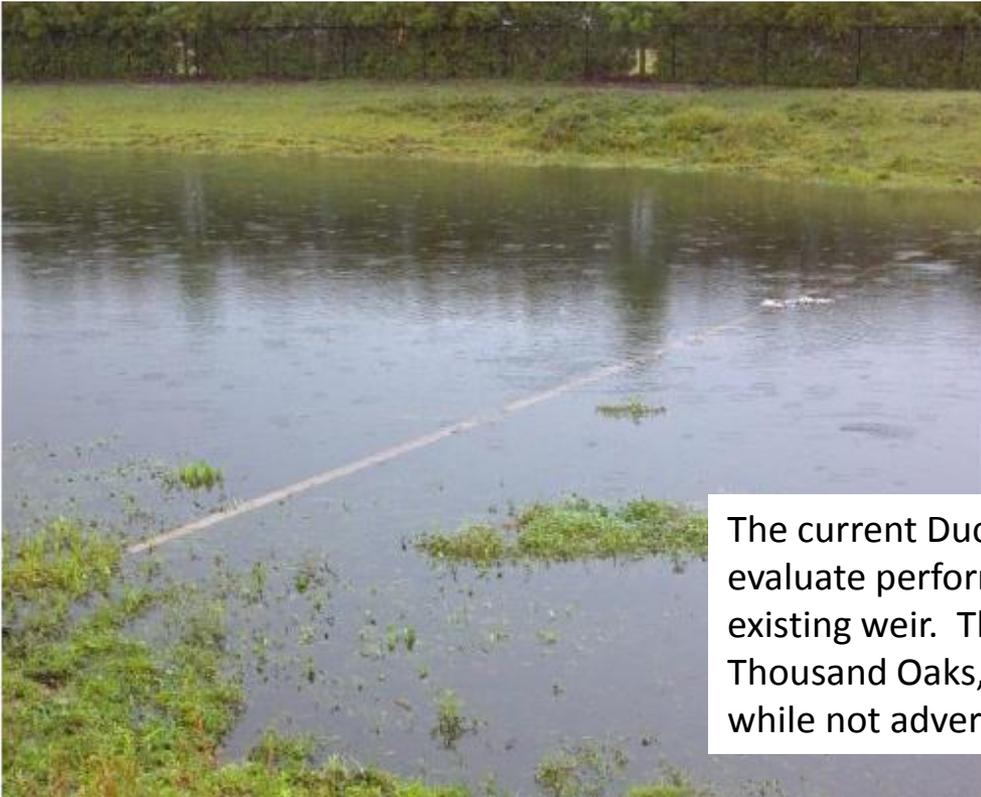
Raising the Weir Upstream of Little Road

The current Duck Slough watershed model was used to evaluate performance of various alternatives for raising the existing weir. The goal is to reduce flow at Little Road into Thousand Oaks, sufficient to eliminate flooding of homes, while not adversely affecting adjacent properties.

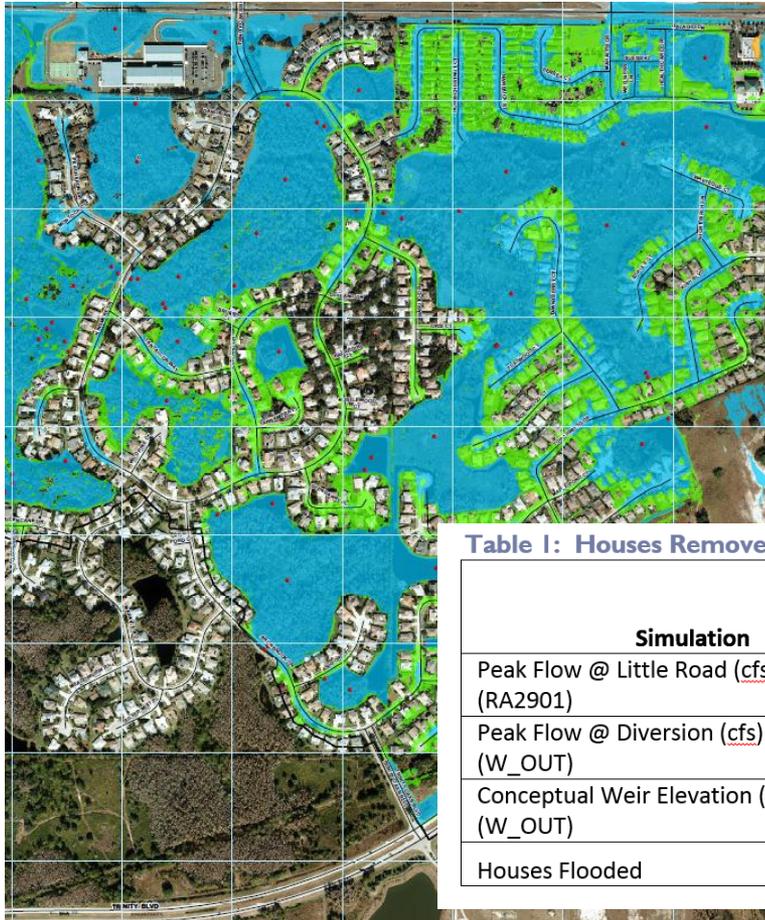
Significant Flow Reduction is Needed at Little Road to Eliminate Downstream Residential Flooding

The watershed model was used to estimate the volume of stormwater that would need to be removed during a 100-Year event in order to substantially reduce or eliminate flooding risk of residential structures.

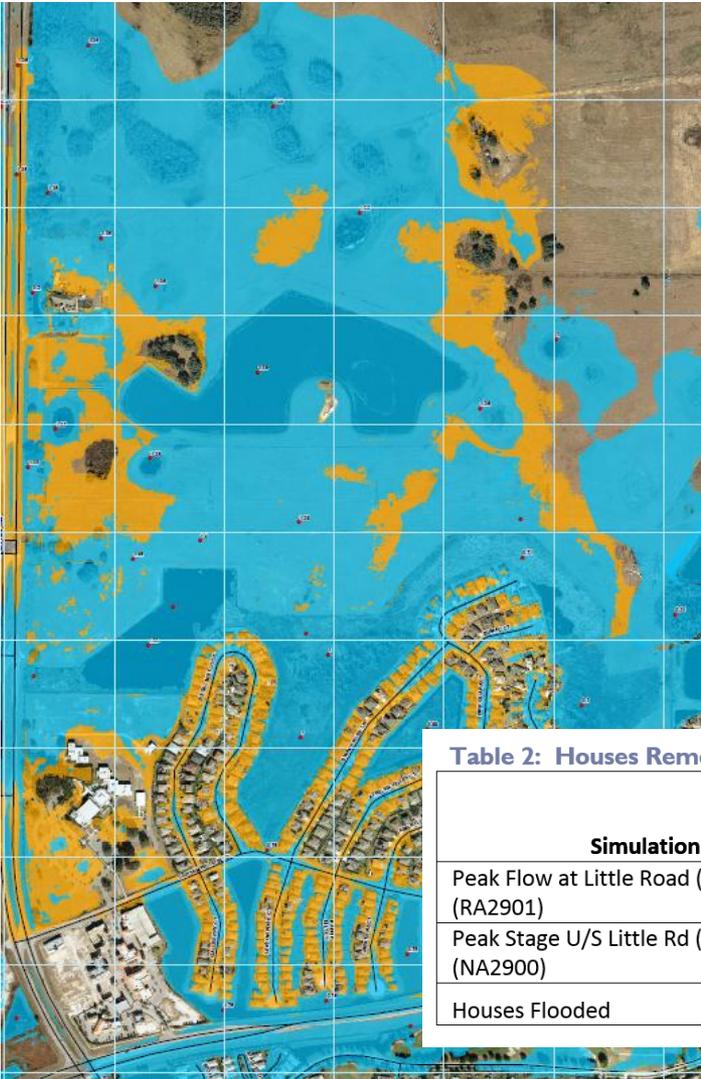
Raising Weir Will Impound Water Upstream

Simply raising the weir at Little Road to reduce the flow rate into Thousand Oaks results in adverse impacts upstream. In order to raise the weir, large volumes of water would need to be impounded and there is not sufficient land available on which to safely store that water.

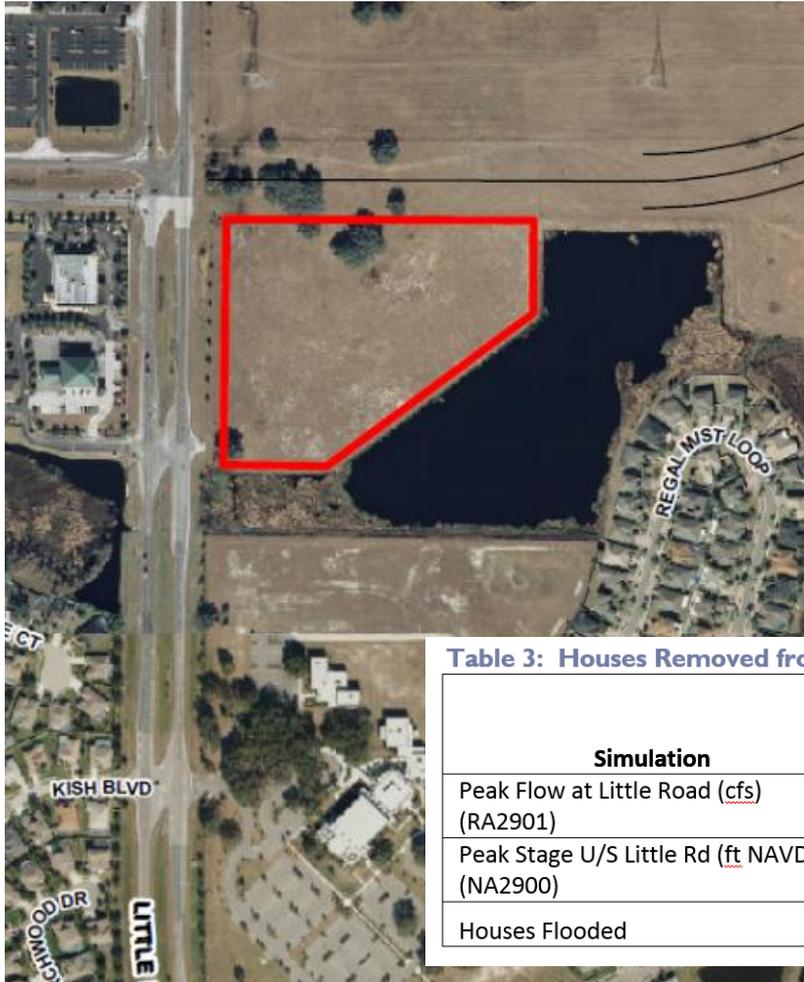
Evaluating Potential Storage Volume on Undeveloped Properties in the Area

Because water table is close to land surface, you cannot dig a deep pit to create available storage. A site like this 11-acre tract fronting Little Road accounts for only a fraction of the required storage volume, and there are few such sites available for consideration.
