Thousand Oaks / Trinity Oaks Problem Solving Task Force

October 27, 2014

Background & Summary of Activities

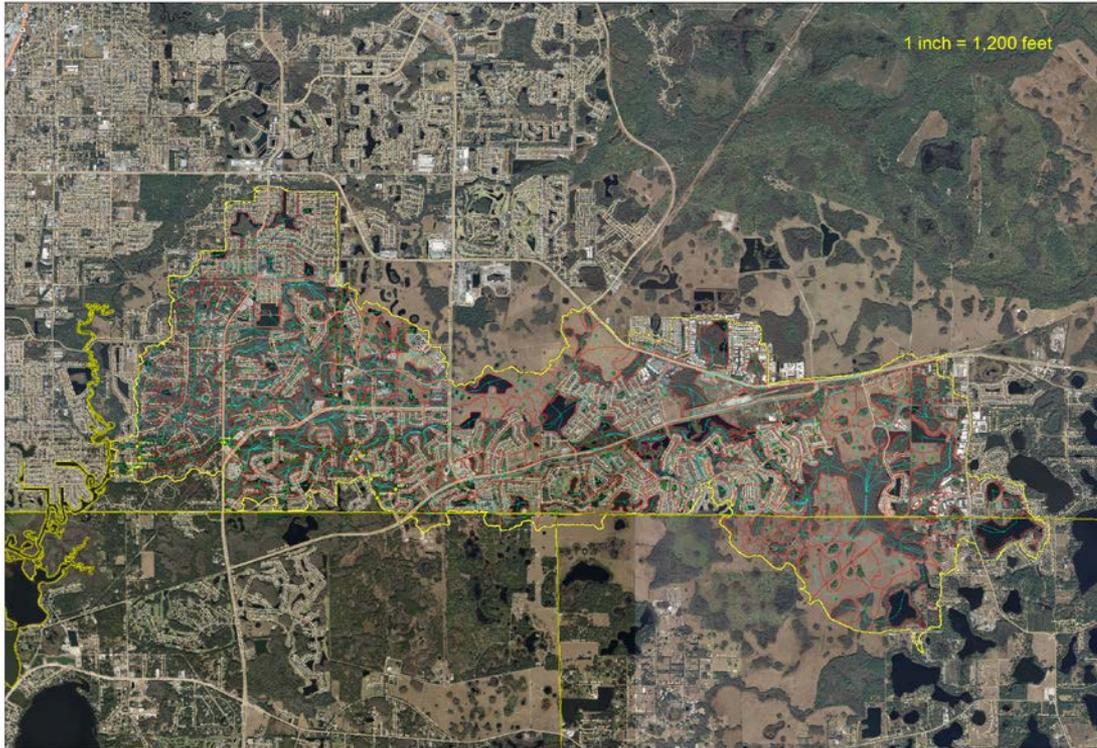
DUCK SLOUGH WATERSHED

- * Watershed is 14.1 sq miles

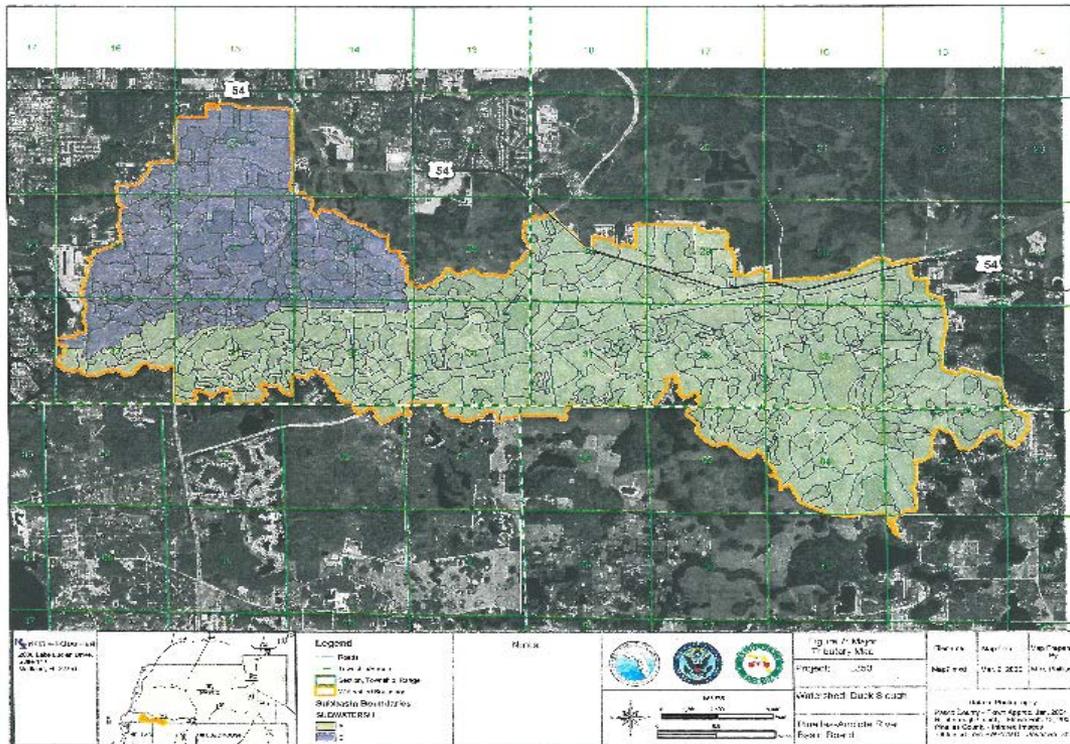
* 10.1 sq Miles Flows Through Affected Developments

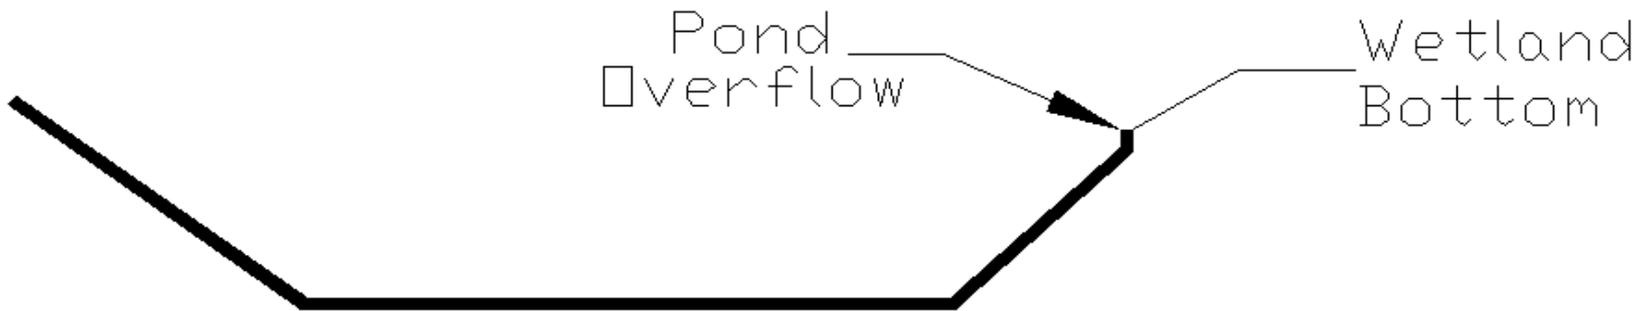
- While the engineering study recognized that the ponds did not drain because the wetlands were higher than the ponds it recommended operable structures for flood control as the only permissible option

Wetland Higher Than Pond Discharge

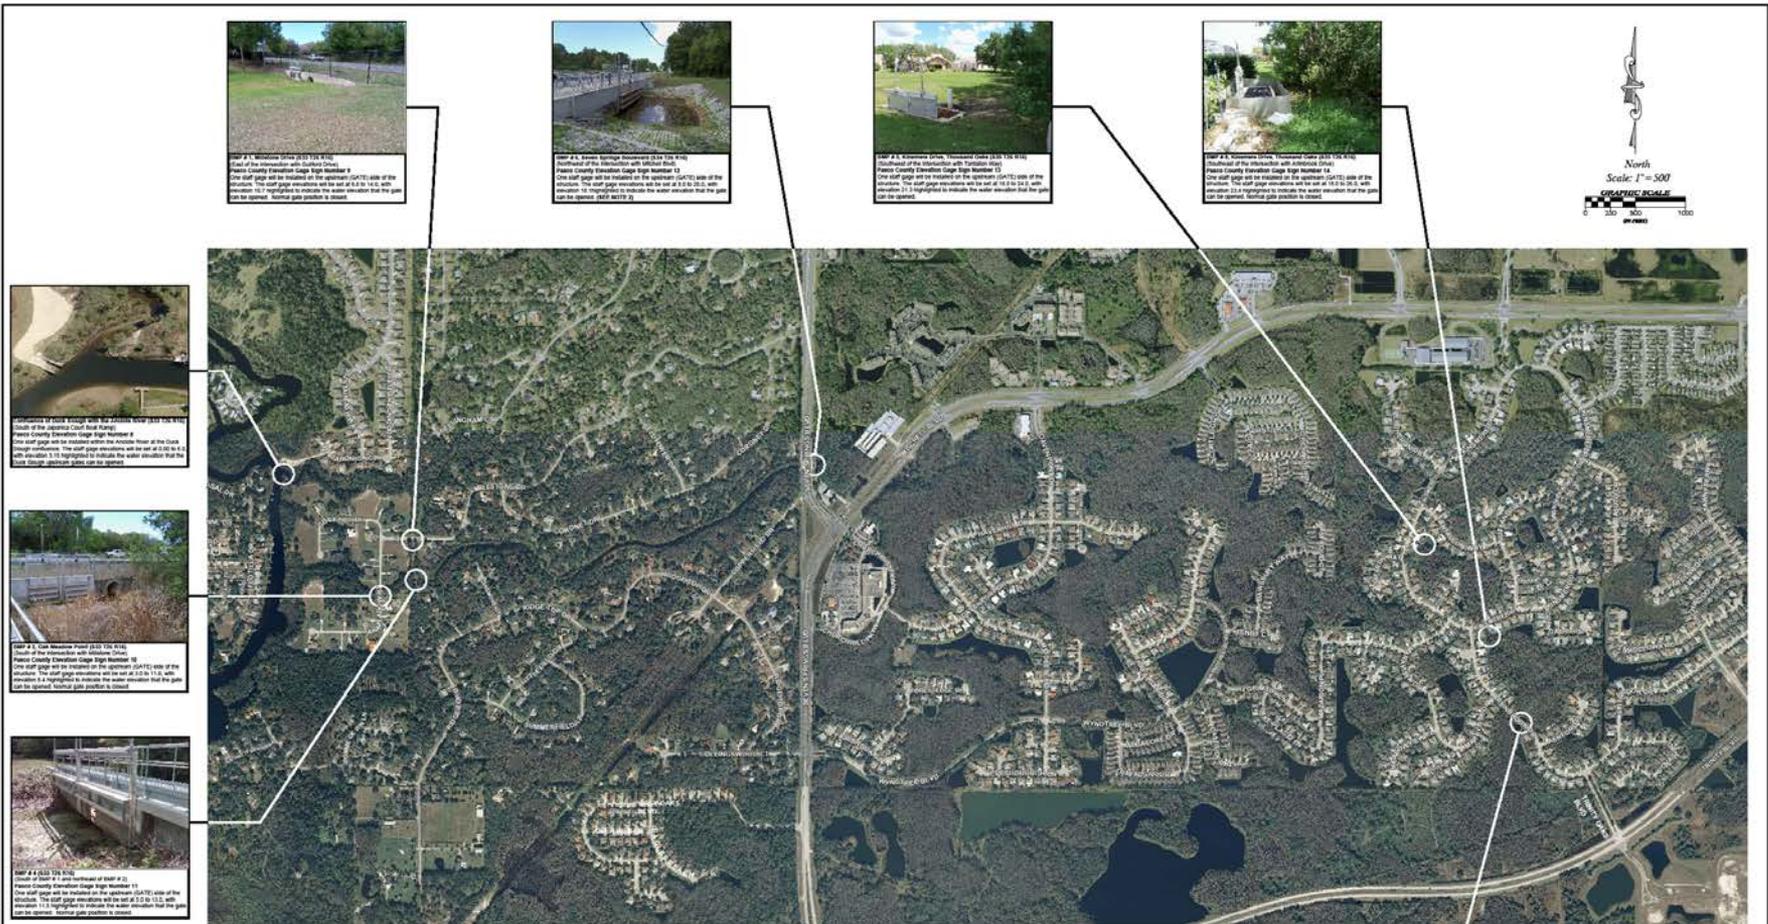
2010 Construction-Operable Structures

- This control gate will remain partially open at gate invert elevation 9.0 ft to cover approximately 78% of the culvert opening to mimic pre-development structure capacity. During emergency flooding conditions, the gates will be opened fully to allow full flow capacity through the culverts.
- The staff gage at BMP # 10 is also located at the confluence of Duck Slough and Brooker Creek.
- This control gate will remain partially open at the gate invert elevation of x.xx ft to maintain normal water levels and hydropenoids in area lakes and wetlands. During emergency flooding conditions, the gate will be opened fully to allow full flow capacity through the culverts.
- Pasco County Road & Bridge Drainage Supervisor, Teddy Laurenti, is requesting to be on site when survey crews are on site to mark and set elevations at each staff gage placement location.

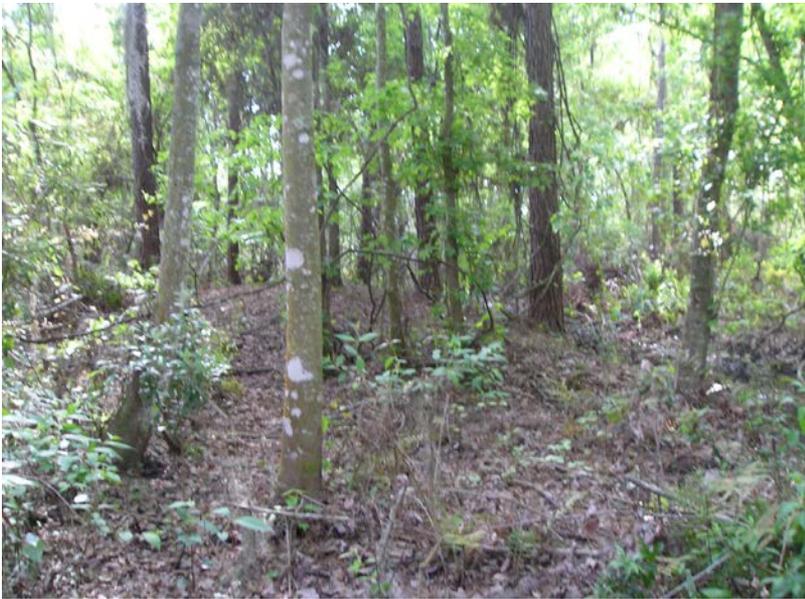
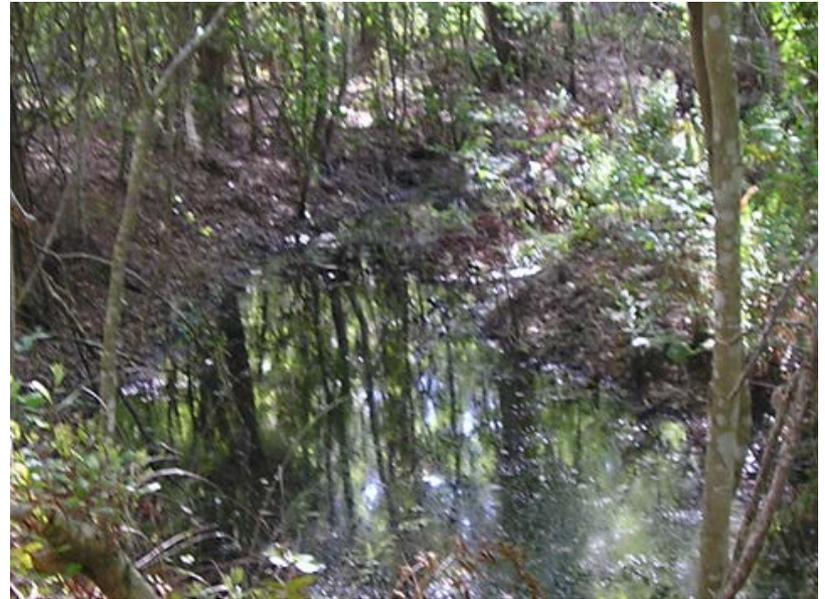
SPOIL PILE

- * We felt that we had found evidence that dredging had occurred at some time in the wetlands.

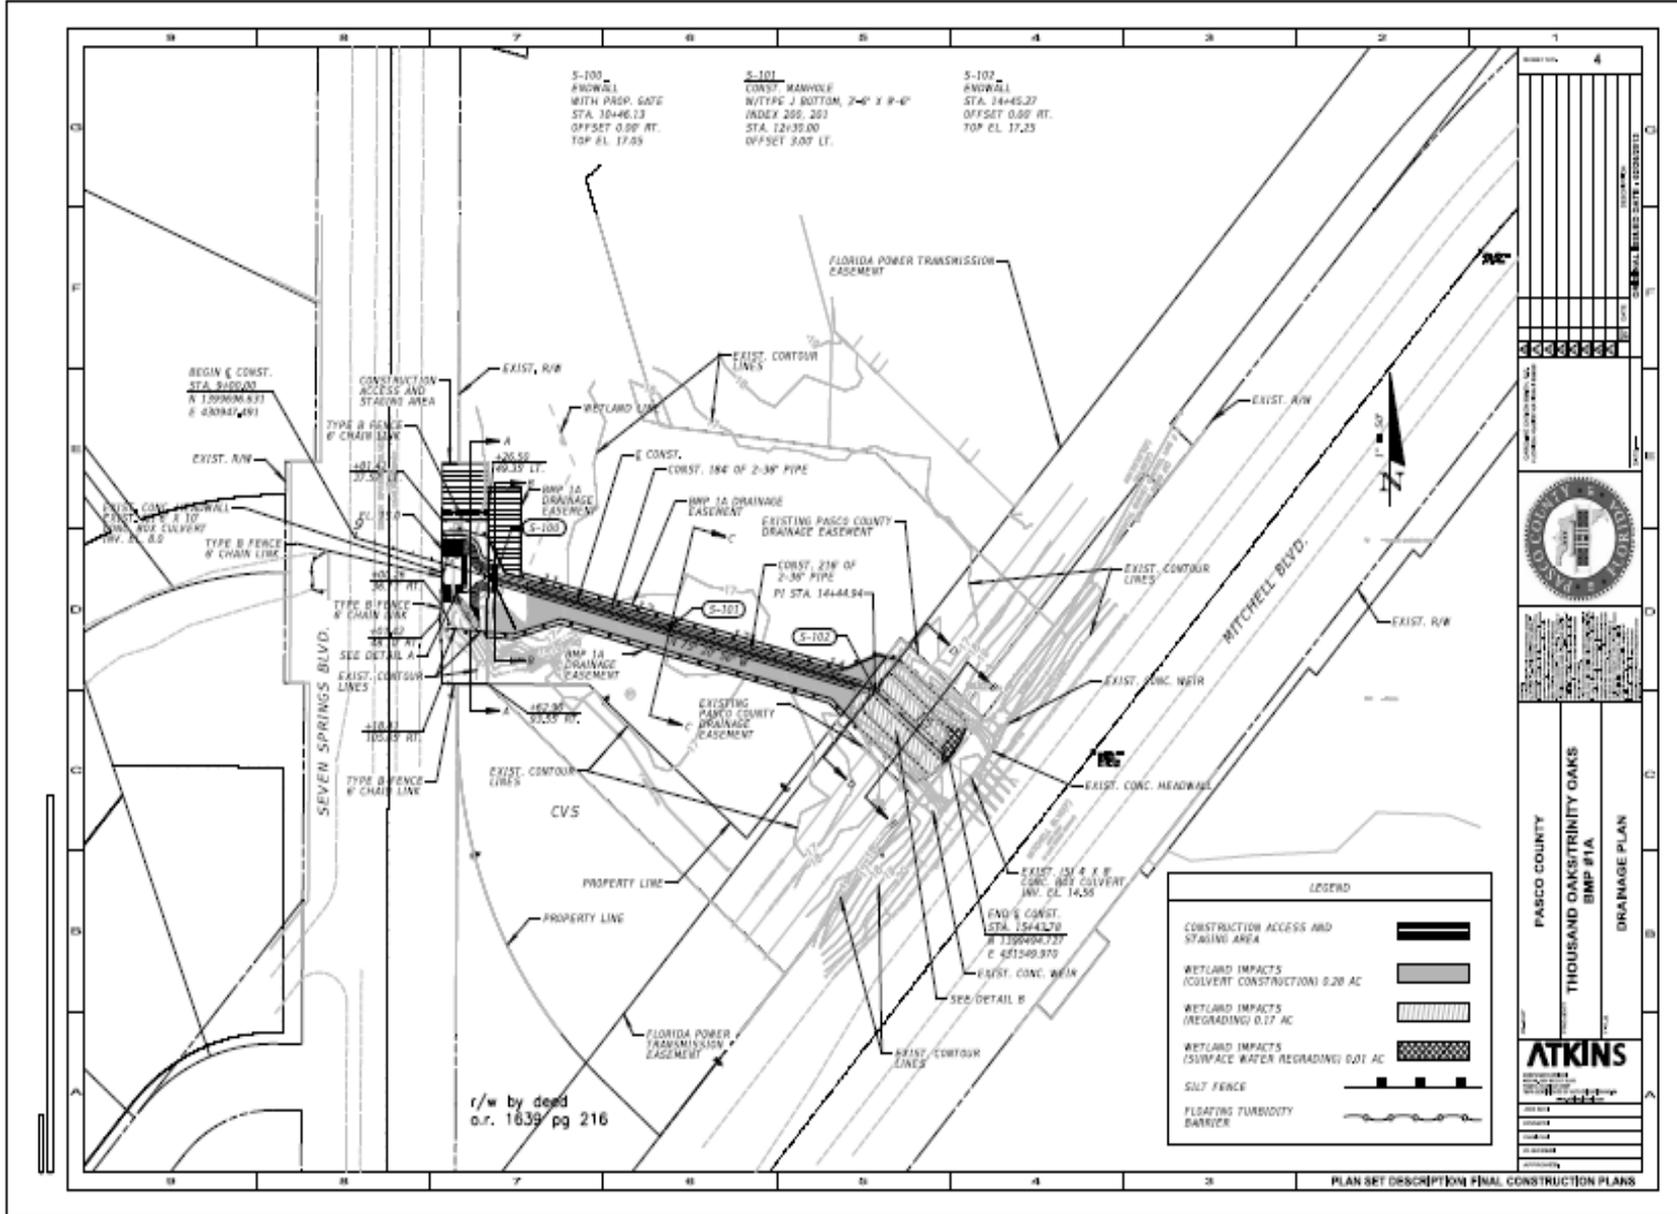
BMP#1A-2 Culverts with Gate

- * **Creation of storage in the upstream wetland prior to a rain event**

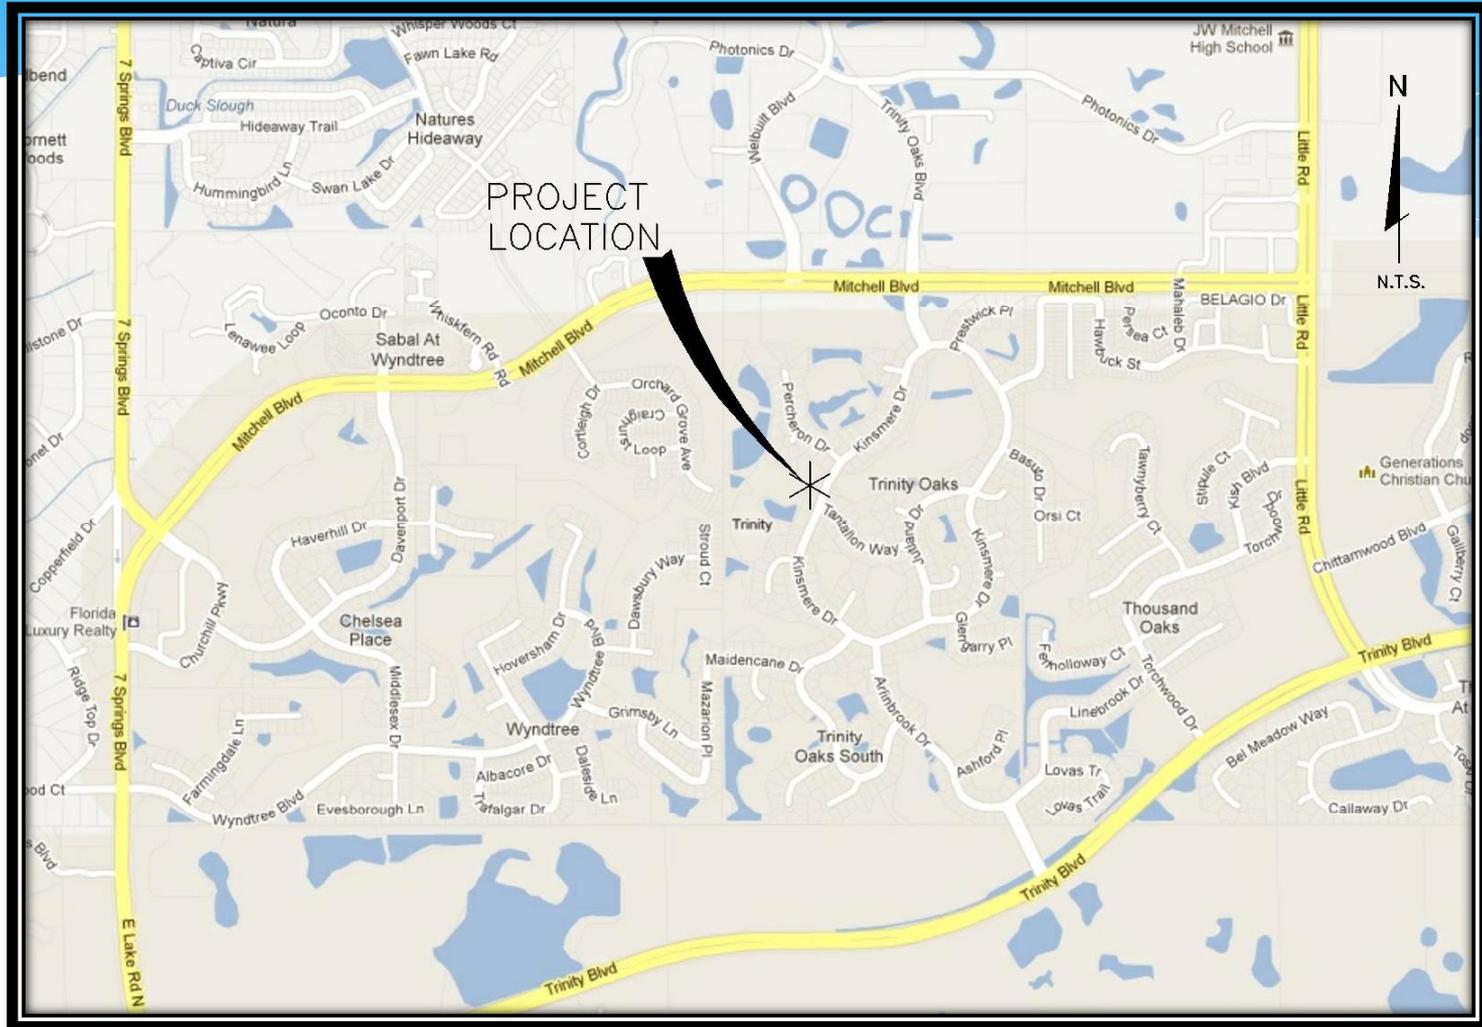
Where is BMP 5?

*** Purpose: to aid pond recovery**

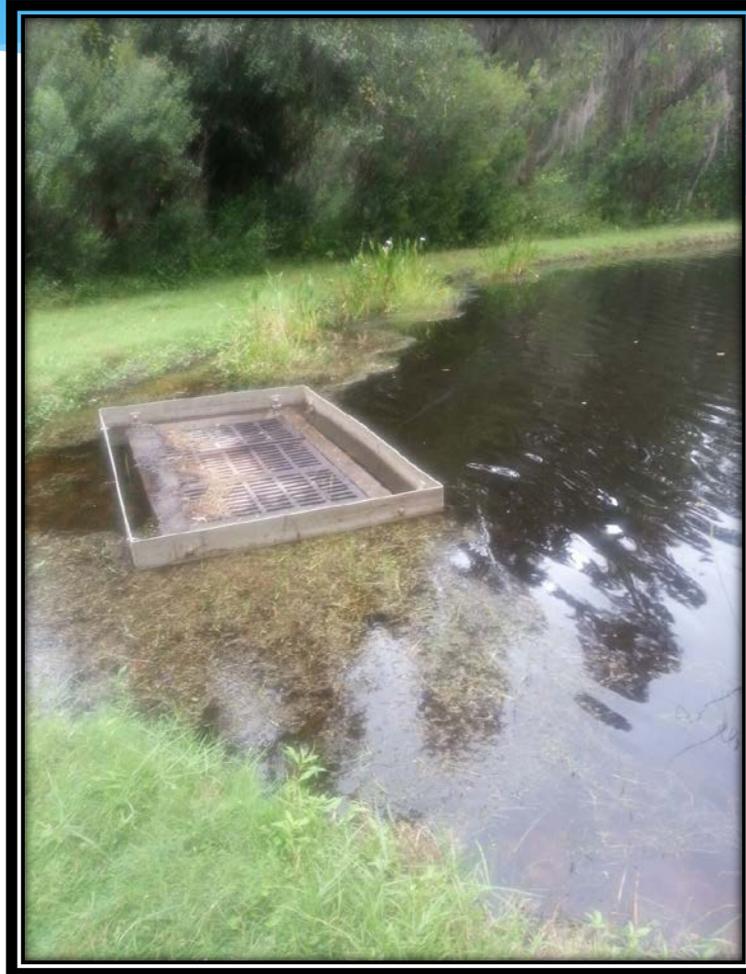
Photograph at Location B

RELOCATE OUTFALL CONTROL STRUCTURE

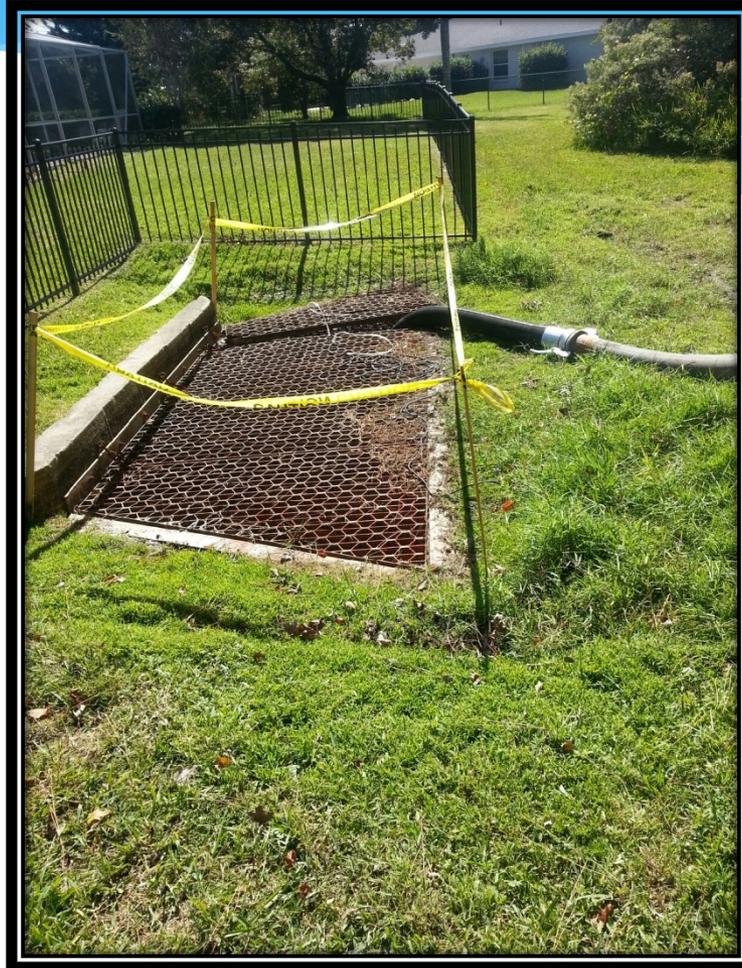
Photograph at Location C

REMOVE EARTHEN DAM DOWNSTREAM OF OUTFALL STRUCTURE

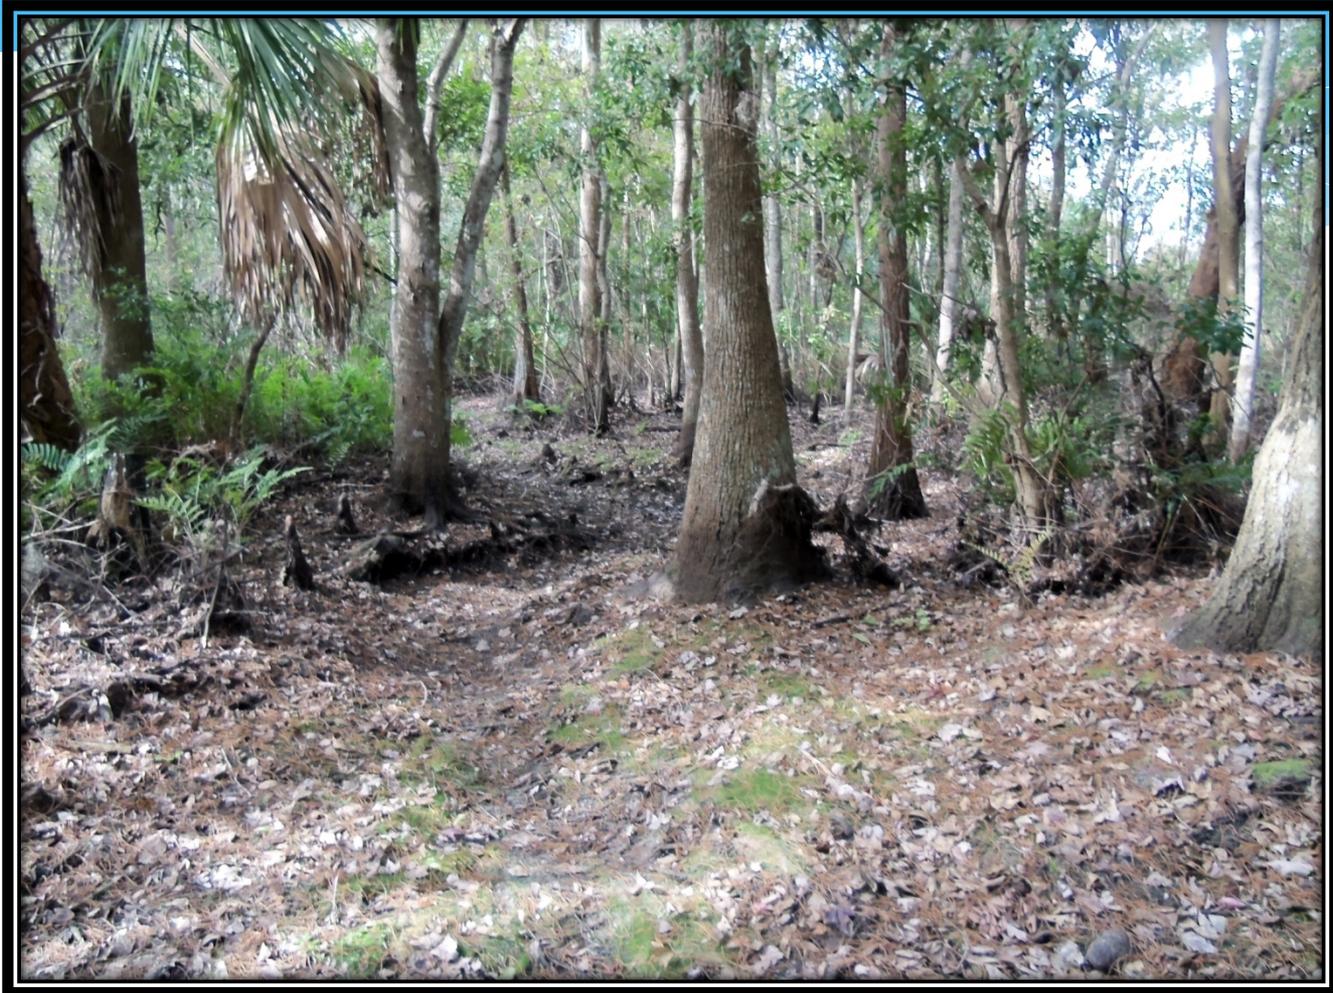
Photograph at Location D

REMOVE SILT FROM FLOW WAY

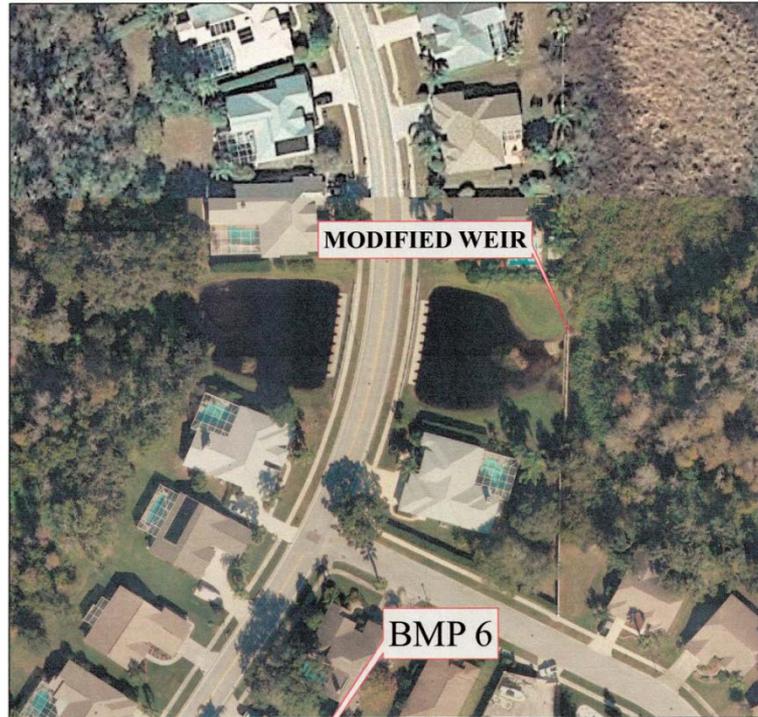
BMP 6A

- * The current Duck Slough watershed model was used to evaluate performance of various alternatives for lowering the existing weir. The goal is to lower normal water level in the upstream wetland by one foot, while not adversely affecting downstream properties.

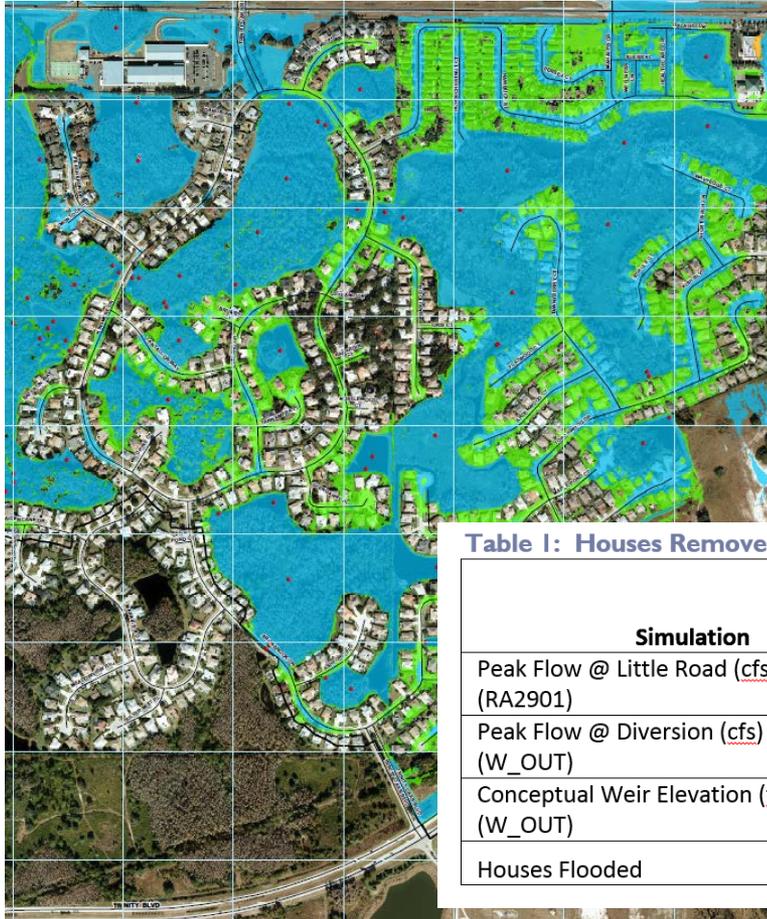
Significant Flow Reduction is Needed at Little Road to Eliminate Downstream Residential Flooding

The watershed model was used to estimate the volume of stormwater that would need to be removed during a 100-Year event in order to substantially reduce or eliminate flooding risk of residential structures.

Simulation	BMP 1,5&6	Water Removed (acre-ft)				
		1182	927	644	382	182
Peak Flow @ Little Road (cfs) (RA2901)	1760	906	1072	1247	1404	1555
Peak Flow @ Diversion (cfs) (W_OUT)	N/A	1084	905	716	501	303
Conceptual Weir Elevation (ft, NAVD88) (W_OUT)	N/A	27.25	27.50	27.75	28.00	28.25
Houses Flooded	17	1	2	5	8	11

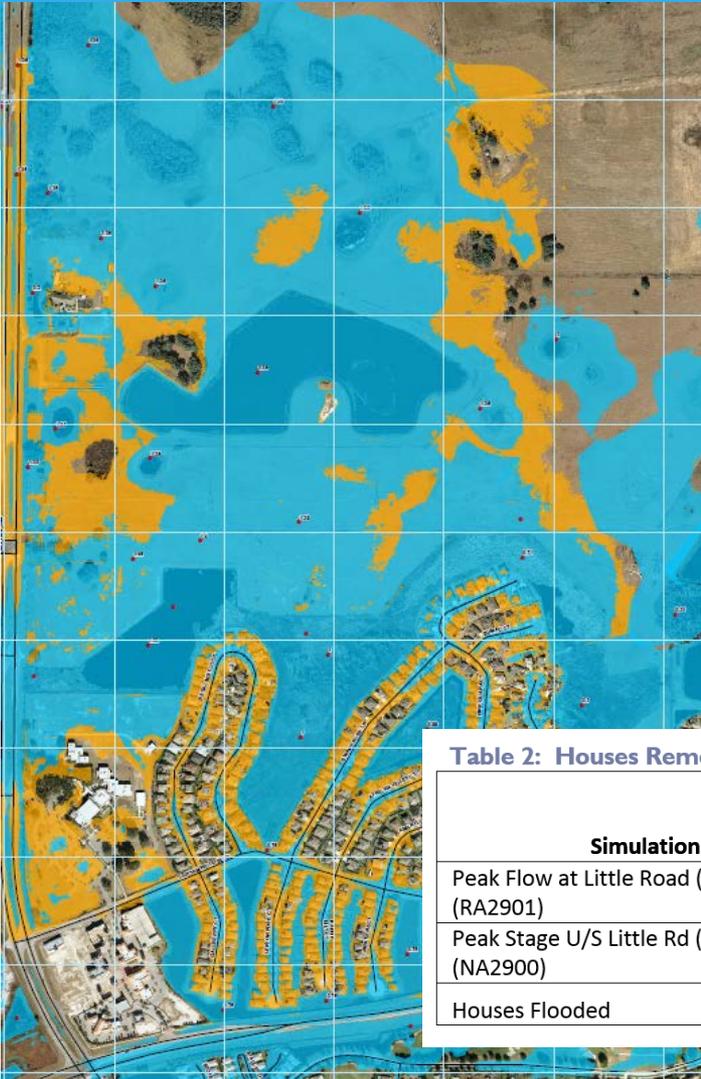
Raising Weir Will Impound Water Upstream

Simply raising the weir at Little Road to reduce the flow rate into Thousand Oaks results in adverse impacts upstream. In order to raise the weir, large volumes of water would need to be impounded and there is not sufficient land available on which to safely store that water.

Simulation	BMP 1,5&6	Conceptual Weir Elevation (ft, NAVD88)							
		26.5	27.0	27.5	28.0	28.5	29.0	29.5	30.0
Peak Flow at Little Road (cfs) (RA2901)	1760	1648	1589	1515	1432	1308	1154	994	836
Peak Stage U/S Little Rd (ft NAVD88) (NA2900)	28.73	28.95	29.06	29.22	29.41	29.65	29.90	30.11	30.26
Houses Flooded	17	16	13	9	8	7	4	1	1

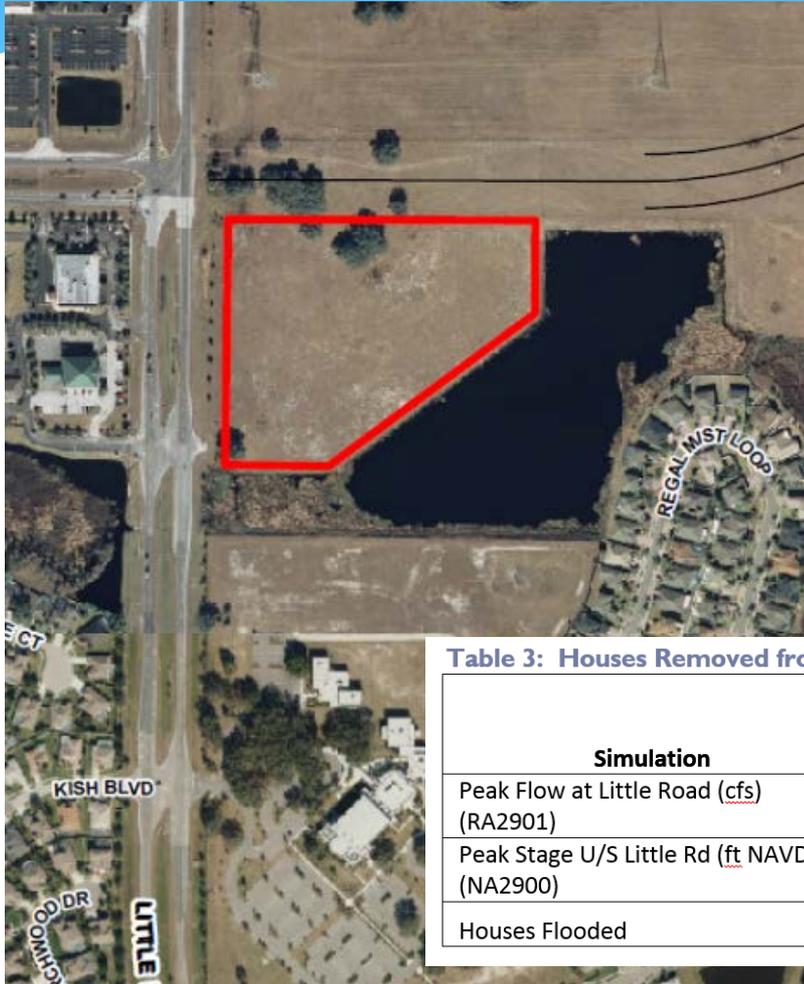
Evaluating Potential Storage Volume on Undeveloped Properties in the Area

Because water table is close to land surface, you cannot dig a deep pit to create available storage. A site like this 11-acre tract fronting Little Road accounts for only a fraction of the required storage volume, and there are few such sites available for consideration.

Simulation	Existing	BMP 1,5 & 6	Utilizing Odyssey Storage	
			Existing	BMP 1,5 & 6
Peak Flow at Little Road (cfs) (RA2901)	1762	1759	1746	1742
Peak Stage U/S Little Rd (ft NAVD88) (NA2900)	28.74	28.73	28.72	28.72
Houses Flooded	17	17	17	17

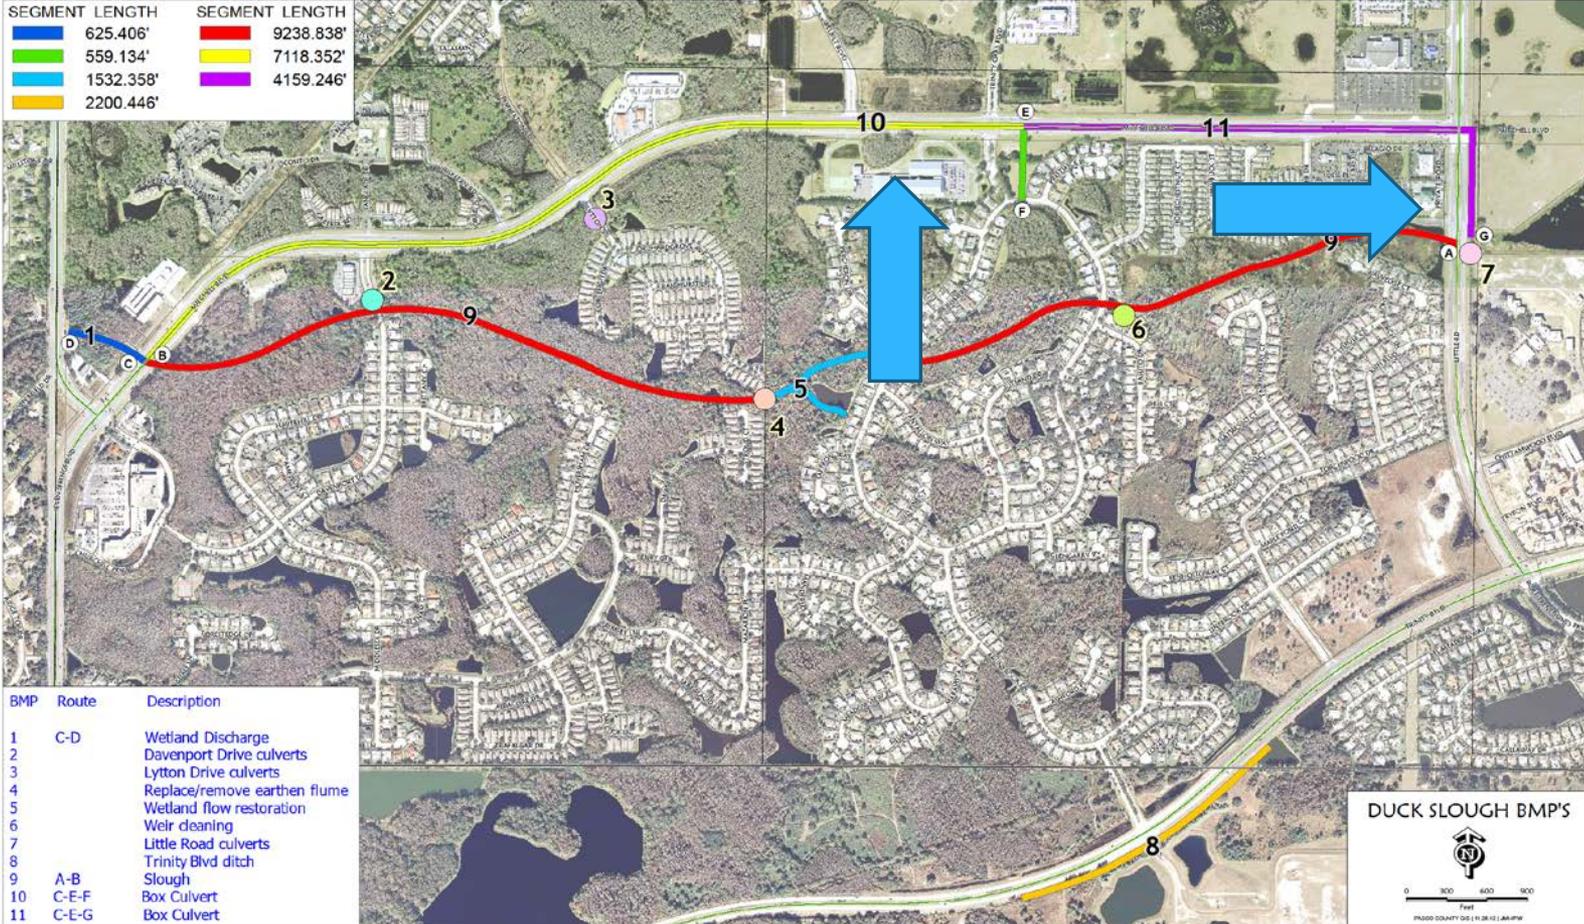
DUCK SLOUGH BMP'S

BMP	Route	Description
1	C-D	Wetland Discharge
2		Davenport Drive culverts
3		Lytton Drive culverts
4		Replace/remove earthen flume
5		Wetland flow restoration
6		Weir cleaning
7		Little Road culverts
8		Trinity Blvd ditch
9	A-B	Slough
10	C-E-F	Box Culvert
11	C-E-G	Box Culvert

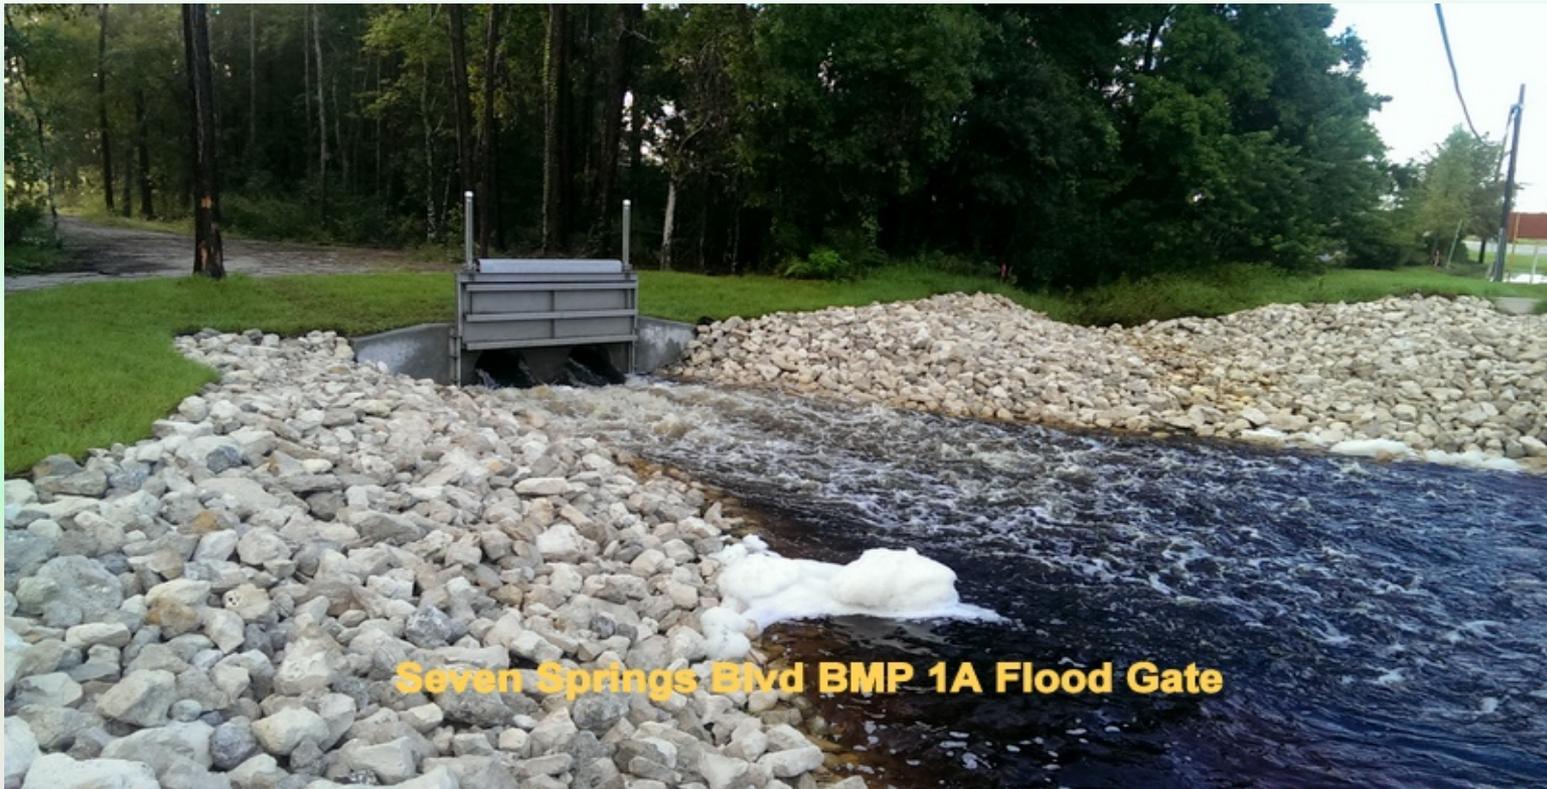
Seven Springs Blvd BMP 1A Flood Gate

Floodgate in Open Position

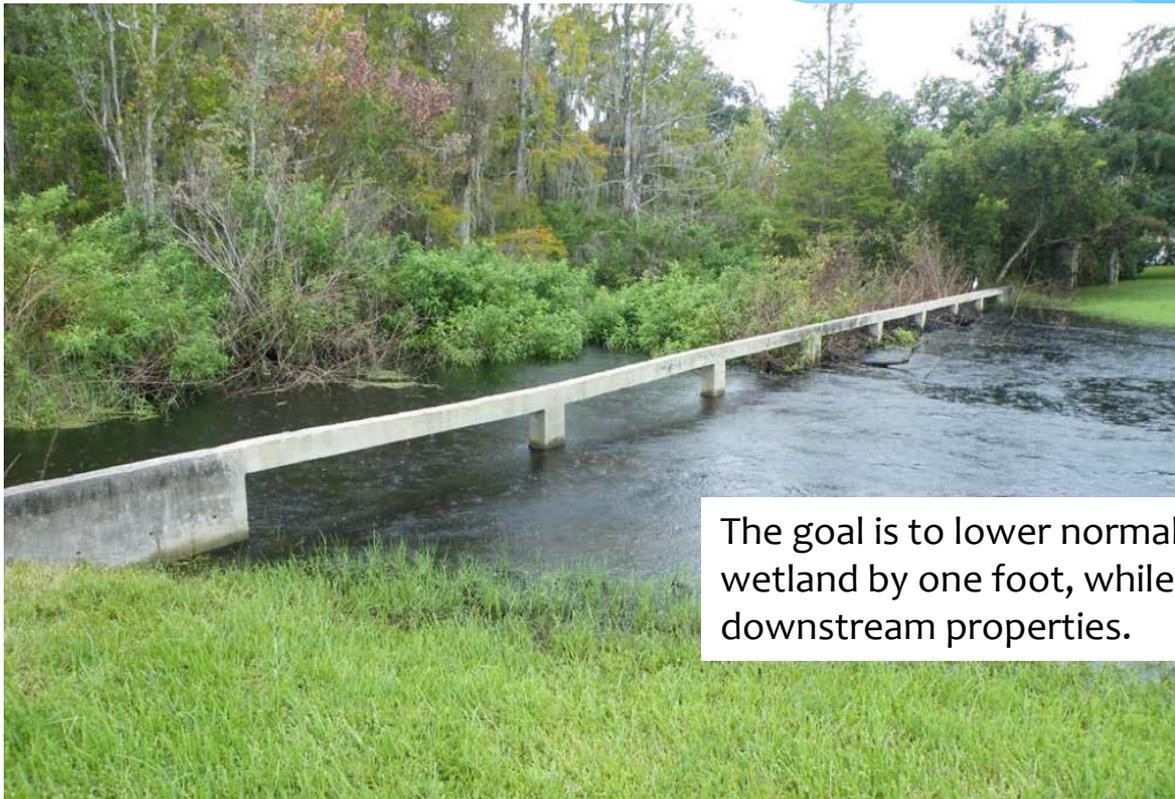
Lowering the Normal Water Level of the Wetland Upstream of East Kinsmere

The goal is to lower normal water level in the upstream wetland by one foot, while not adversely affecting downstream properties.

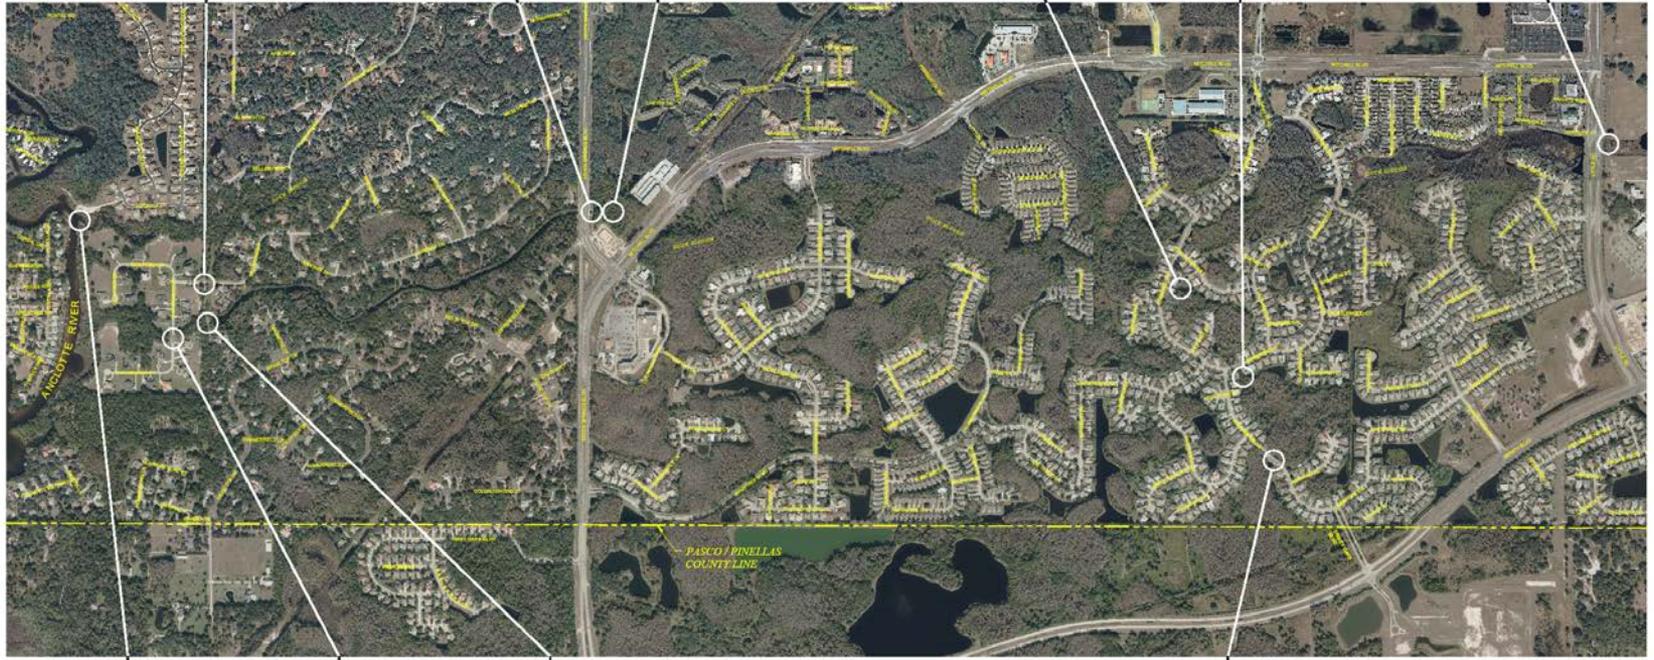
1. This control gate will remain partially open at gate invert elevation 9.0 ft to cover approximately 78% of the culvert opening to mimic pre-development structure capacity. During emergency flooding conditions, the gates will be opened fully to allow full flow capacity through the culverts.
2. The staff gage at BMP # 10 is also located at the confluence of Duck Slough and Brooker Creek.
3. This control gate will remain partially open at the gate invert elevation of X.XX ft to maintain normal water levels and hydroperiods in area lakes and wetlands. During emergency flooding conditions, the gate will be opened fully to allow full flow capacity through the culverts. (Gate invert elevation to be determined by SWFWMD evaluation of the Brooker Creek Basin Study, information not available at this time.)
4. SWFWMD Permit No. 43034034.

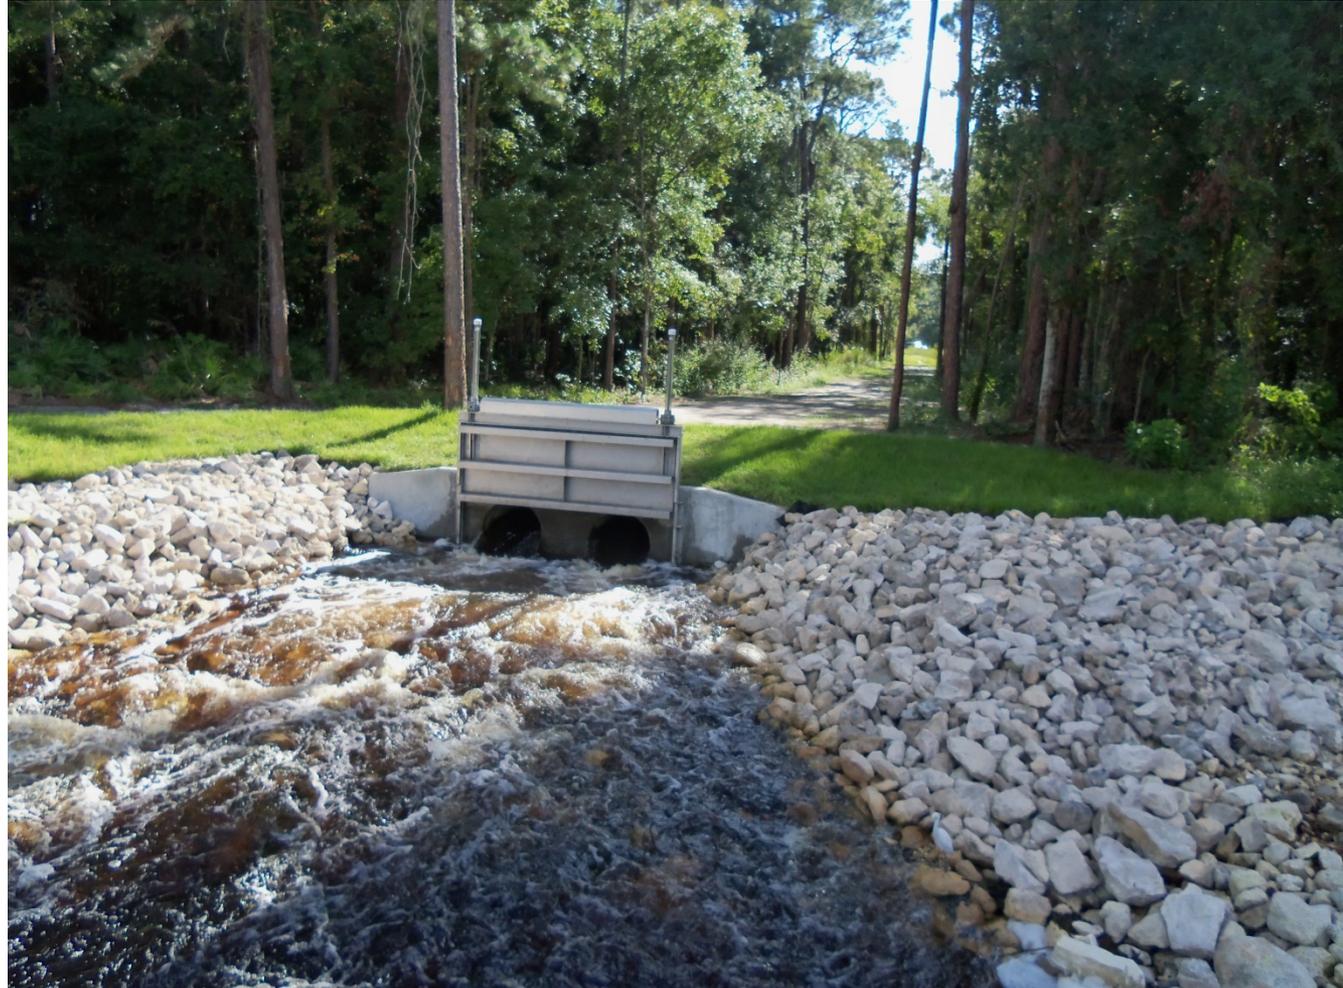
Possible Pumping Location- Mitchell to Seven Springs

- * Open gate at BMP 1A in lieu of Pump Locations 3 & 4
