Thousand Oaks / Trinity Oaks Problem Solving Task Force

October 27, 2014

Background & Summary of Activities

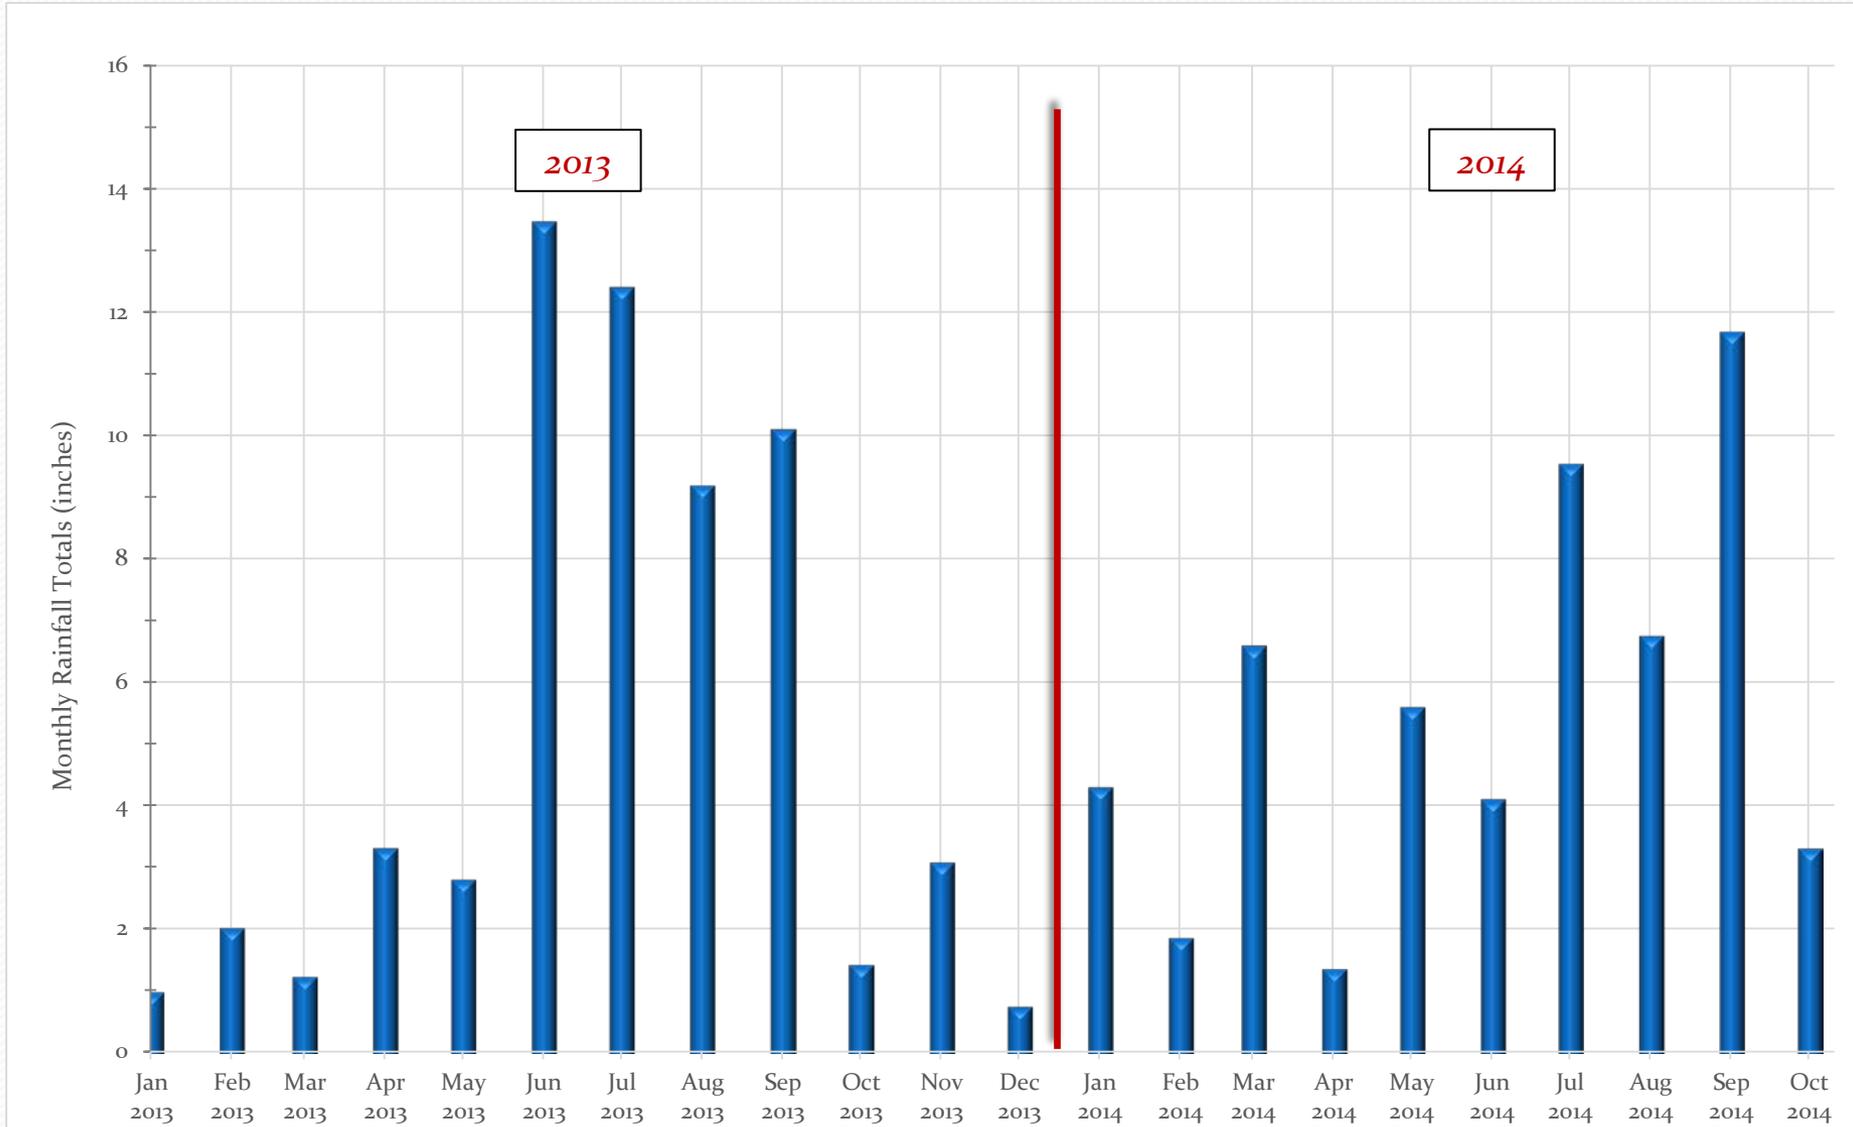
Monthly Rainfall Average

Month	SWFWMD Rainfall Gauge			
	Starkey	St Pete 42	Eldridge-Wilde 2n	Avg (Duck Slough)
Jan-13	0.71	0.77	0.88	0.79
Feb-13	1.94	1.89	1.66	1.83
Mar-13	0.59	1.2	1.31	1.03
Apr-13	2.76	3.79	2.83	3.13
May-13	2.43	4.2	1.22	2.62
Jun-13	13.34	14.22	12.29	13.28
Jul-13	12.77	10.36	13.52	12.22
Aug-13	11.45	5.47	10.08	9.00
Sep-13	9.19	11.07	9.48	9.91
Oct-13	0.71	1.49	1.49	1.23
Nov-13	3.12	3.28	2.29	2.90
Dec-13	0.76	0.33	0.56	0.55
Jan-14	4.25	4.86	3.23	4.11
Feb-14	1.64	1.77	1.59	1.67
Mar-14	7.43	5.82	5.95	6.40
Apr-14	0.56	1.88	1.06	1.17
May-14	5.53	6.02	4.69	5.41
Jun-14	2.9	5.45	3.41	3.92
Jul-14	8.5	10.14	9.41	9.35
Aug-14	7.78	6.42	5.48	6.56
Sep-14	11.18	9.16	14.14	11.49
Oct-14	3.54	2.85	2.97	3.12
2013 Total	59.77	58.07	57.61	58.48
2014 (Jan-Oct)	53.31	54.37	51.93	53.20
