**Regency Palms
Port Richey, Florida**

**Multi-Family Mortgage
Revenue Bond Program
Application**

Property Name: Regency Palms Apts		Property Type: Multifamily Apartments									
Address: 8332 Alnwick Circle		Property Age: 16									
City and State: Port Richey, FL		No. of units: 200									
Site Survey Date: 11/4-5/2015		Square feet: 248,815									
Report Date: November 12, 2015		Analysis Term: 20									
EBI Project #: 1715000325											
Section #	Section Name	Condition					Action Required	Critical Repairs	Non-Critical Repairs	Replacement Reserves	
		Excellent	Good	Fair	Poor	NA					
SITE CONDITIONS

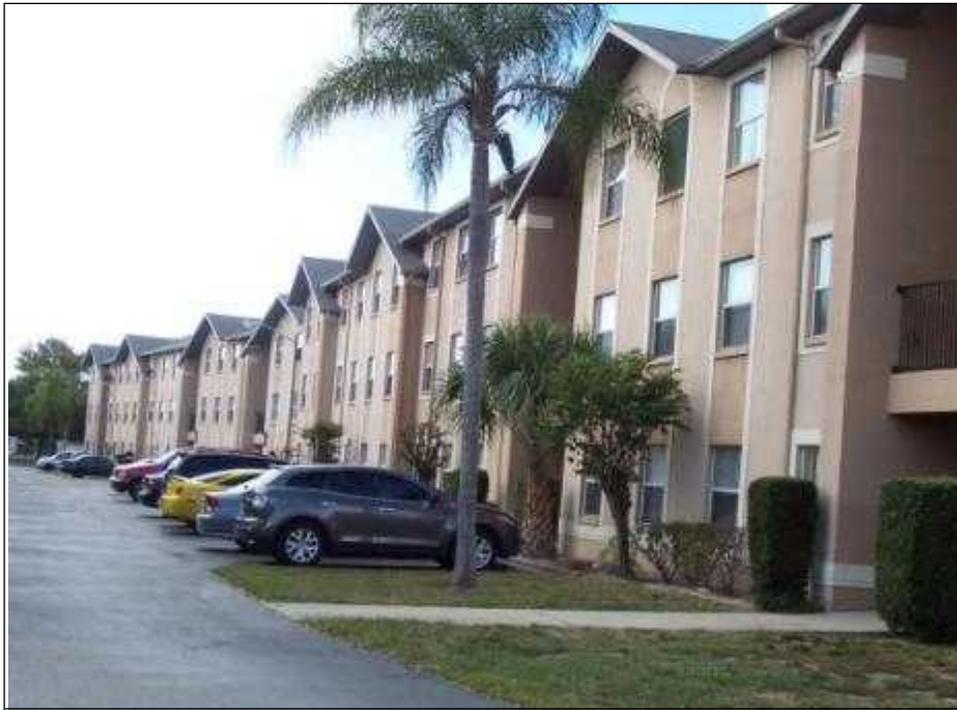
1. Front façade of buildings 2 and 3

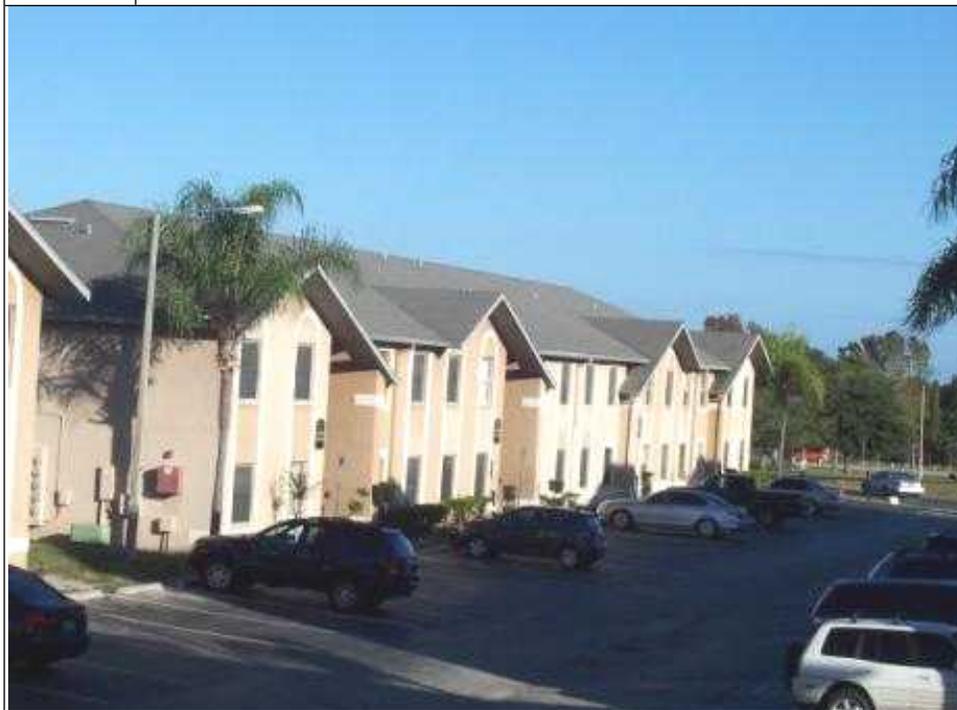
2. Front façade of building 4

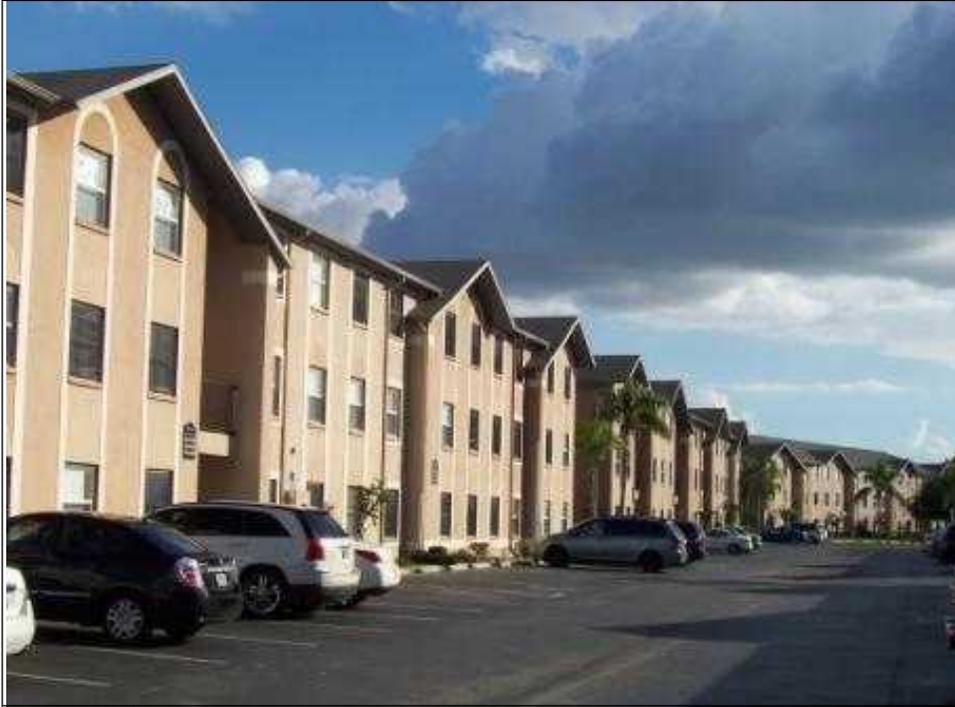
3. Front façade of buildings

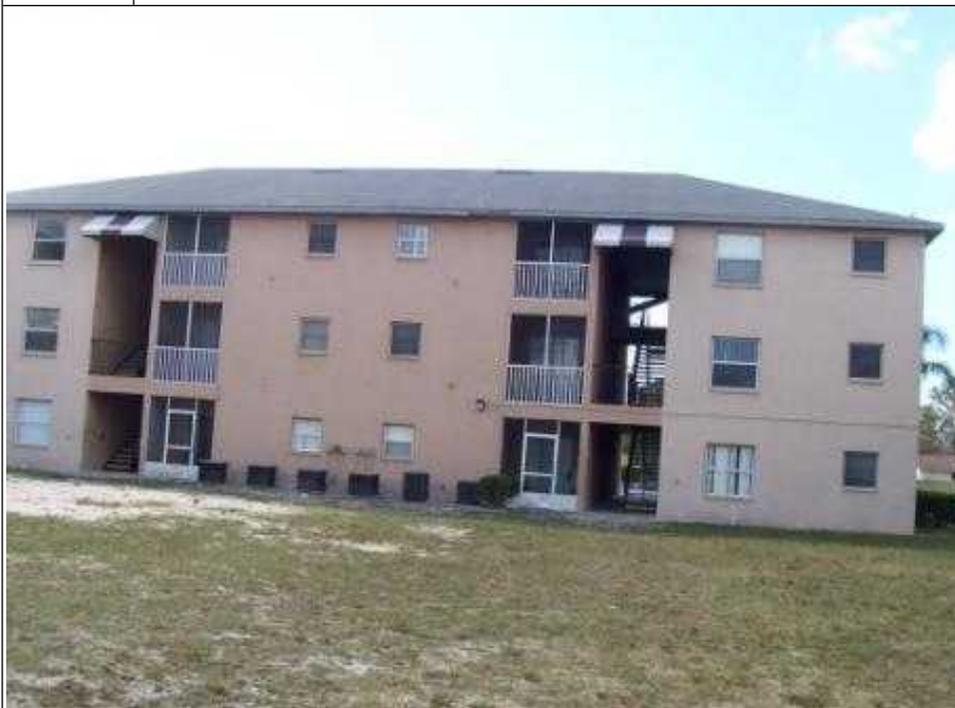
4. Rear facade of building 10

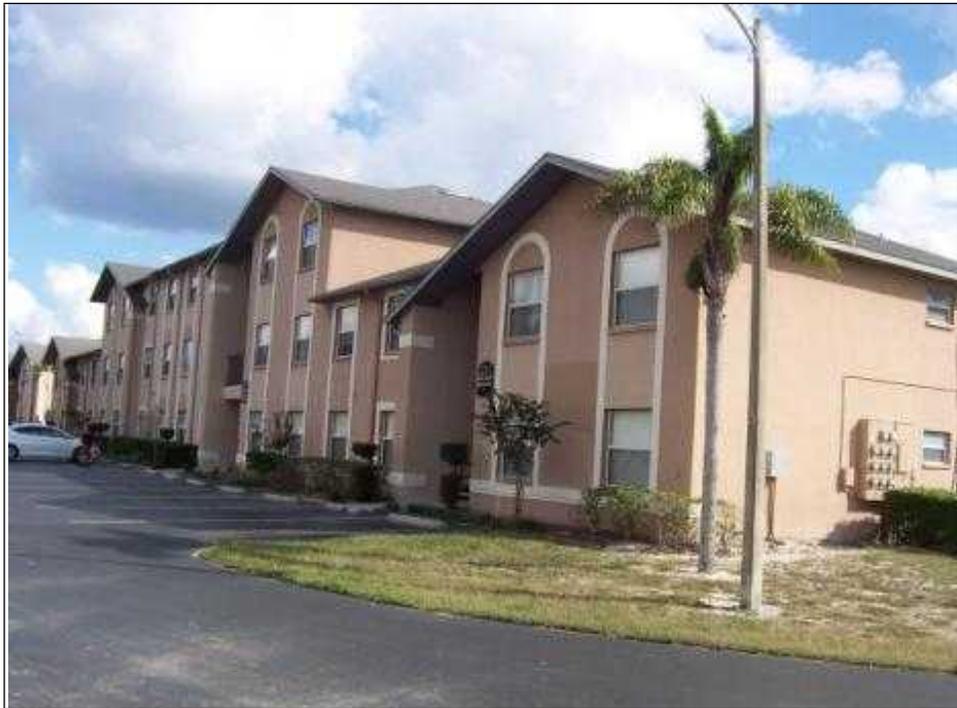
5. Front facade of building 7

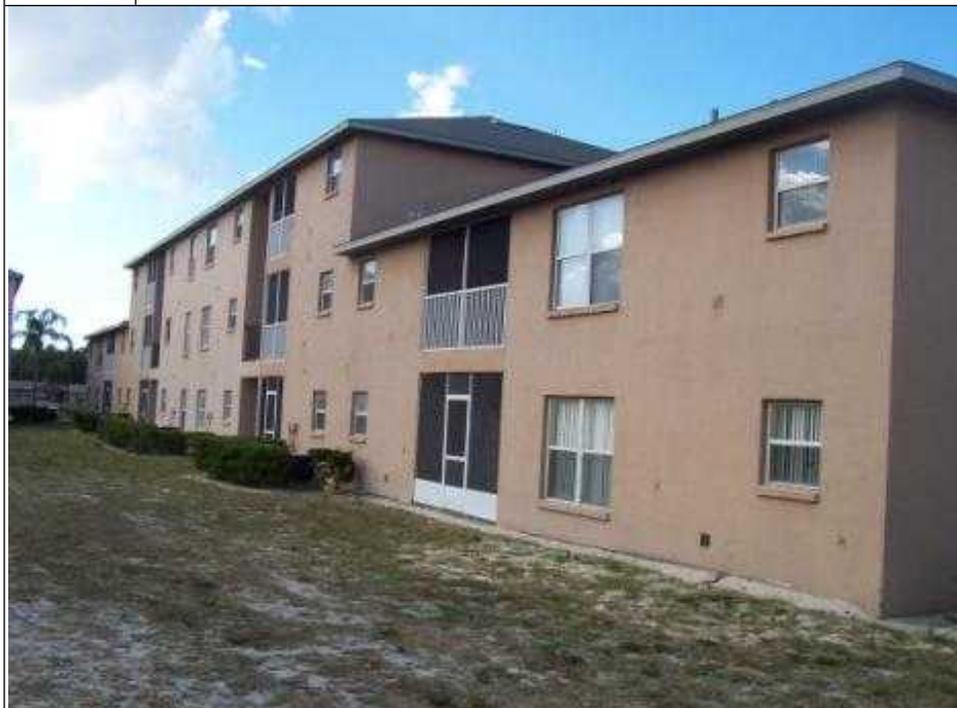
6. Rear facade of building 7

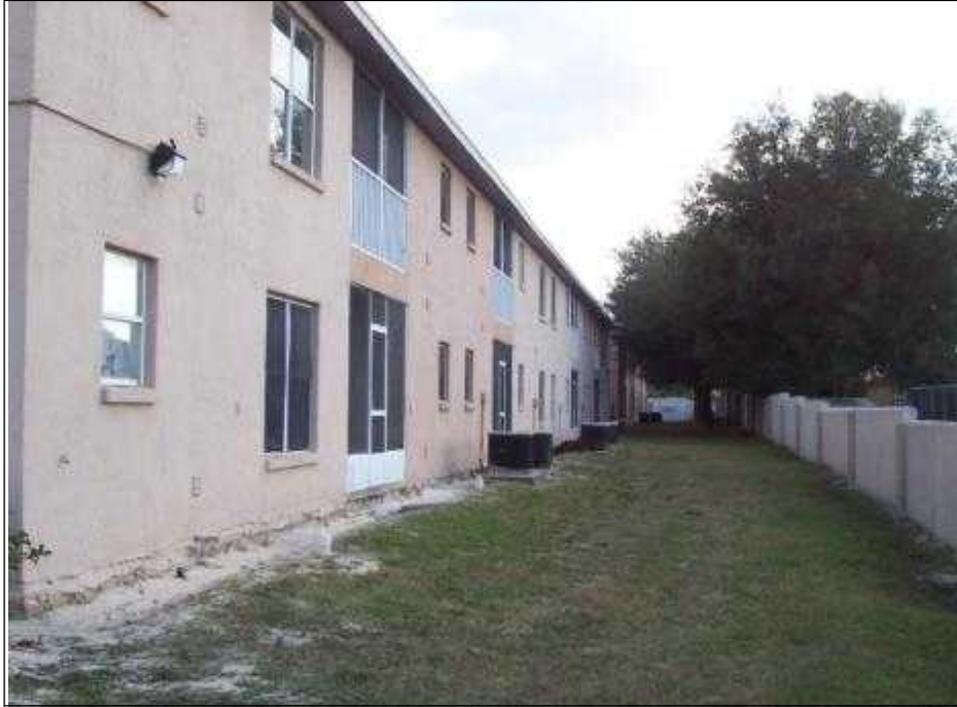
7. Rear facade of buildings 4 & 5 and adjacent landscaping

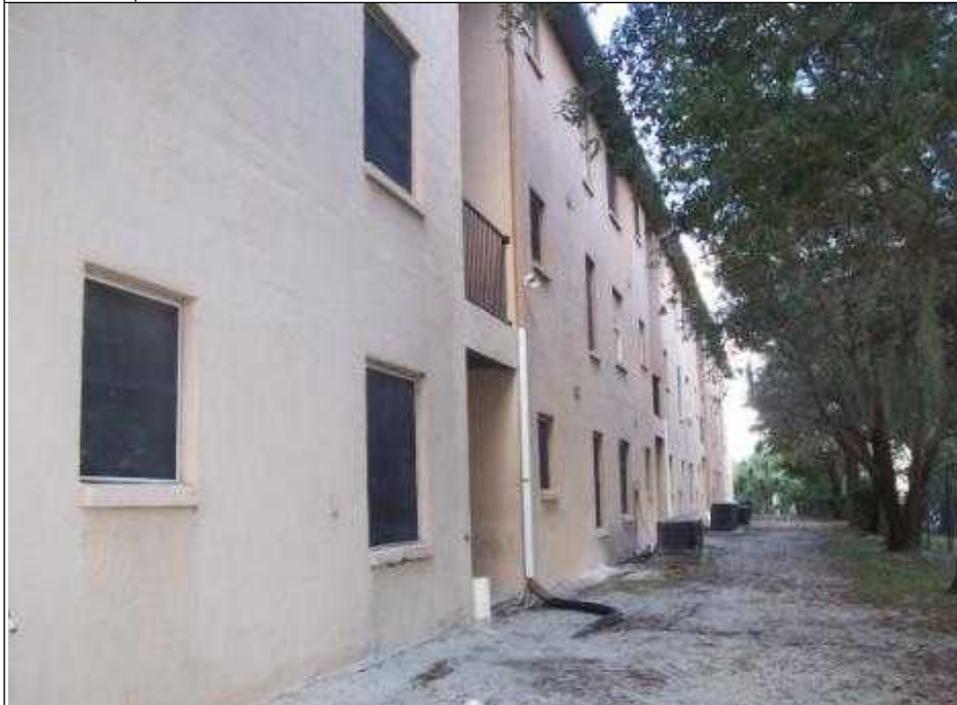
8. Rear facade of building 3 and adjacent landscaping

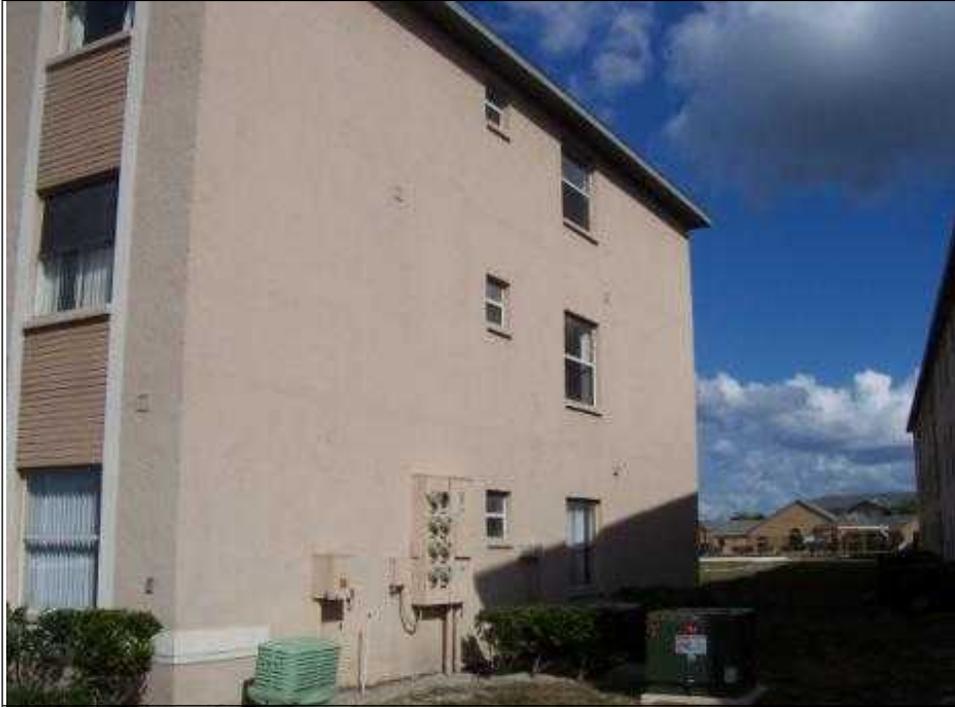
9. Side façade of building 10

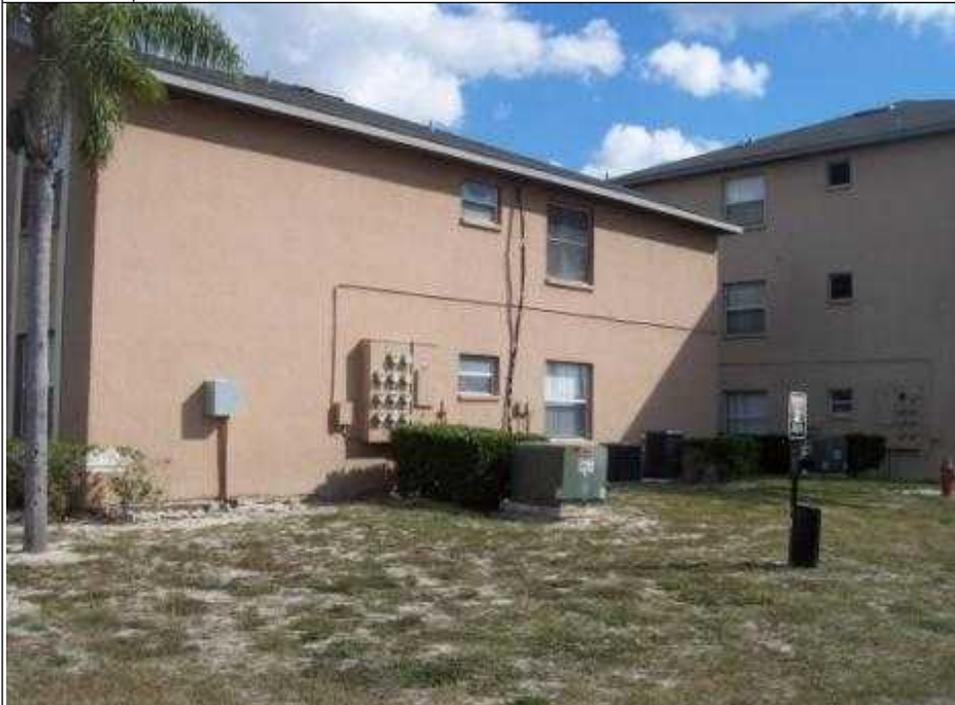
10. Side façade of building 7 and adjacent landscaping

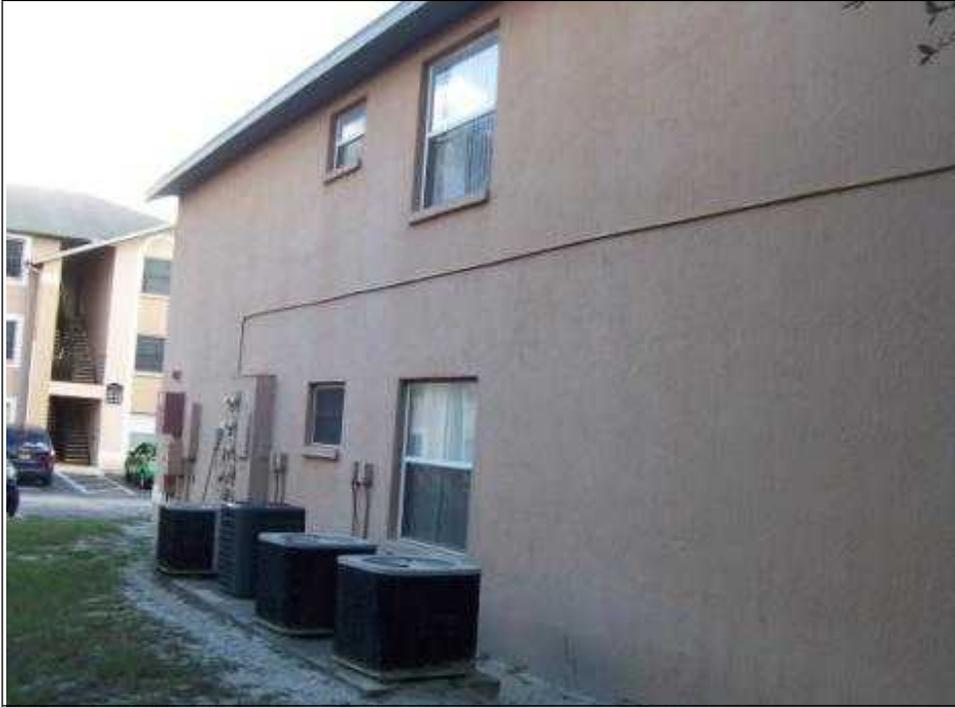
11. Side façade of building 5

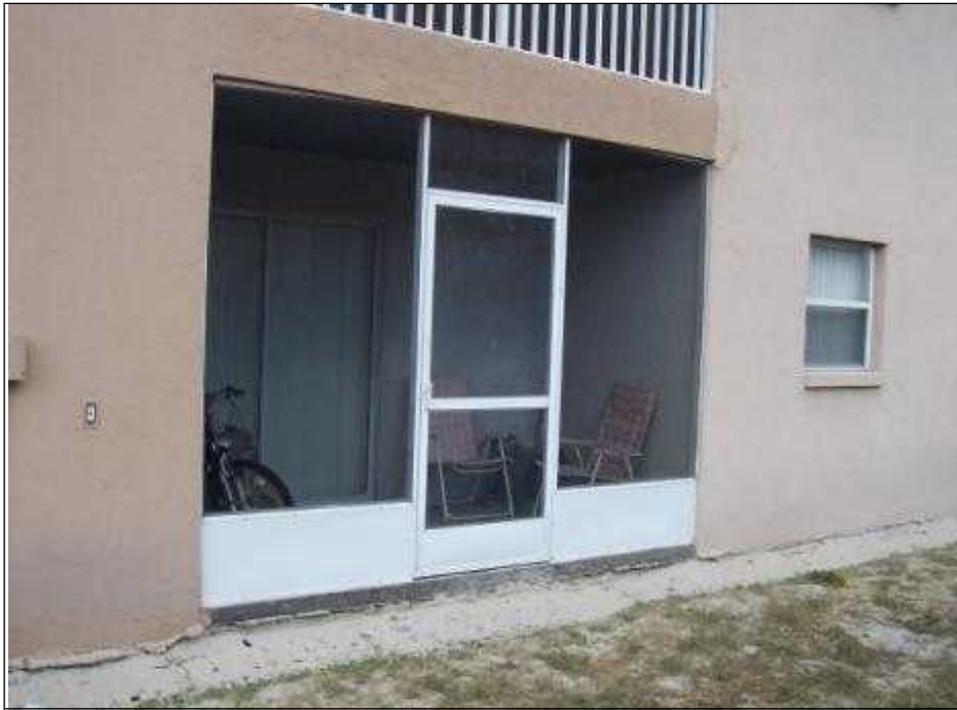
15. Another view of a patio enclosure

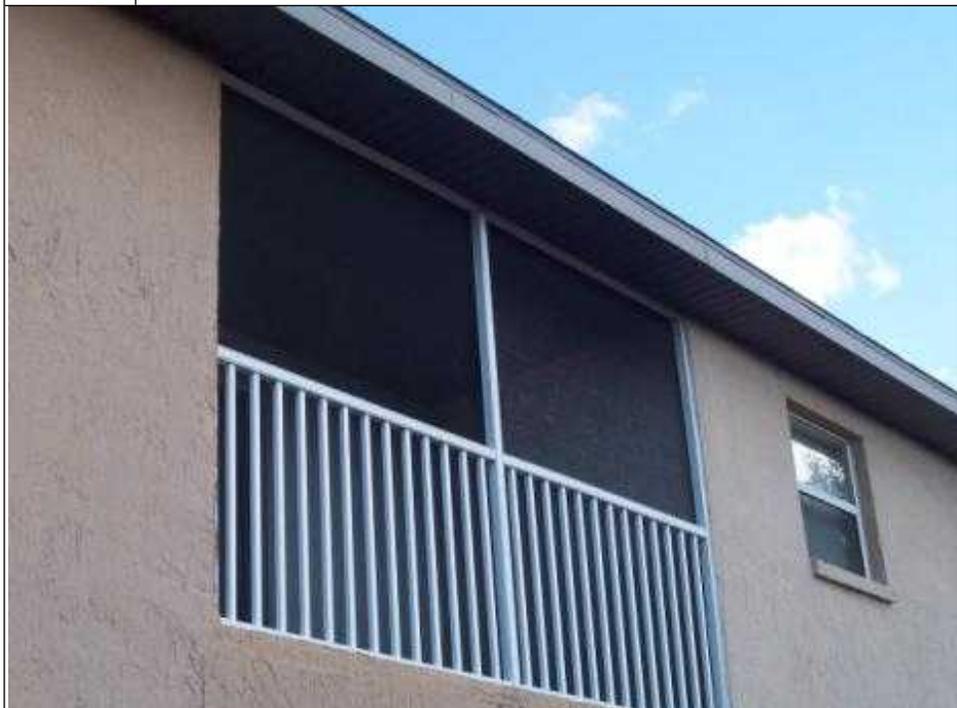
16. Balcony enclosure

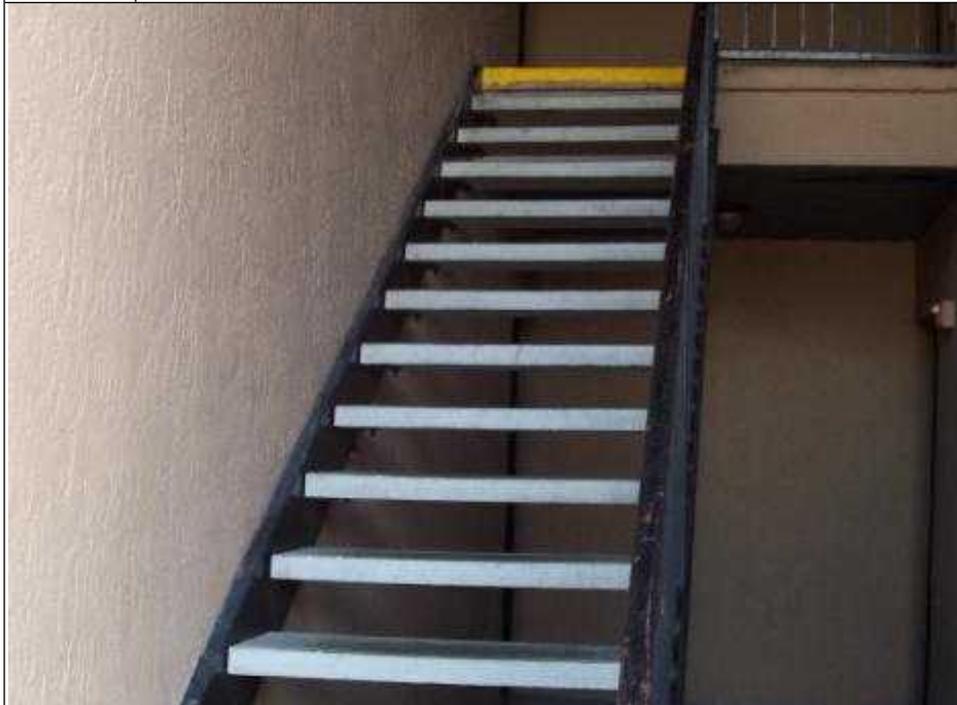
18. Exterior stairway

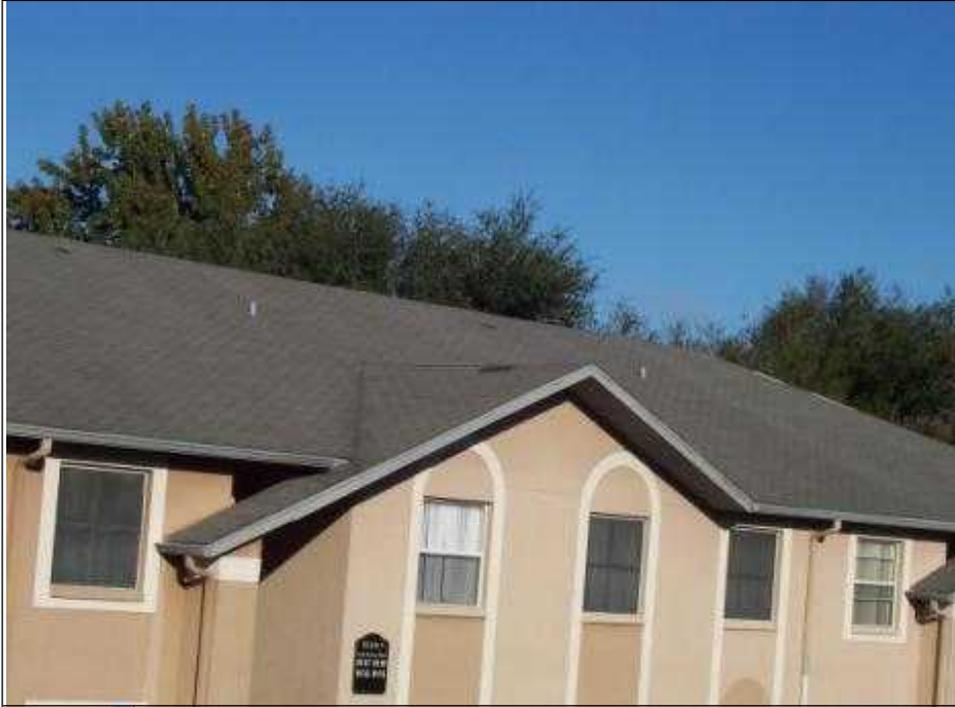
23. Another view of a building roof

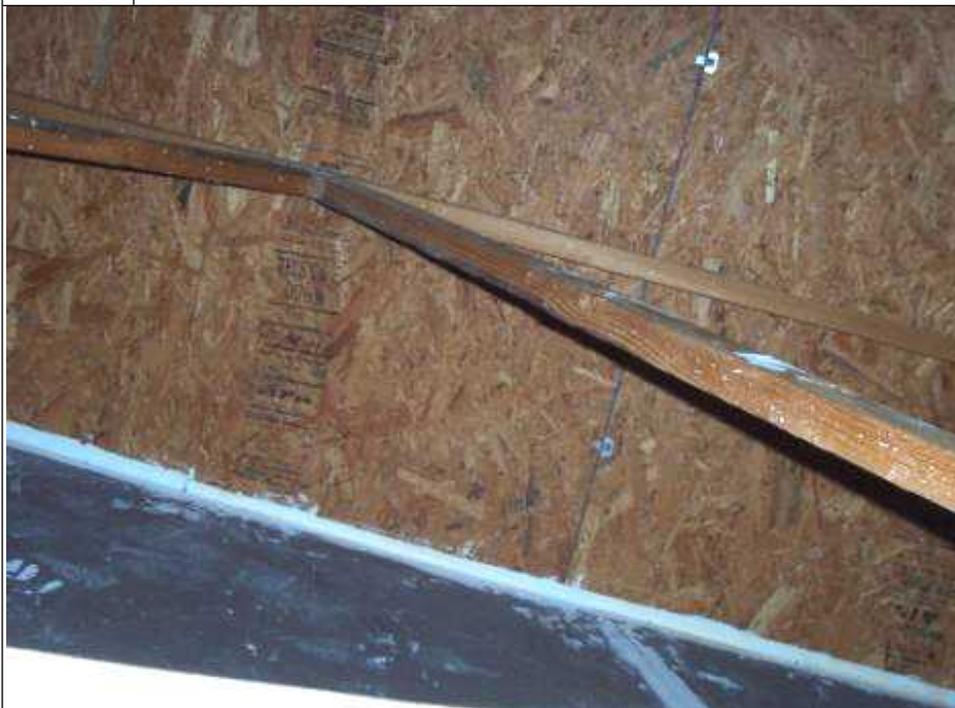
24. Roof deck and framing as viewed from within a down dwelling unit

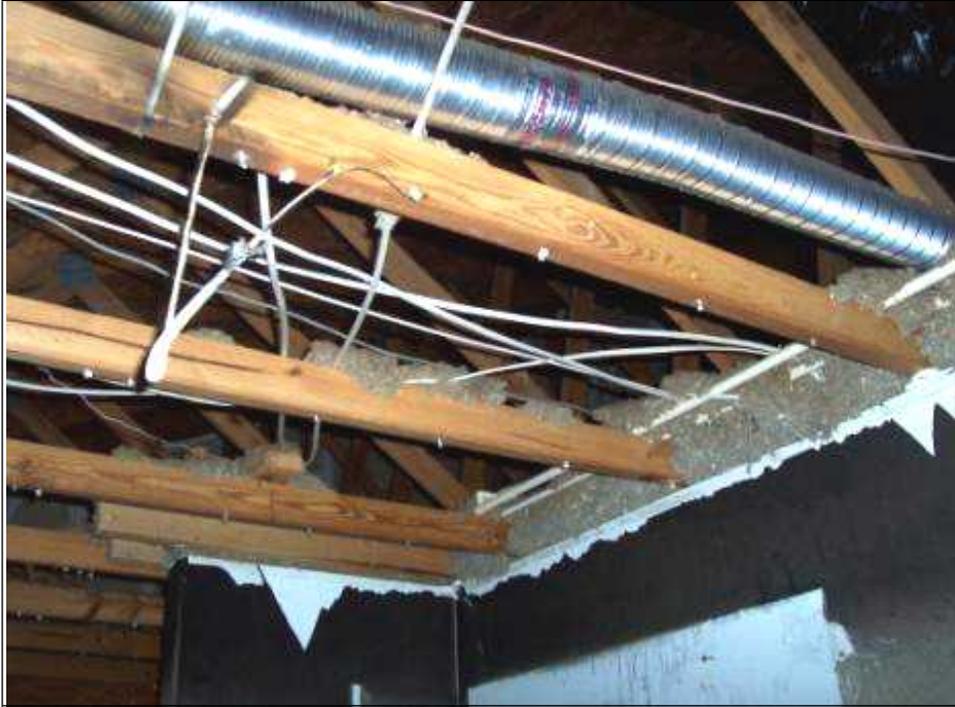
25. Another view of the roof deck and framing as viewed from within a down dwelling unit

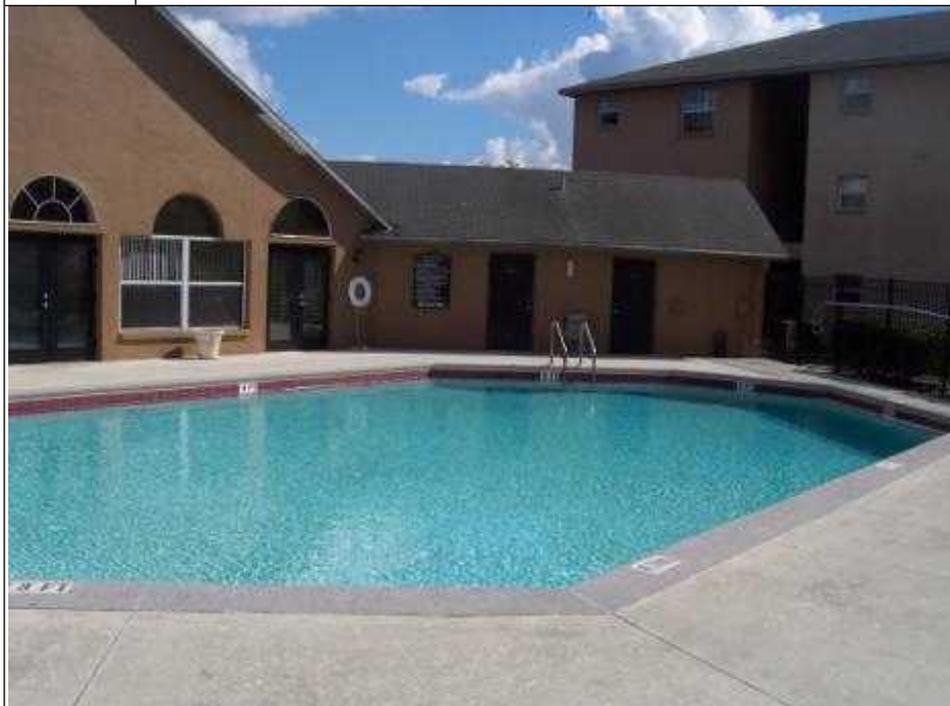
28. Western façade of leasing office and adjacent swimming pool area

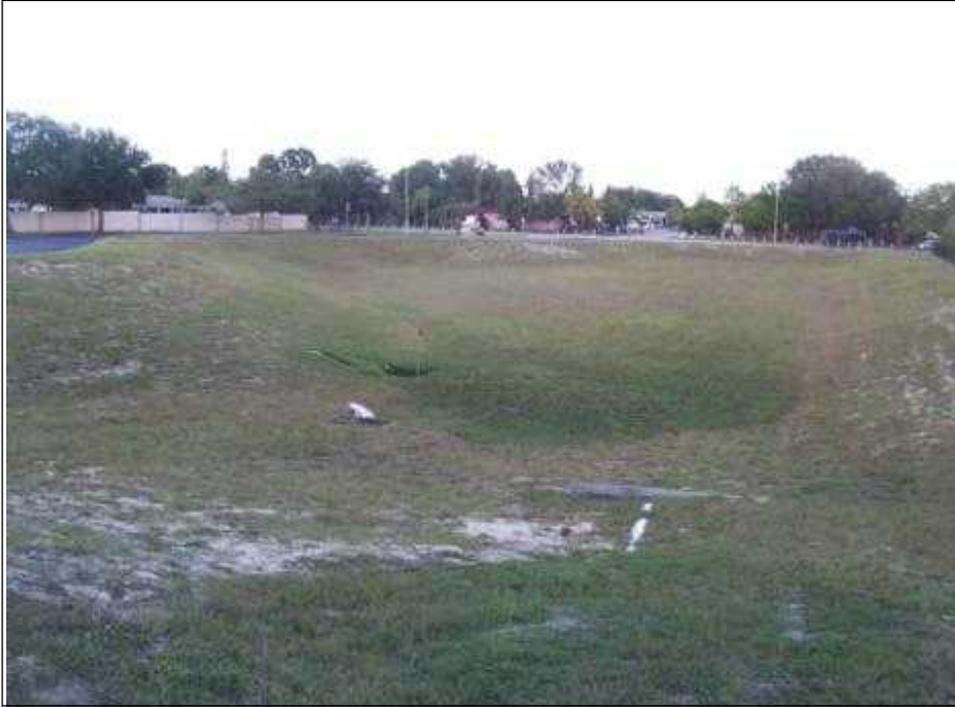
29. Detention pond located on northeast area of Subject Property

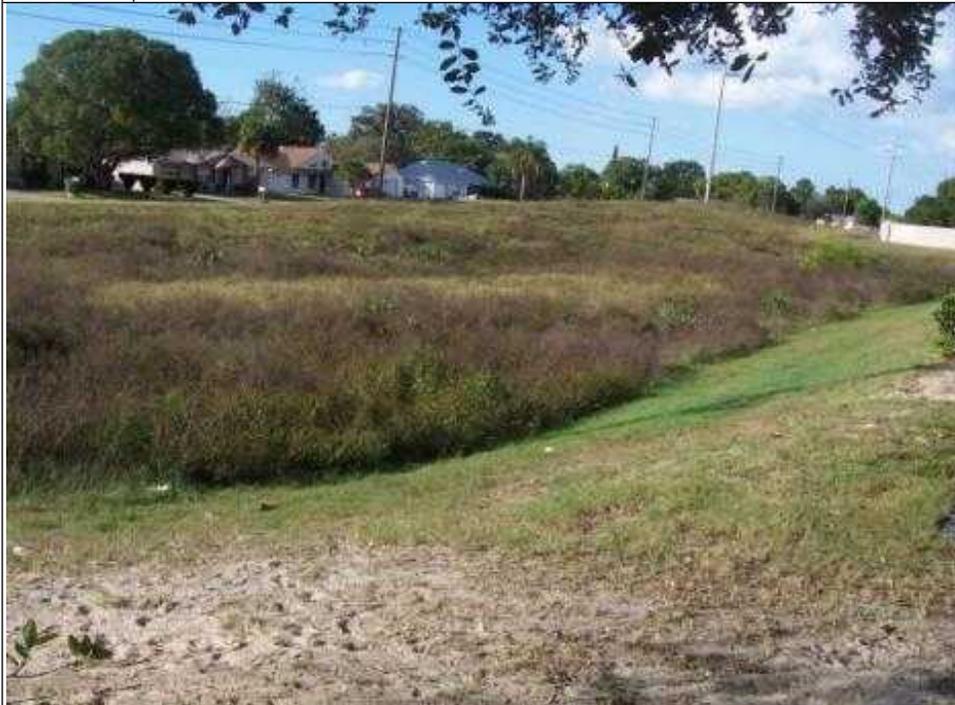
30. Detention pond located on southwest area of Subject Property

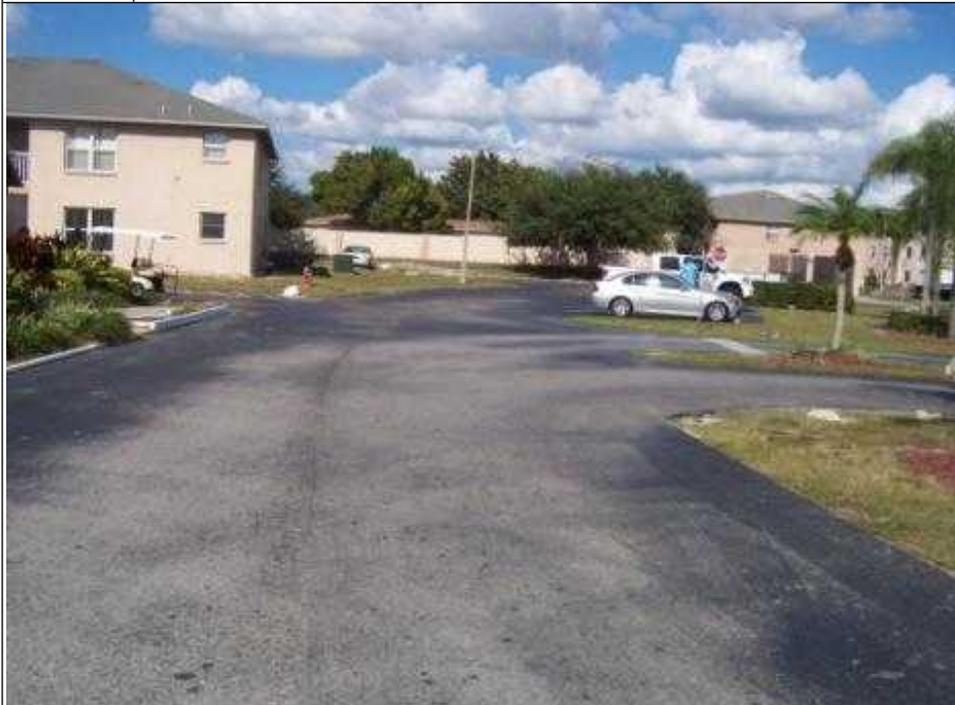
36. View of parking area

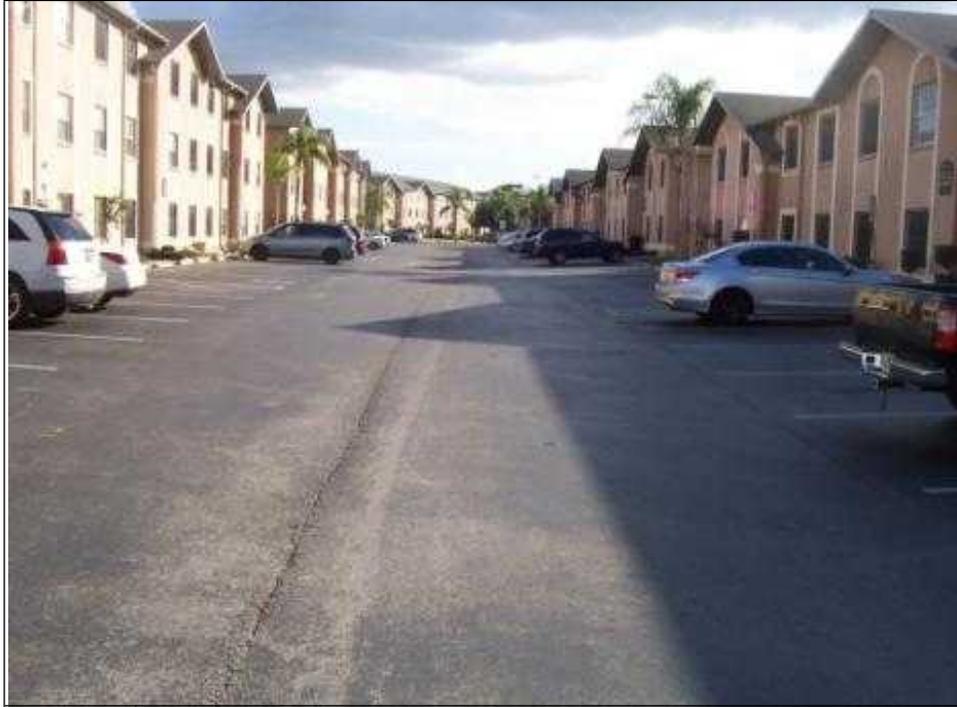
37. Another view of the parking area

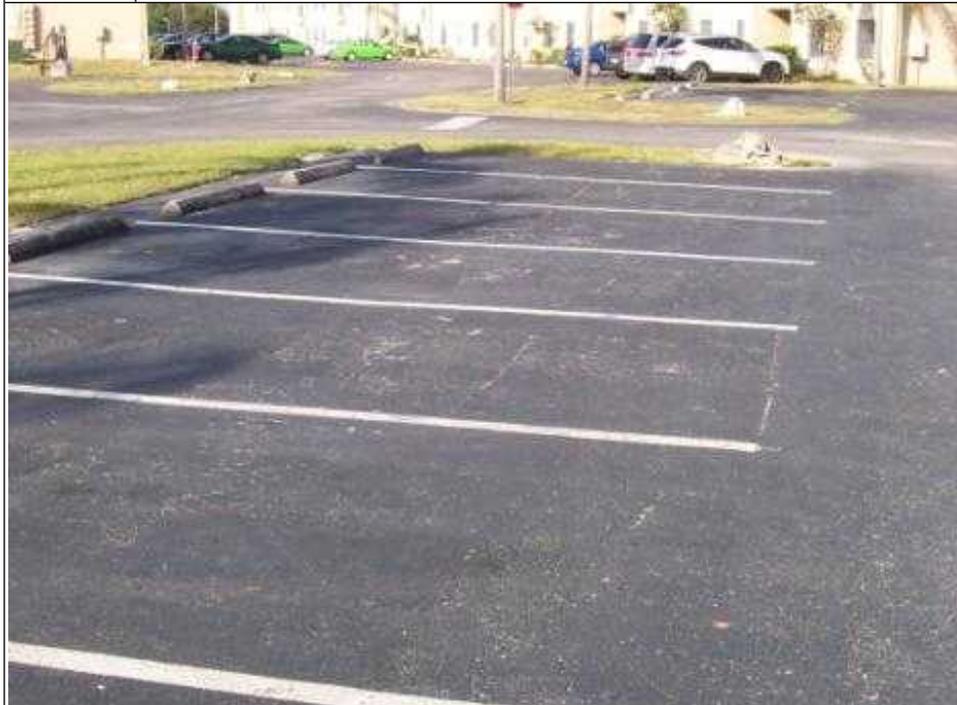
40.

Parking lane markings

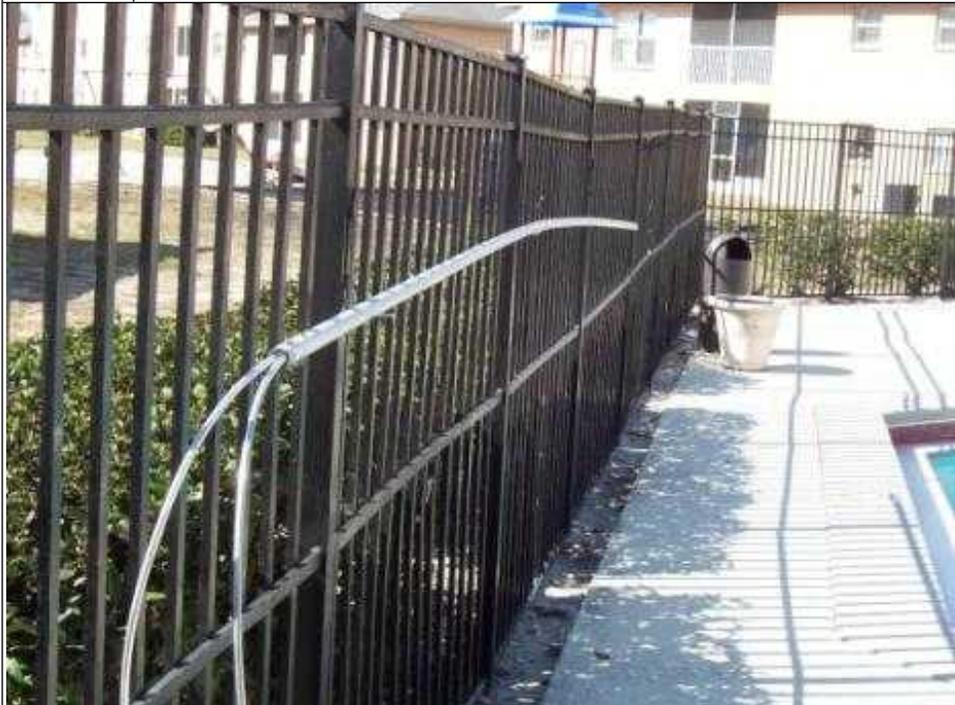
48. Fencing surrounding the swimming pool area

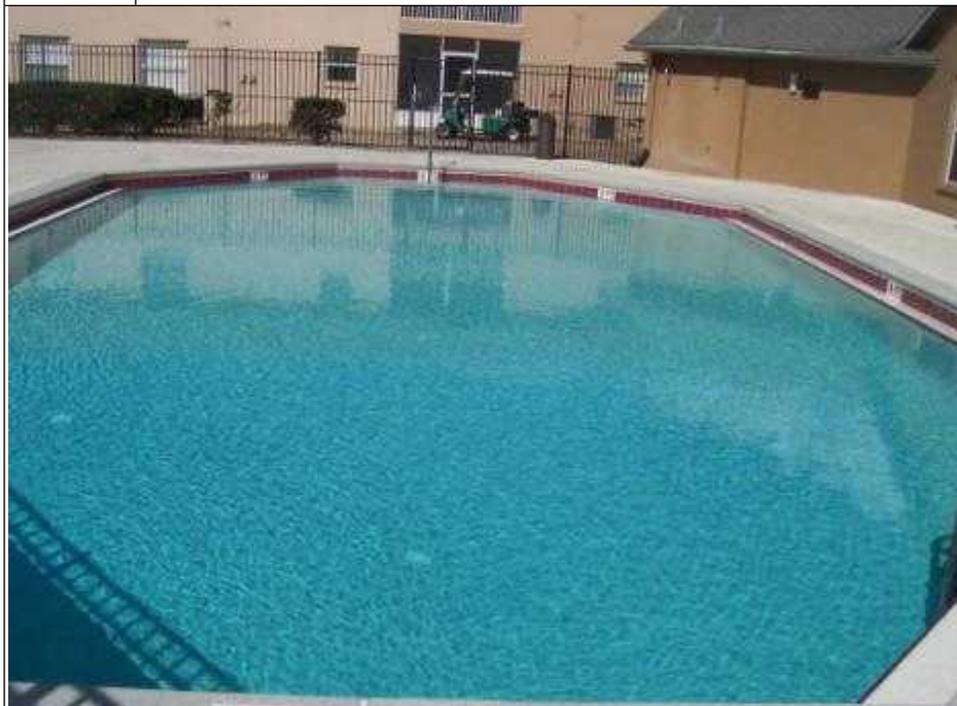
50. Swimming pool

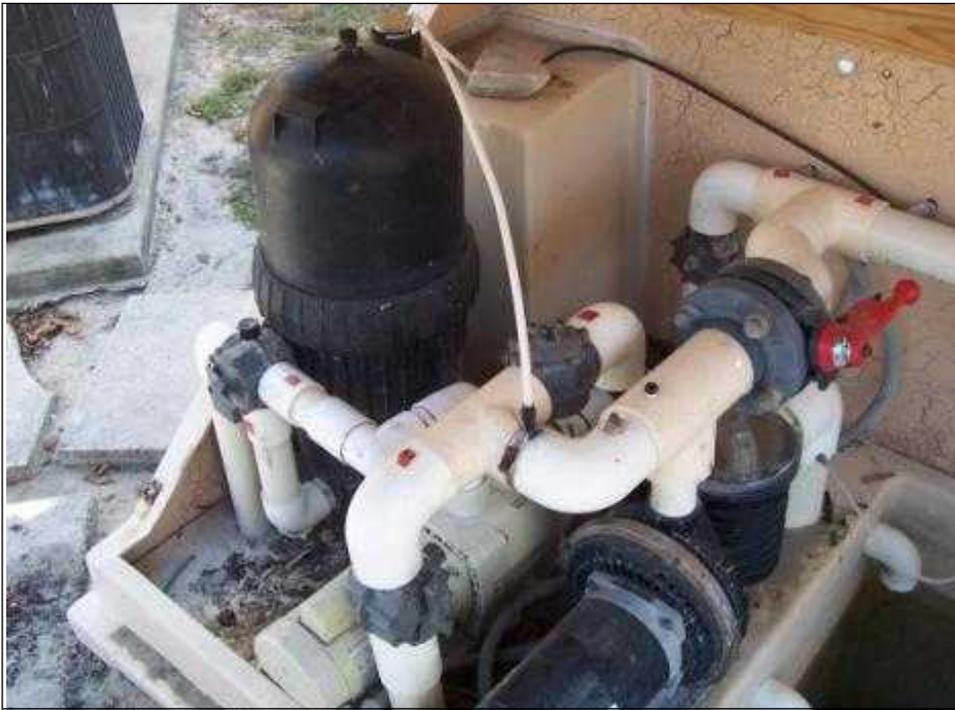
51. Swimming pool filtration equipment

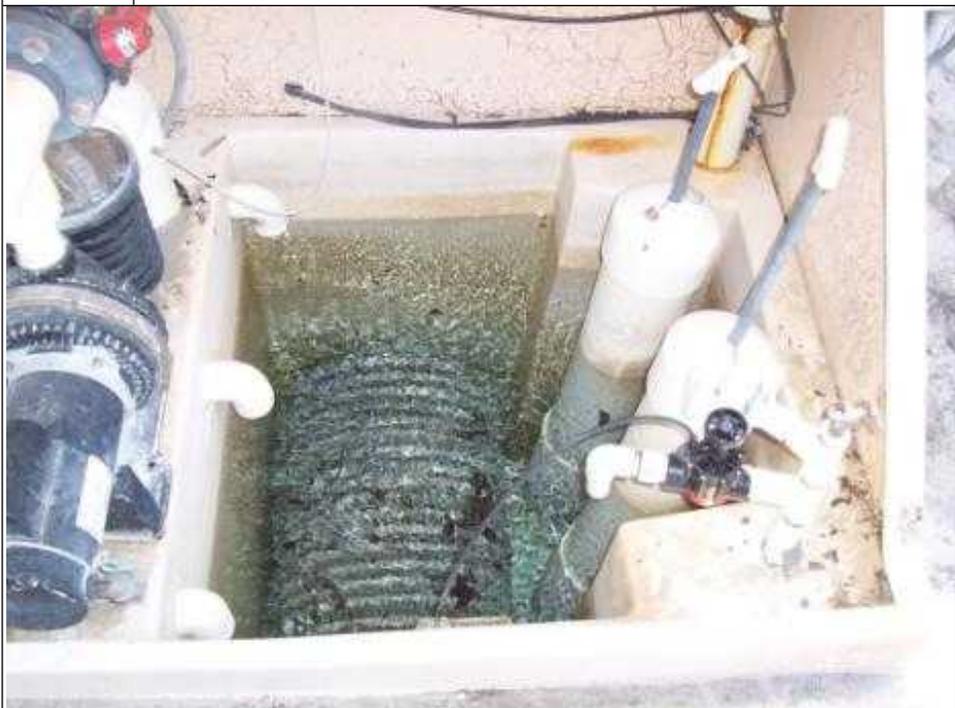
52. Another view of the swimming pool filtration equipment

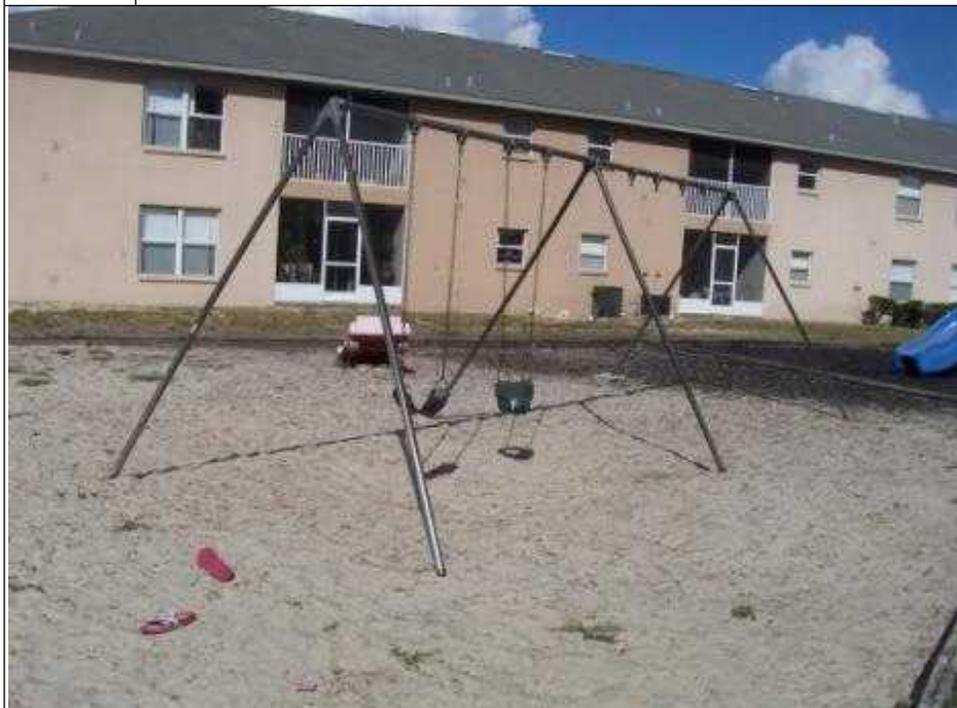
56. Swing set

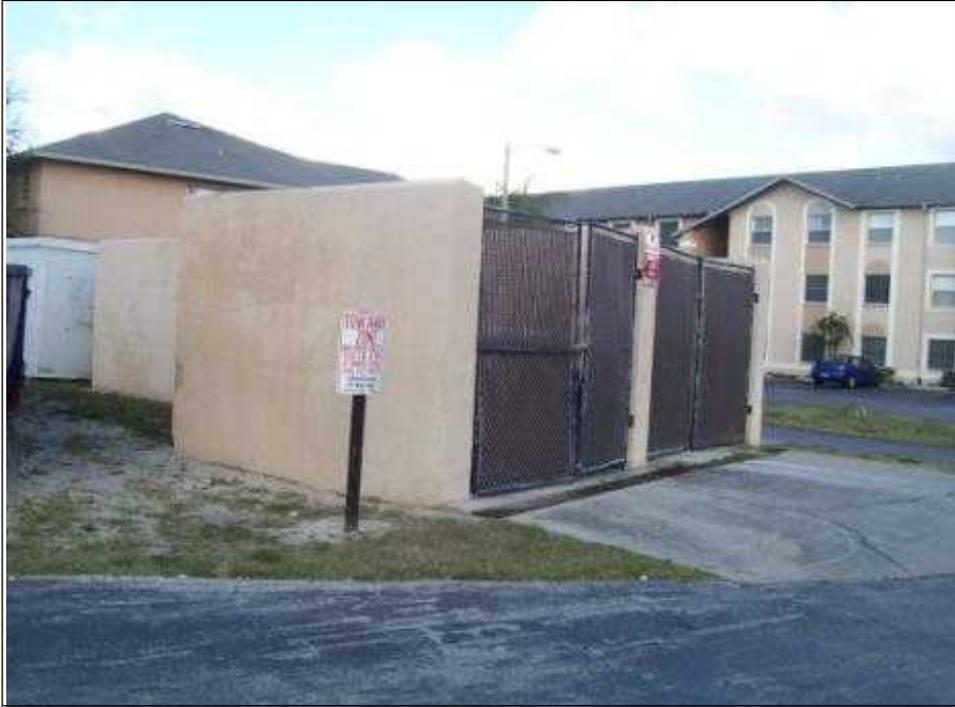
61. Solid waste receptacle enclosure

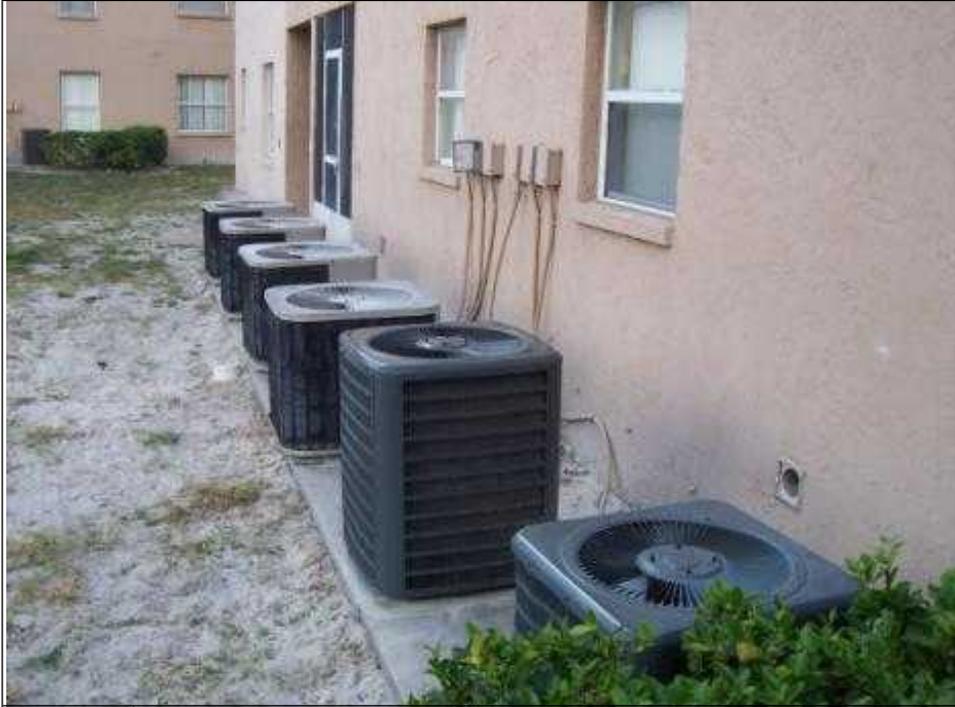
63. Split system condenser units

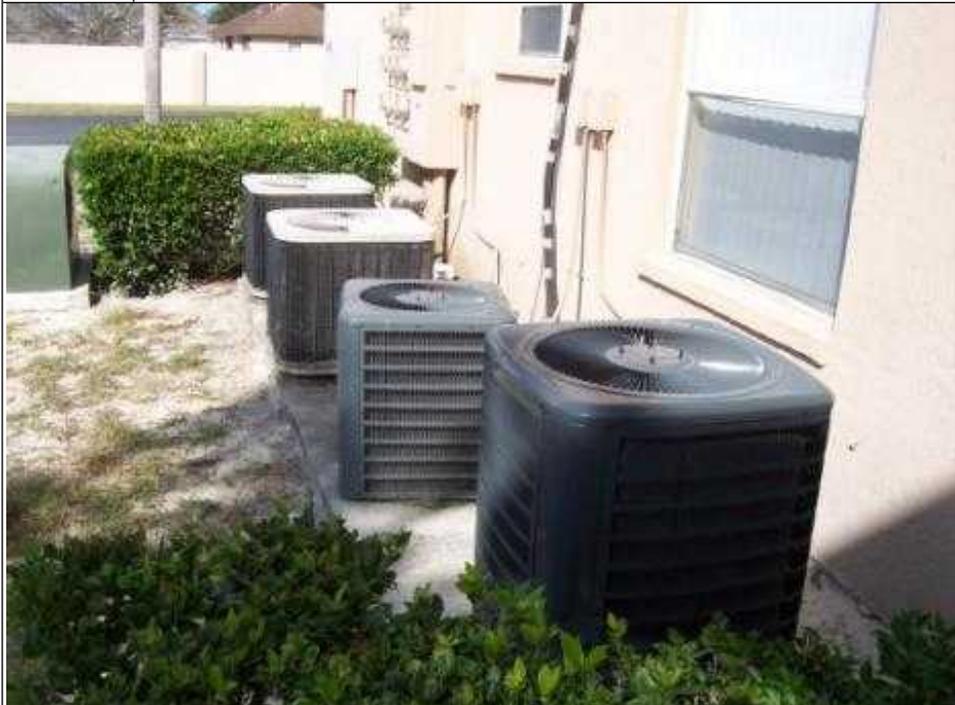
64. Split system condenser units

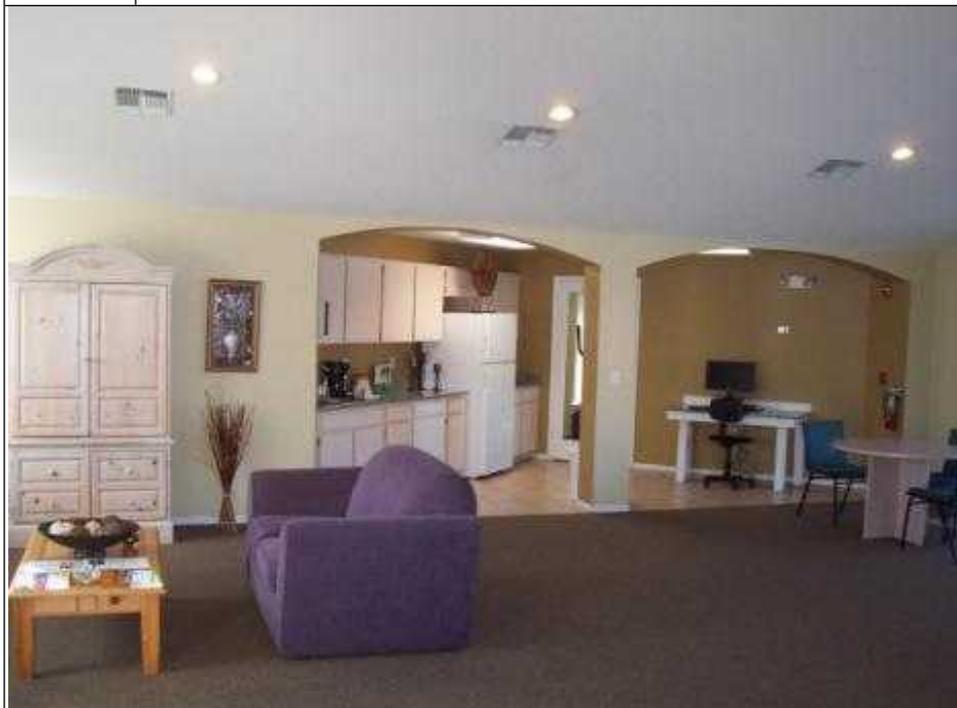
66. Interior view of leasing office

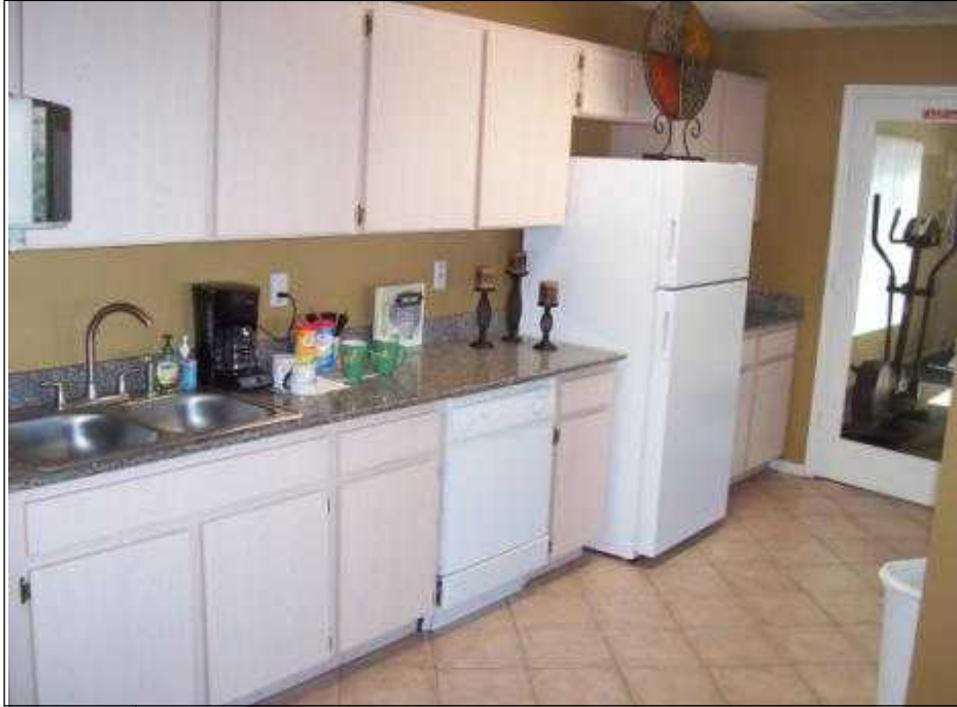
67. Kitchen located in leasing office
