**Regency Palms
Port Richey, Florida**

**Multi-Family Mortgage
Revenue Bond Program
Application**

Property Name: Regency Palms Apts		Property Type: Multifamily Apartments									
Address: 8332 Alnwick Circle		Property Age: 16									
City and State: Port Richey, FL		No. of units: 200									
Site Survey Date: 11/4-5/2015		Square feet: 248,815									
Report Date: November 12, 2015		Analysis Term: 20									
EBI Project #: 1715000325											
Section #	Section Name	Condition					Action Required	Critical Repairs	Non-Critical Repairs	Replacement Reserves	
		Excellent	Good	Fair	Poor	NA					
SITE CONDITIONS

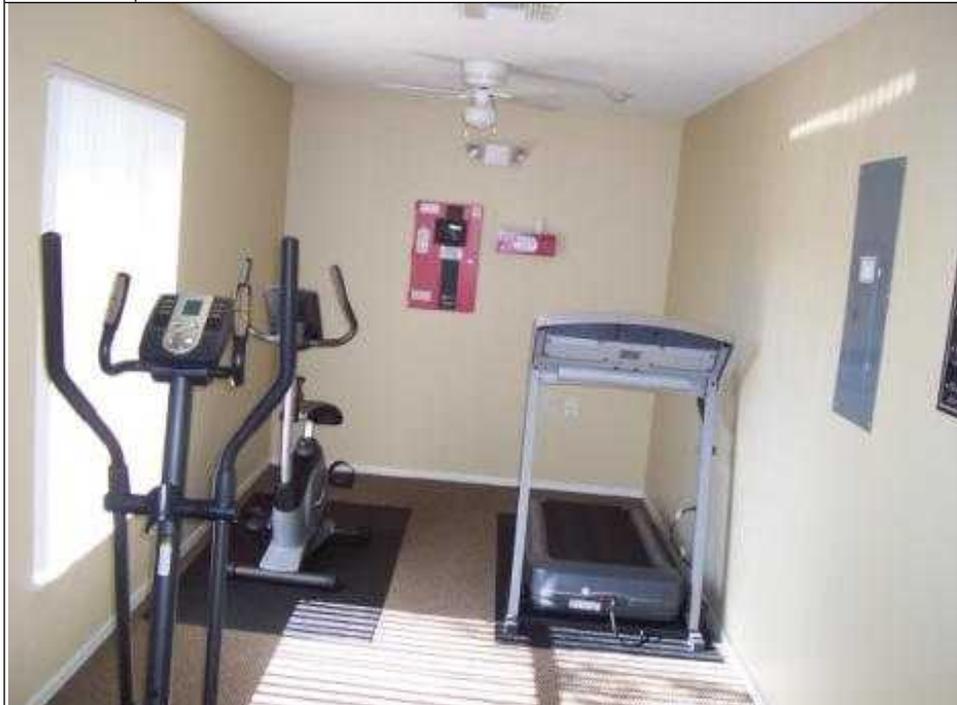
68. Fitness room located in leasing office

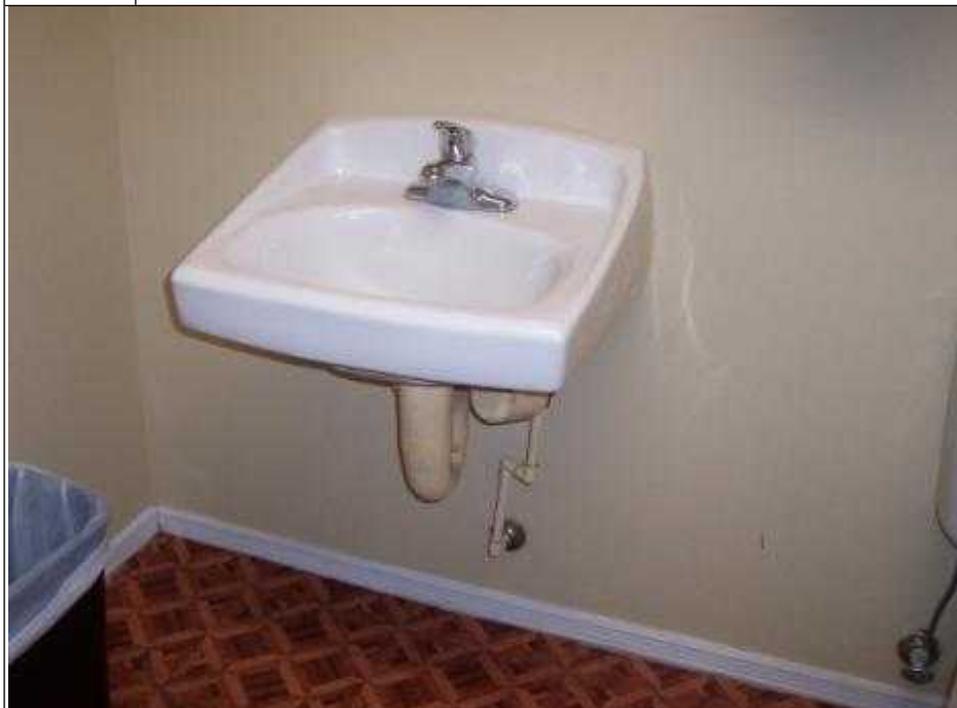
70. Sink located in Unisex public restroom

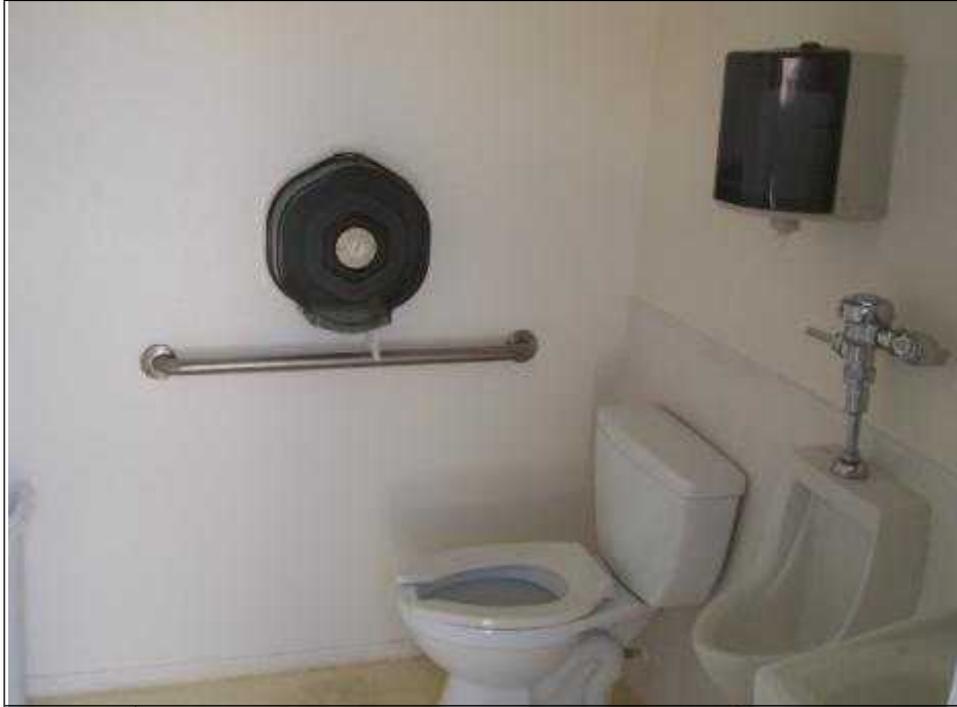
73. Men's restroom located in by the swimming pool area

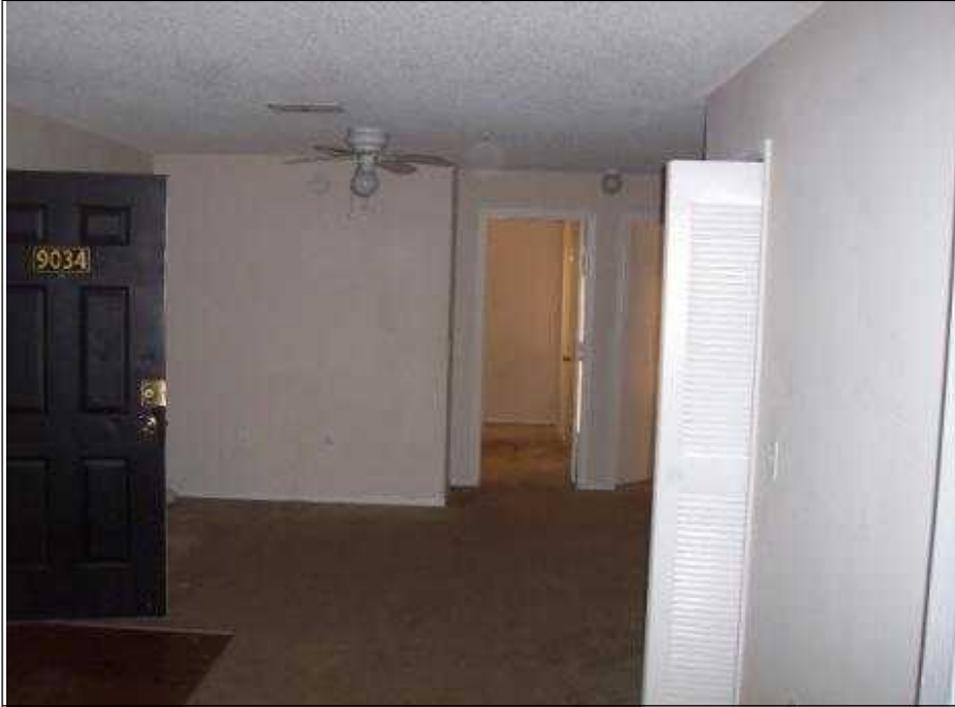
75. Dwelling unit living room

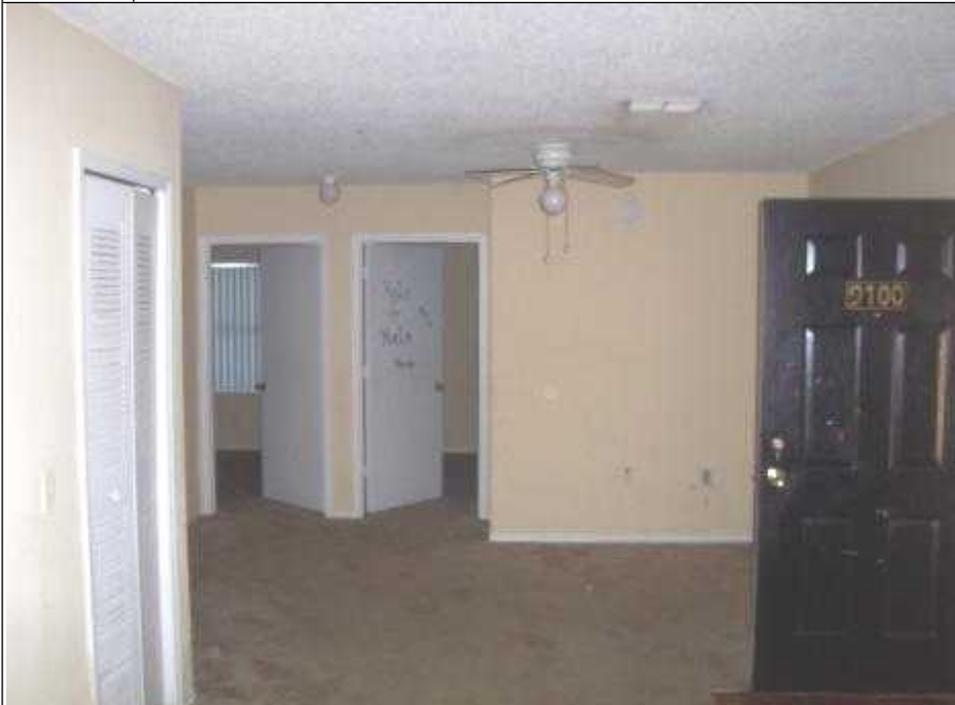
76. Another view of an dwelling unit living room

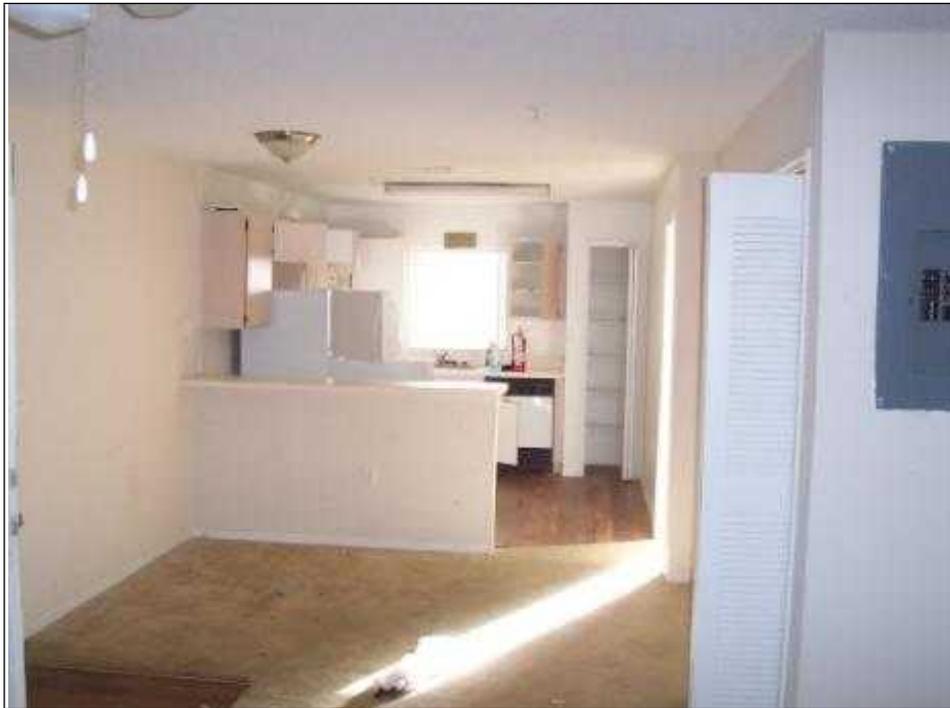
77. View toward an apartment living room and kitchen

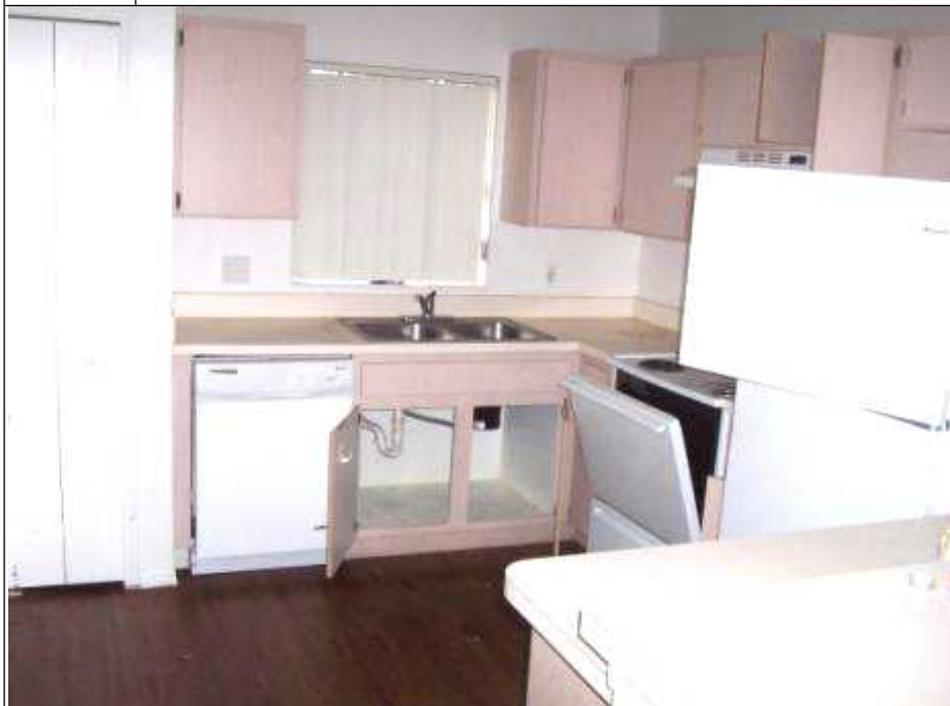
78. Dwelling unit kitchen of a vacant unit

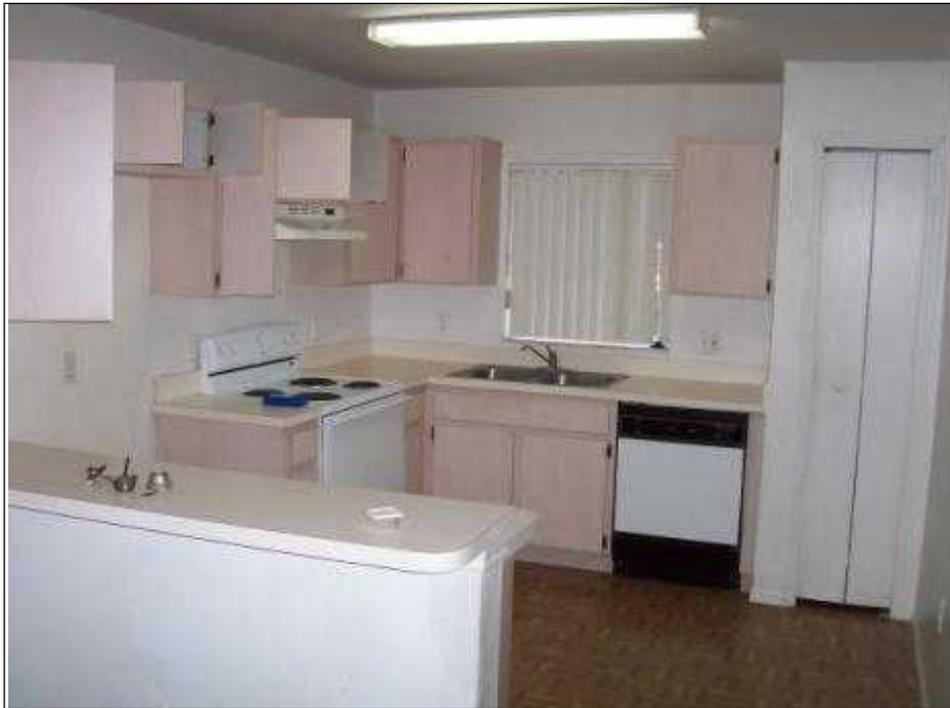
79. Dwelling unit kitchen of a vacant unit

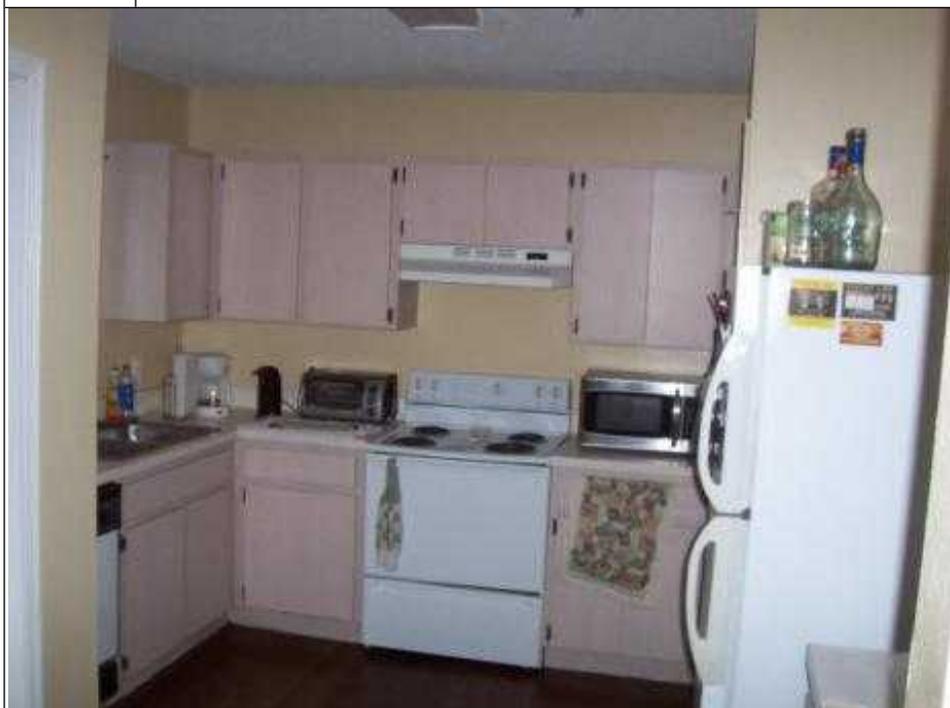
80. Dwelling unit kitchen of an occupied unit

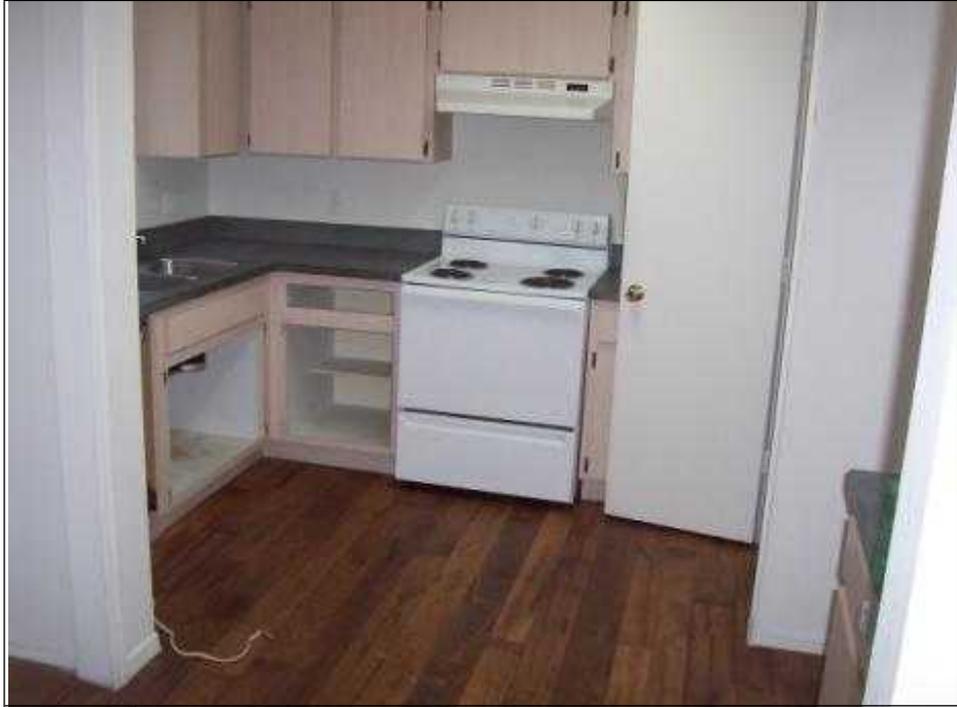
81. Dwelling unit kitchen of an occupied unit

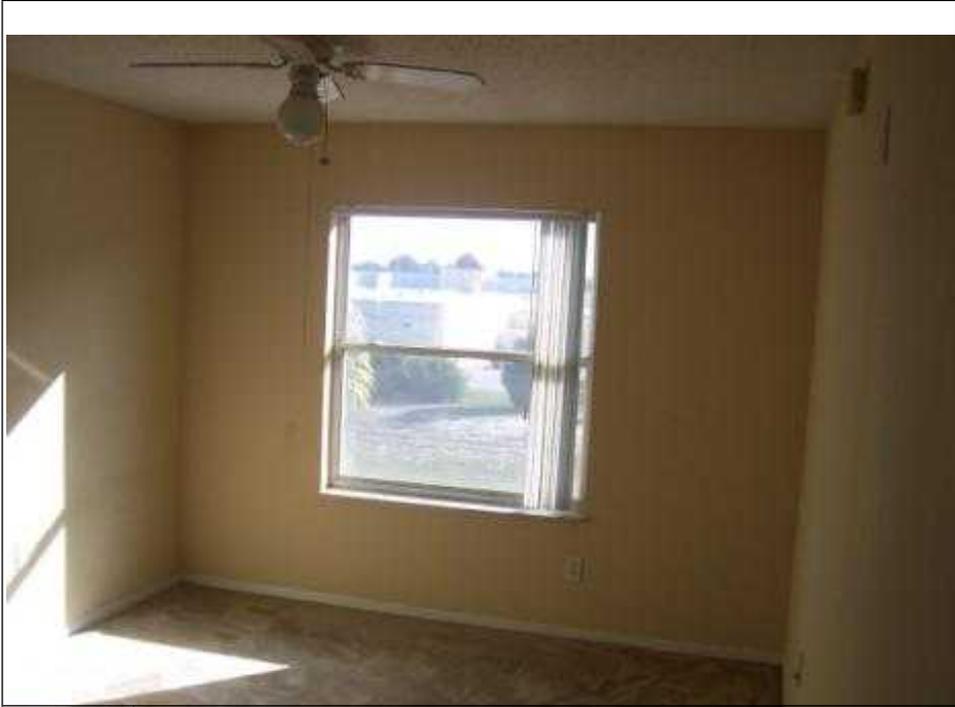
85. Bedroom located in an dwelling unit

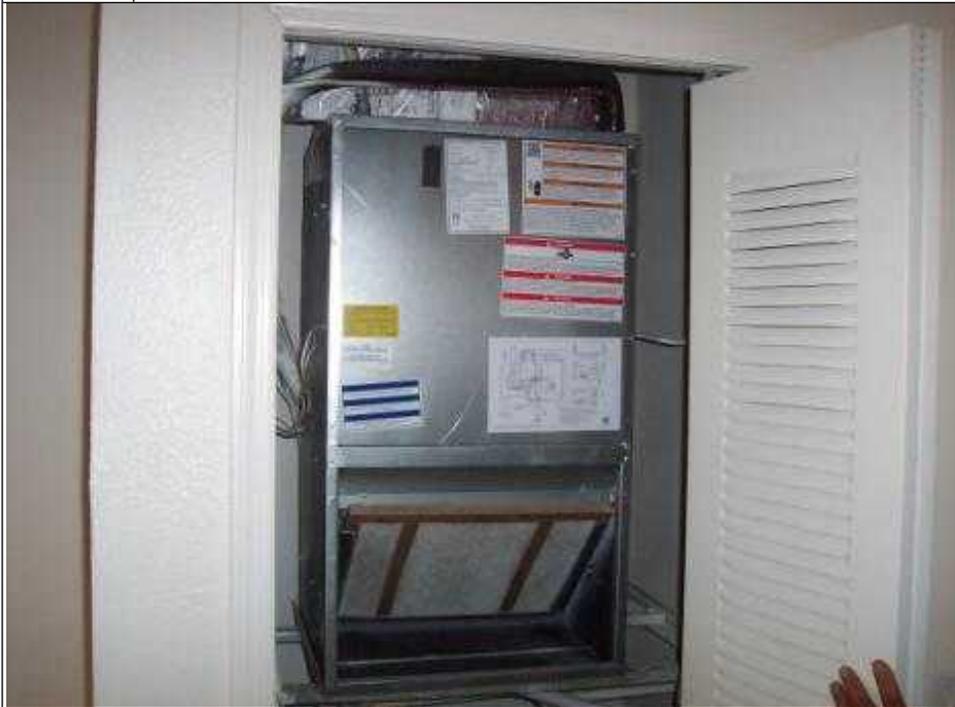
92. Recently replaced air handler unit

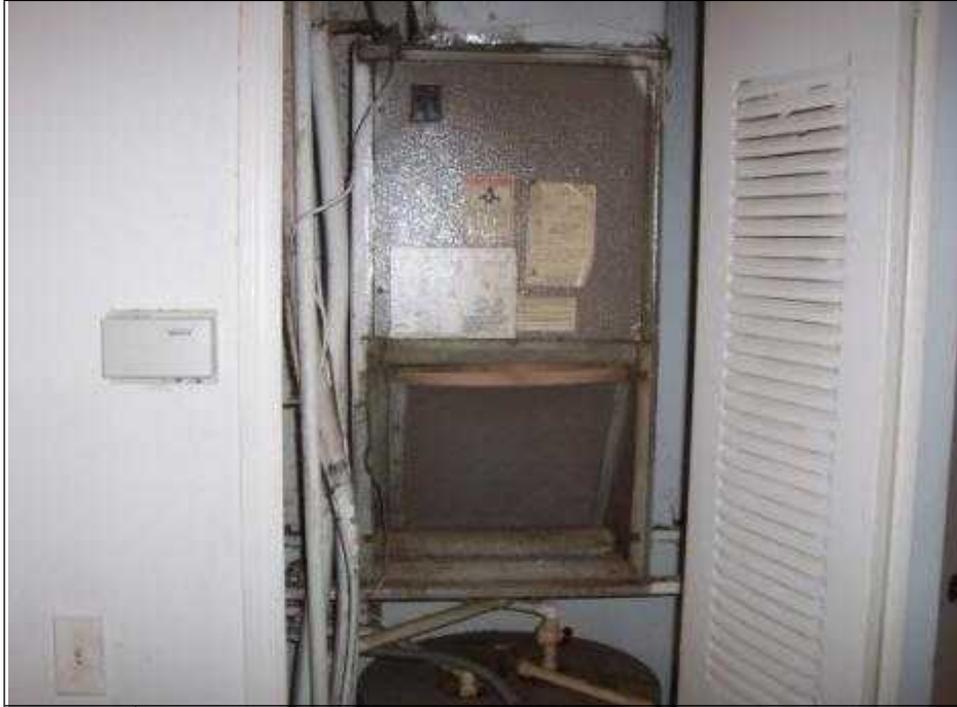
93. Spilt system air handling unit from original construction

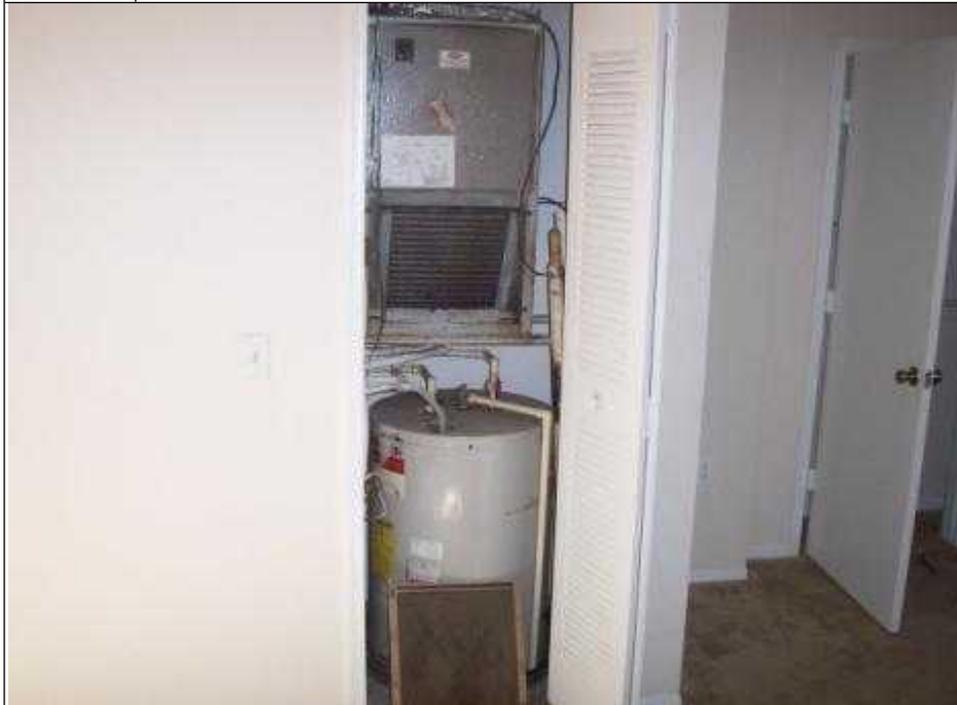
94. Water heater and split system air handling unit

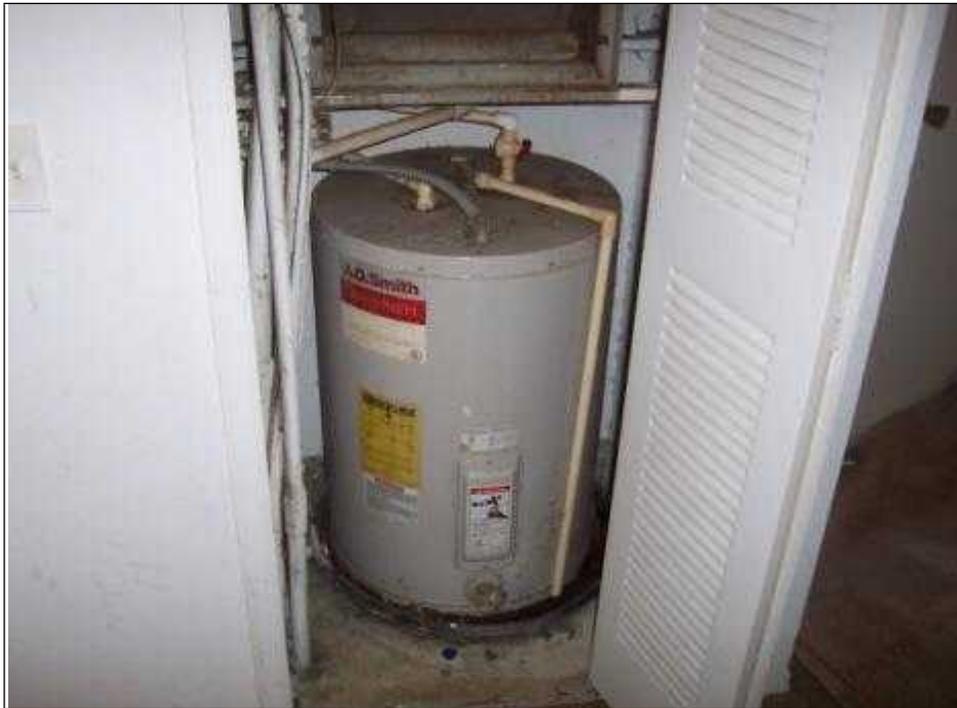
95. Water heater unit

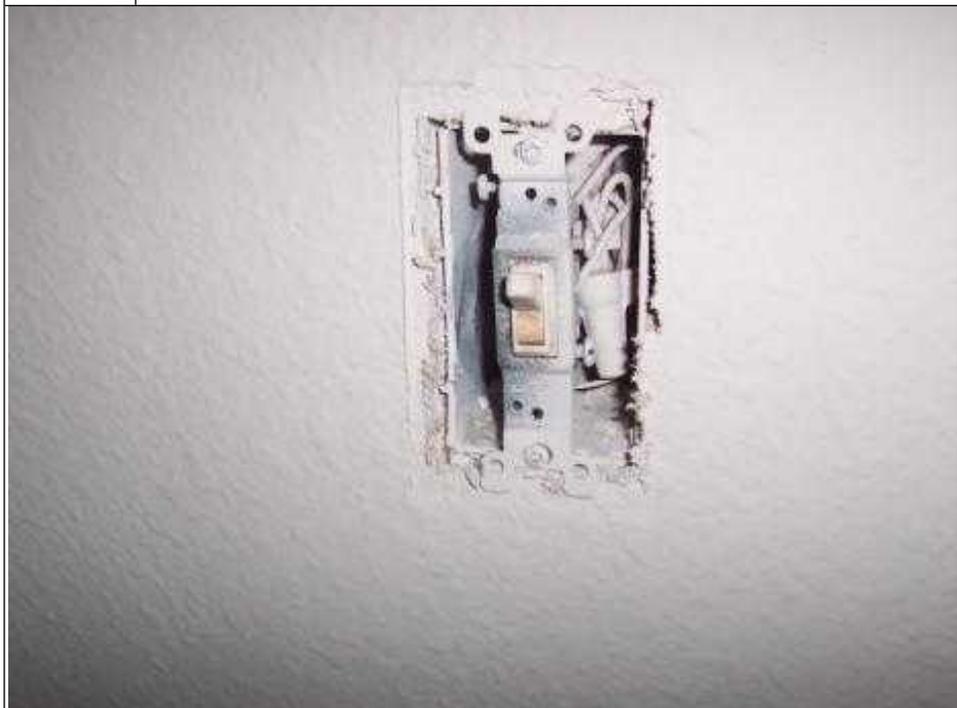
96. Close-up of copper branch wiring

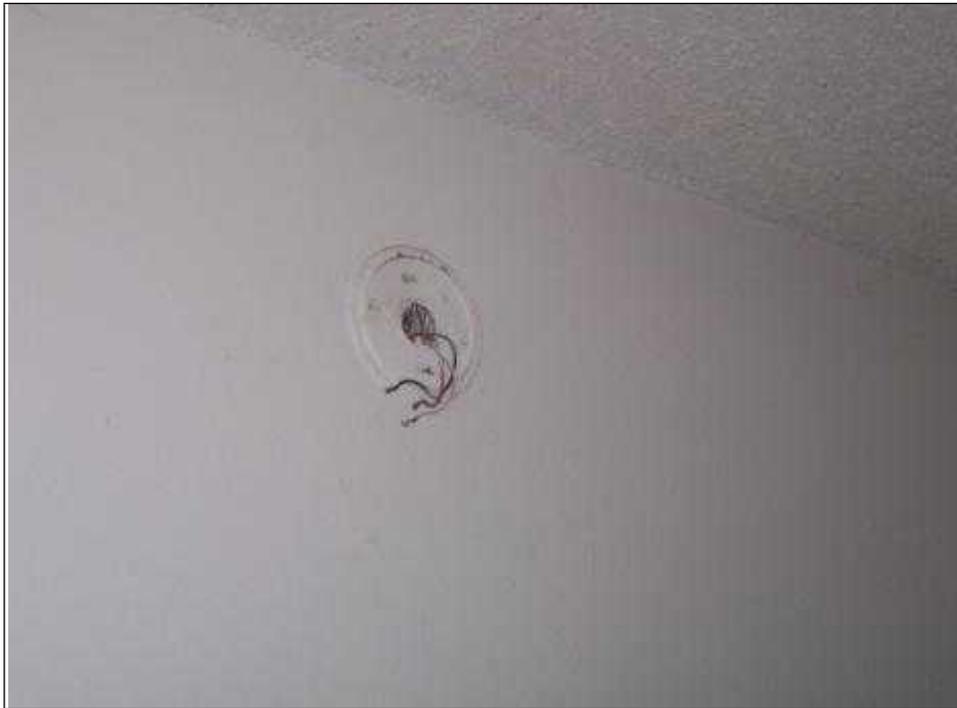
97. Close-up of hard-wiring for smoke detector

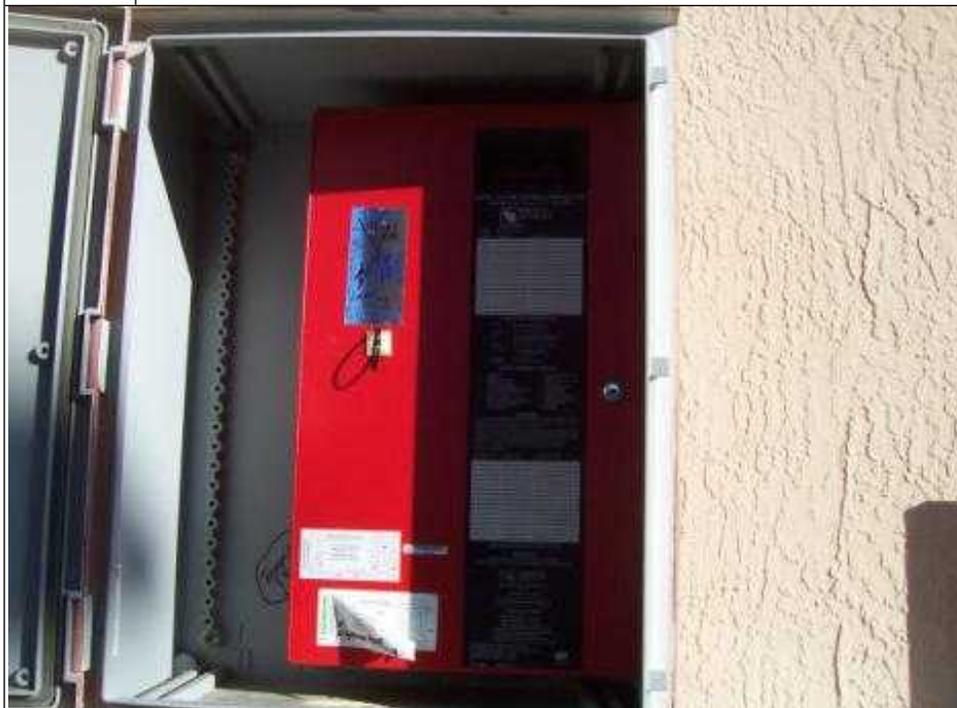
98. Building-mounted fire alarm control panel
